Satsop River Topography

Topographic (LiDAR) Data for the lower Satsop River floodplain. Note the prominent alluvial fan (red color midway between SR 12 and the Chehalis River), the WDFW pits and spoils piles (white and red colors between Satsop and Keyes Road) and the many remnant channels of the Satsop and Chehalis Rivers.

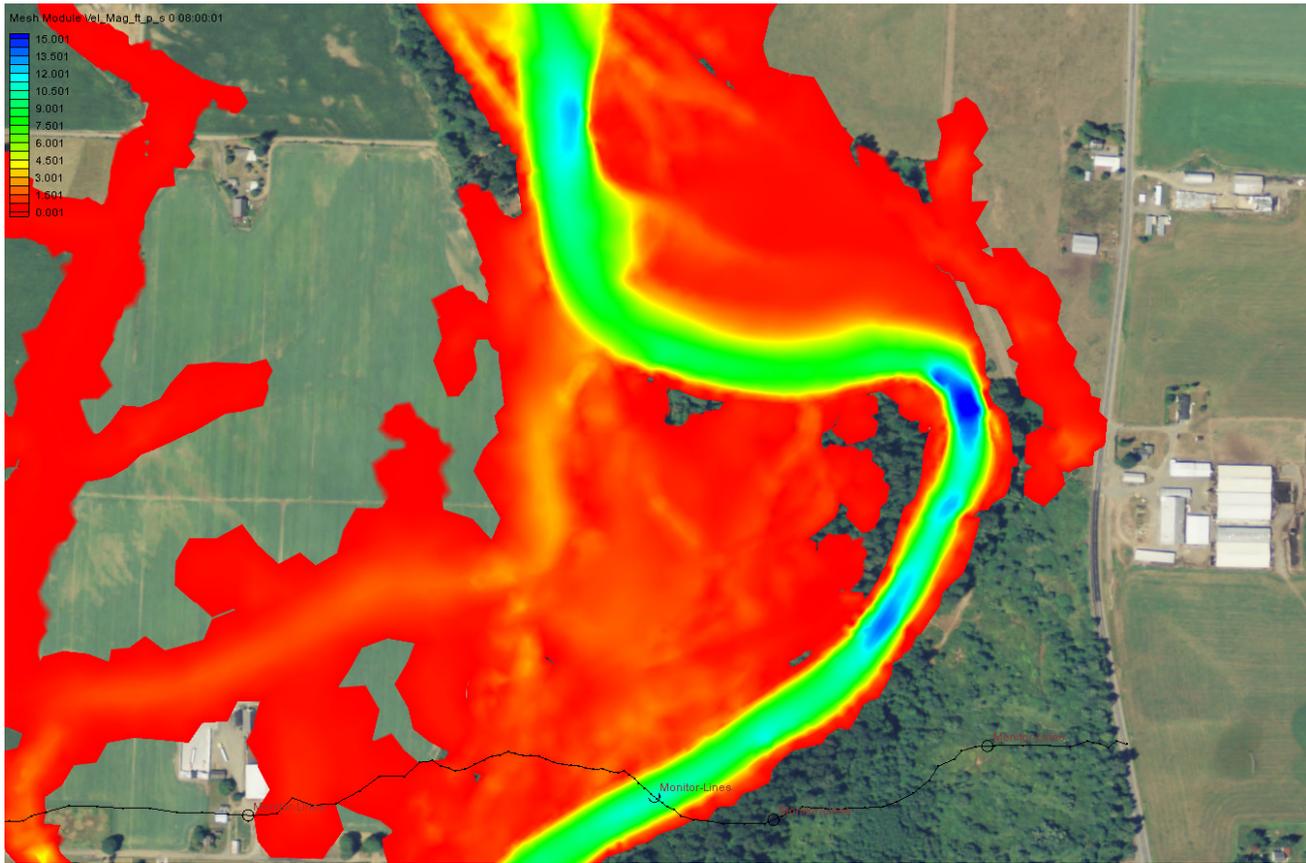
Nov 2012 Flood: Water velocity magnitude at failed revetment – hour 8 (16,800 cfs)

Zoomed in view showing the velocities magnitudes and patterns near the location of the revetment failure near Keyes Road. Note the high velocities (greater than 14 feet per second) and angle of attack towards the west (east) bank of the river. This location is a concern for additional bank erosion.

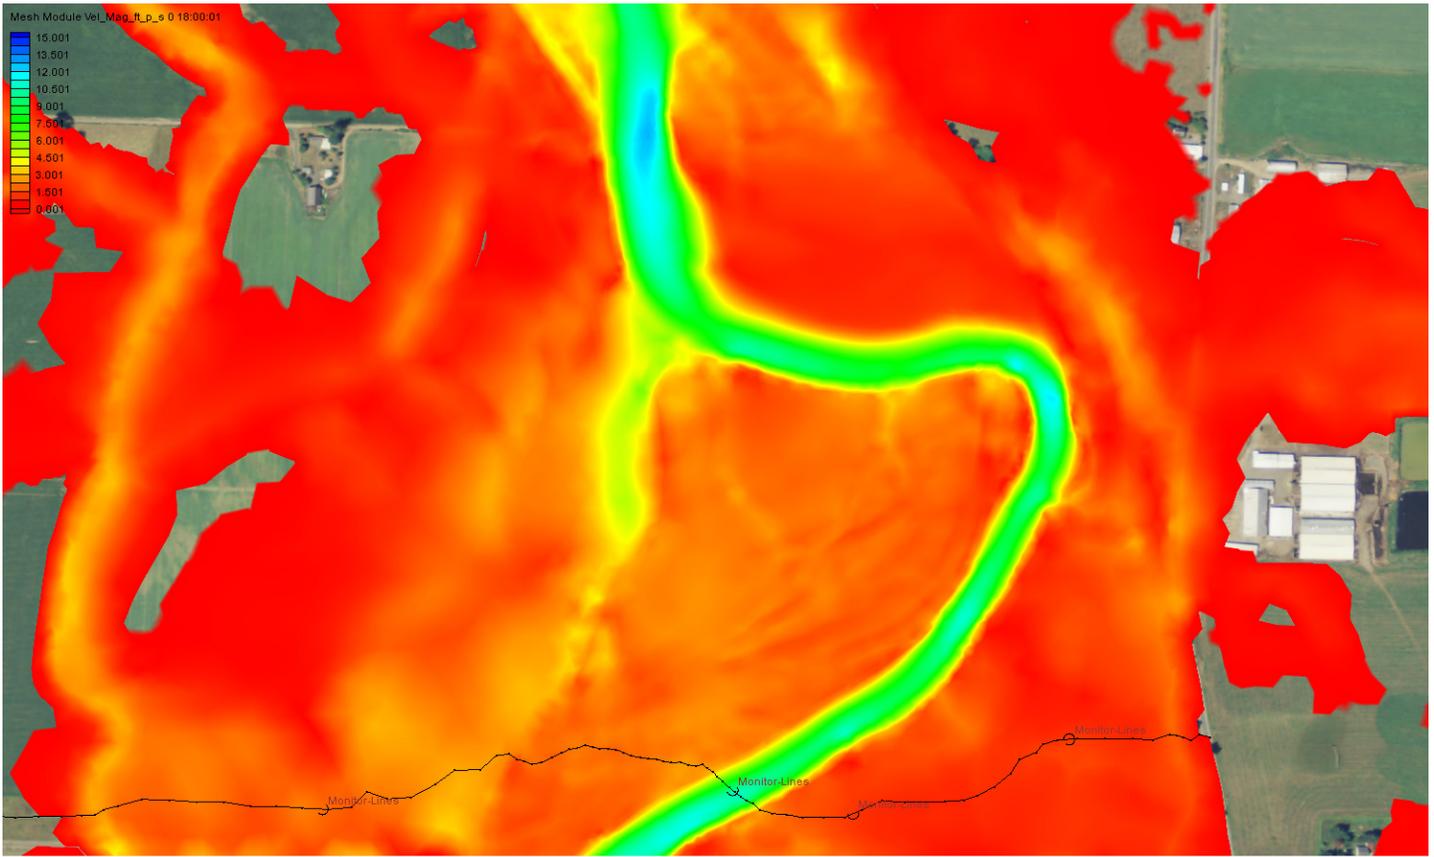
Nov 2012 Flood: Water velocity magnitude at failed revetment – hour 18 (Peak of event) (28,900 cfs)

Zoomed in view showing the velocity magnitudes and patterns near the location of the revetment failure near Keys Road at the peak of the November 2012 event. Note that the velocities are significantly lower than earlier in the event as overbank flows tend to backwater the site and reduce overall flow velocities and attack of the left bank.
