# **Reach Assessment for the SR 107 Chehalis River Bridge at Montesano**

**Work Order XL-2008**

**Robert W. Schanz, PE, LHG  
Jim Park, Hydrologist  
WSDOT Environmental Services  
Watershed Management Program**

**July 2005**

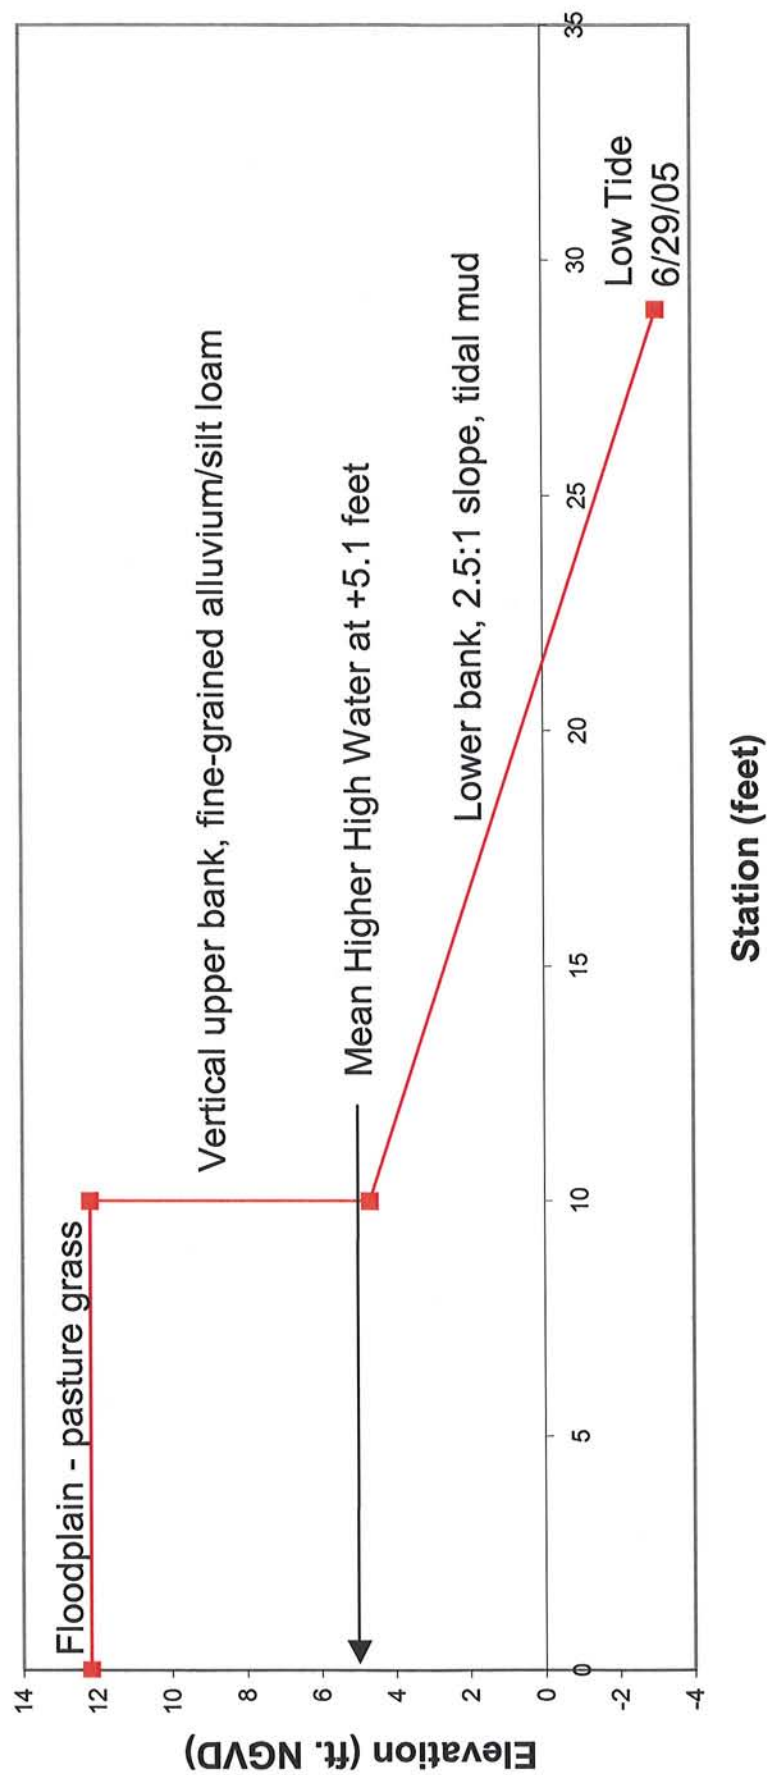
Figure 2. Profile of the Eroding Bank 200' Upstream of the SR 107 Bridge

Figure 2 shows a profile of the eroding bank at the center of the first scallop. The upper section of bank is nearly vertical and extends about 8 feet from the top of the bank. At about Mean Higher High Water level the bank transitions into tidal mud and slopes at 2.5:1 down to the low tide level. This profile is typical of eroding channels in tidal environments, where the upper section of bank slumps off in vertical chunks that are reworked by daily tidal flows to create a gentler slope on the lower bank.

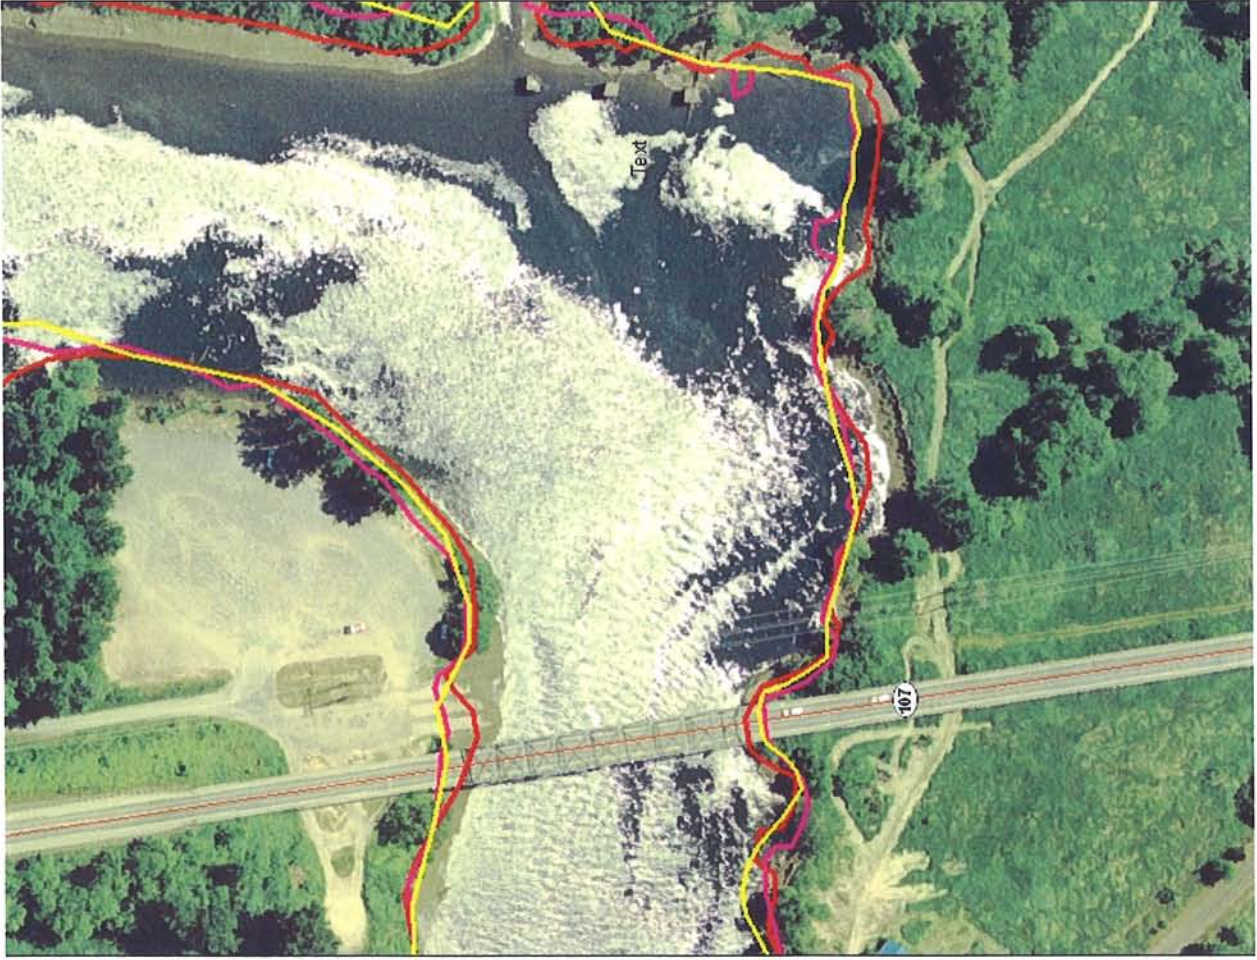
Figure 3  
Photo Record of Bank Erosion

Aerial photos from 1964, 1979, 1990, and 2003 provide a historical record of the erosion problem (Figure 3). In 1964 and 1979 the beginnings of the erosion scallops can be seen, and the deepest part of the first scallop is about 90 feet inland of the bridge abutment pier (Pier 2). Little change can be seen in the bank between 1964 and 1979. Between 1979 and 1990 the bank lost about 20 feet in the first scallop and 30 feet in the second scallop, but trees remained along most of the bank. Erosion becomes more severe between 1990 and 2003, with a loss of most trees and up to 40 feet of bank in the deepest part of the first scallop. Much of this may have occurred during the 1996 flood event, which is generally the largest flood of record in the Chehalis basin.

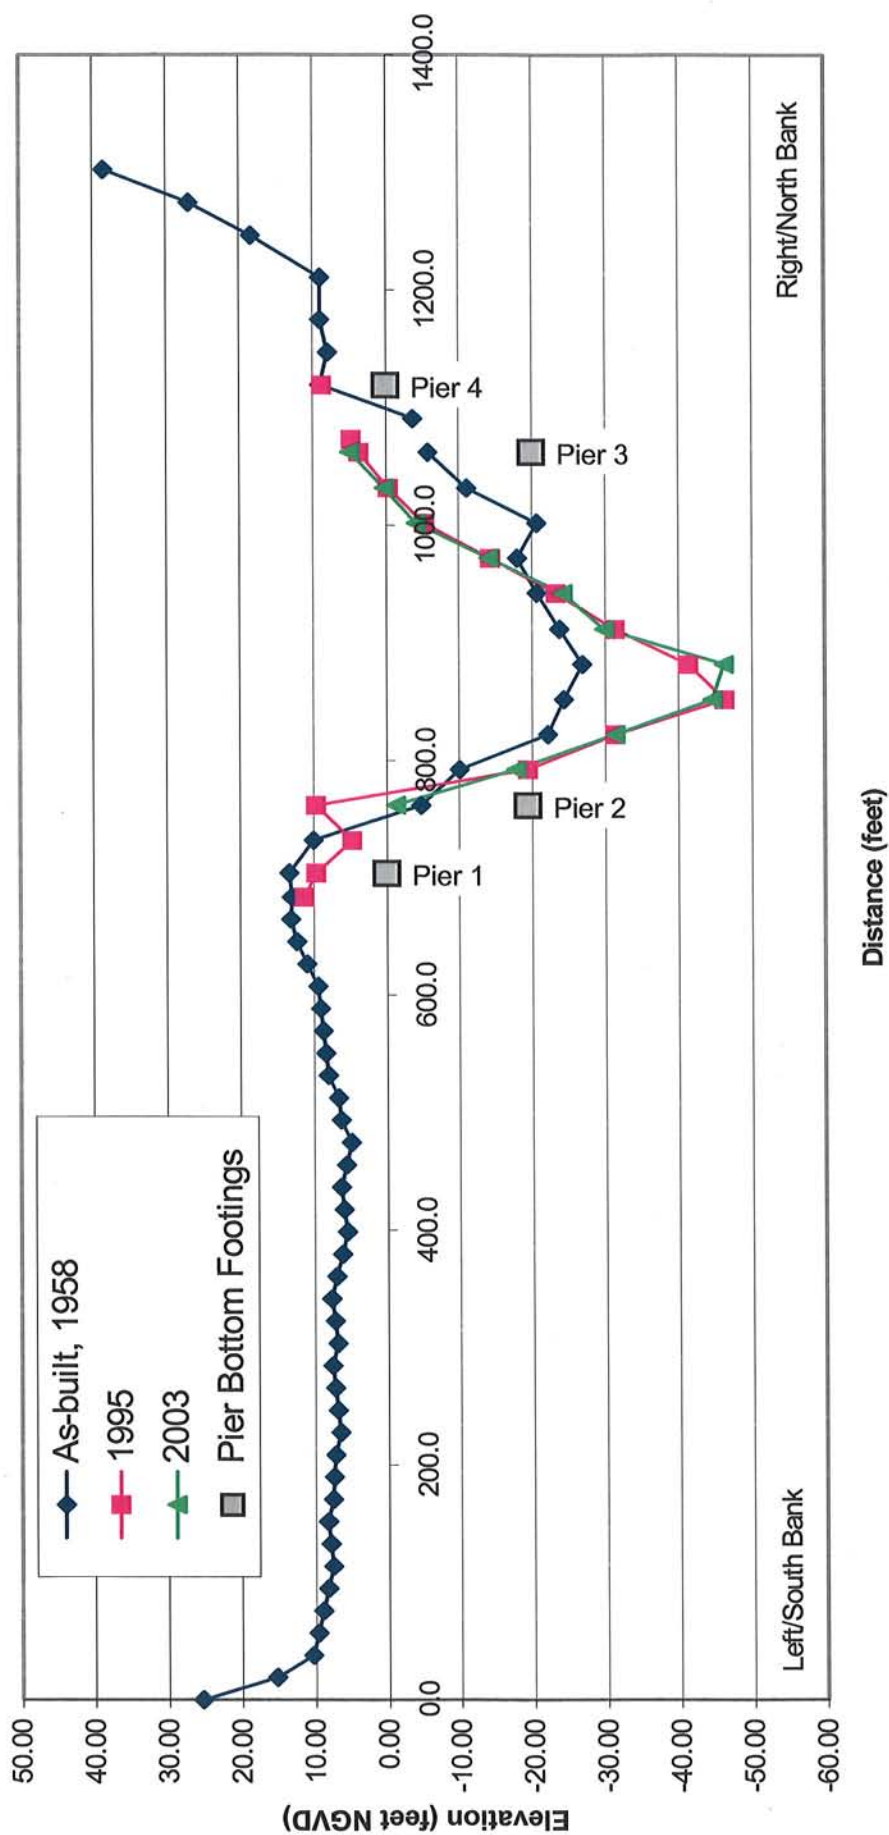
Figure 4. Bridge Survey Cross Sections at the SR 107 Bridge

Figure 4 shows cross sections of the river at the bridge from various bridge surveys. These cross-sections extend over the riprapped base of the pier, and do not include the unarmored eroding section of bank. When the bridge was built the channel had a top width of 390 feet and a thalweg elevation of -27 feet NGVD. Later bridge surveys show a substantial amount of fill placed in the right bank channel, probably to construct the WDFW boat ramp. This reduced the top width of the active channel to about 300 feet. The river responded to confinement by the bridge piers and the boat ramp by scouring a new thalweg down to -46 feet NGVD (19 feet deeper than the as-built thalweg). The channel thalweg has since stabilized, with little change observed between the 1995 and 2003 elevations.

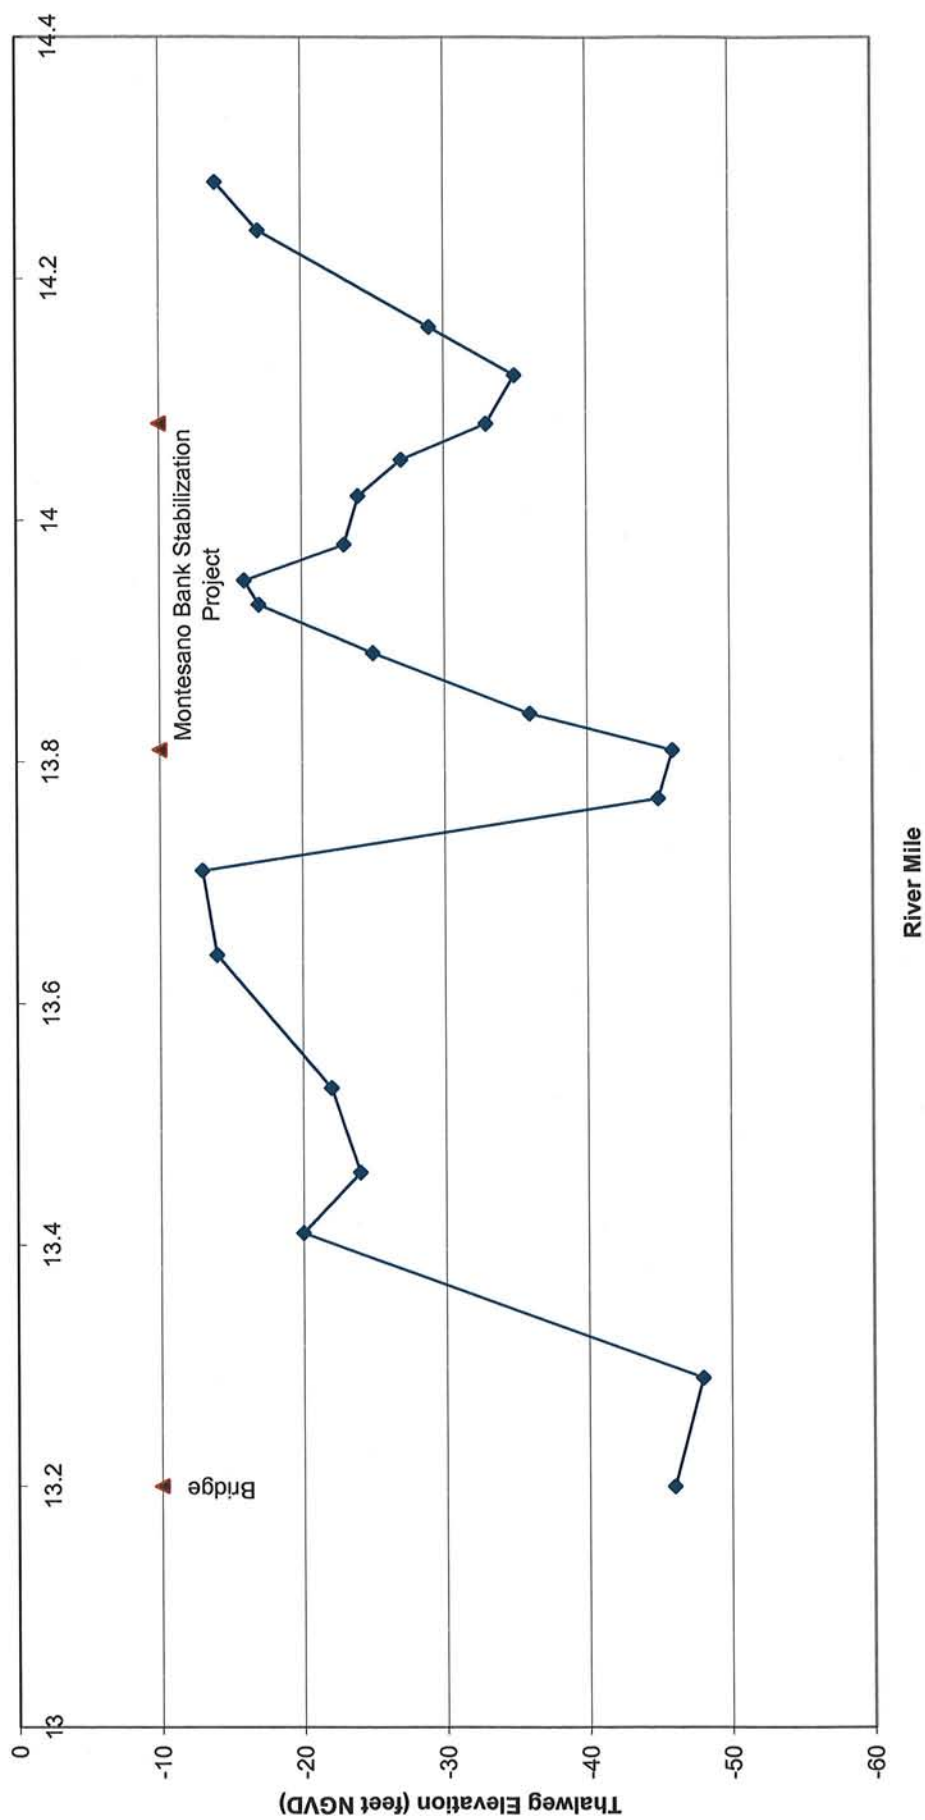
Figure 7. Riverbed Profile Upstream of the SR 107 Bridge

Figure 7 shows the profile of the riverbed in the project reach, derived from WSDOT bridge surveys and cross-sections surveyed by PIE (1996). Note that this profile predates construction of the City of Montesano bank stabilization project. The overall gradient in this reach is almost flat, with a natural bed elevation of between -15 and -20 feet NGVD. At constrictions the river scours deep holes in the riverbed to below -45 feet NGVD. This has occurred at the SR 107 bridge, at the upstream end of the lumber mill, and just upstream of the oxbow above the City of Montesano bank stabilization project. Bridge surveys show that the depth of the scour hole at the bridge has changed little since 1995.

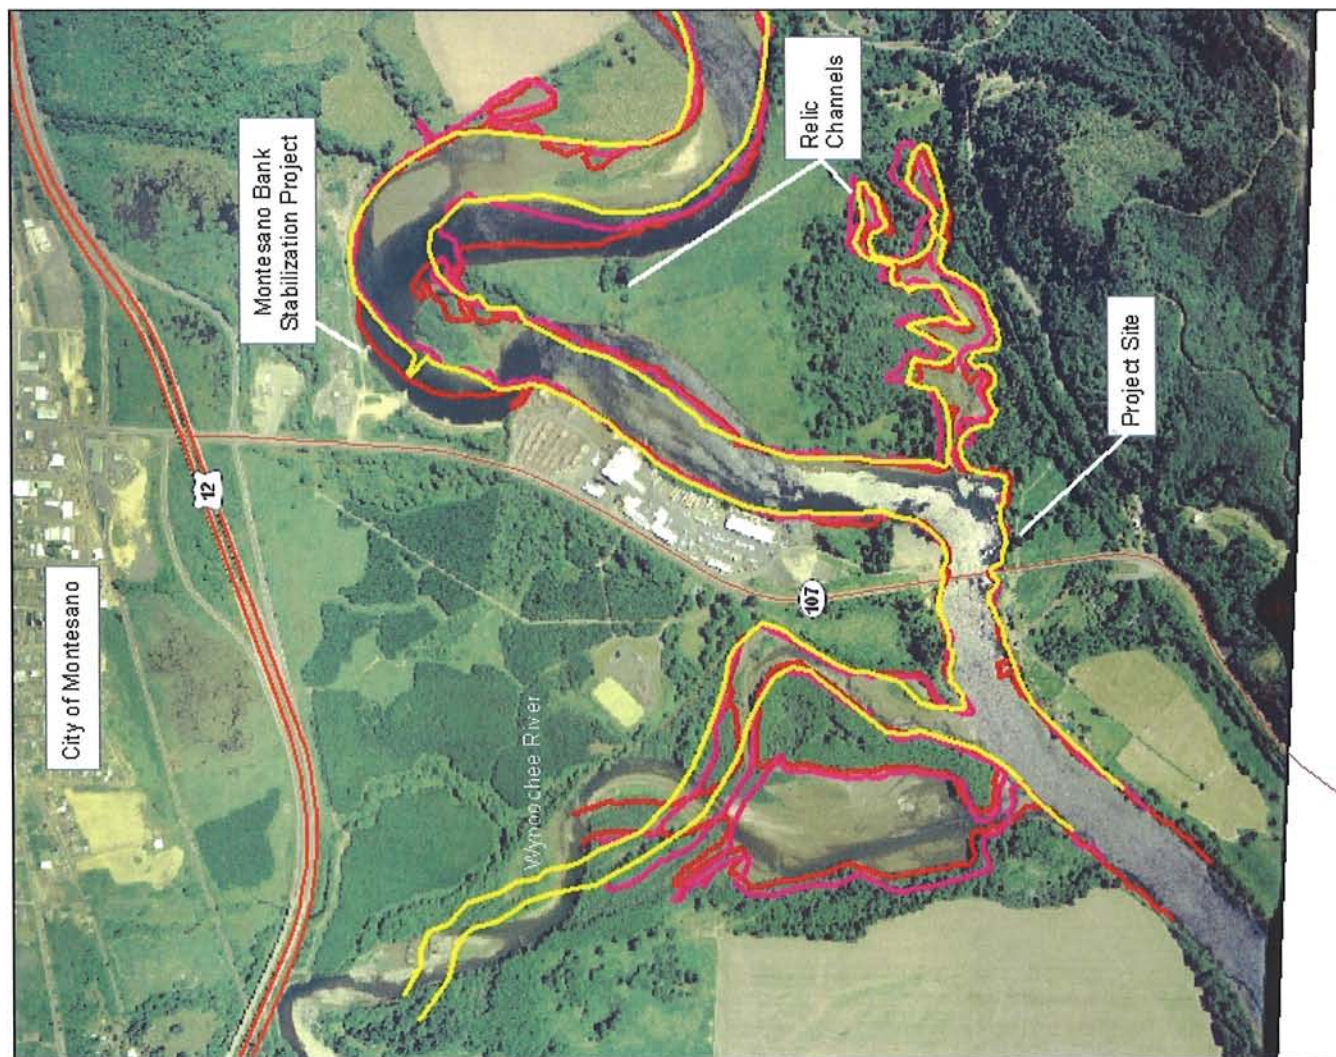
Figure 8  
Historic River Alignments

Figure 8 overlays river channel alignments from the 1964, 1979, 1990, and 2003 aerial photos. With the exception of the erosion of scallops along the left bank, the general alignment of the river at the bridge has changed little since 1964. Changes are more significant upstream near the Mary's River lumber mill. From 1964 through 2003 the meander bend upstream of the mill migrated westward towards SR 107, with the largest changes occurring after 1979. In 2002 the City of Montesano installed a series of rock barbs and a riprap blanket to stabilize the outside of this meander bend. The upstream end of the lumber mill was also armored with rock to tie into the Montesano project. During our site visit in May 2005 these bank protection measures were still in place, and there was no evidence of new migration of the outside of the bend. However, these bank protection measures have combined to direct flow against the bank opposite the mill. This bank is now eroding rapidly, and has retreated up to 190 feet since 1990.
