SUBJECT: ASSESMENT AND MITIGATION PLAN, GROUND SUBSIDENCE
AT WILLAPA REGIONAL WASTEWATER FACILITY
CITY OF RAYMOND, PACIFIC COUNTY, WASHINGTON
G&O #11419.00

CITIES OF RAYMOND & SOUTH BEND
PACIFIC COUNTY WASHINGTON
WILLAPA REGIONAL WASTEWATER FACILITIES
SCHEDULE A - WILLAPA REGIONAL WASTEWATER TREATMENT FACILITIES
WWTP SITE NORTH ROAD GRADING PLAN

RE: **SETTLEMENT EVALUATION**
Willapa Regional Wastewater Treatment Plant
Raymond, Washington

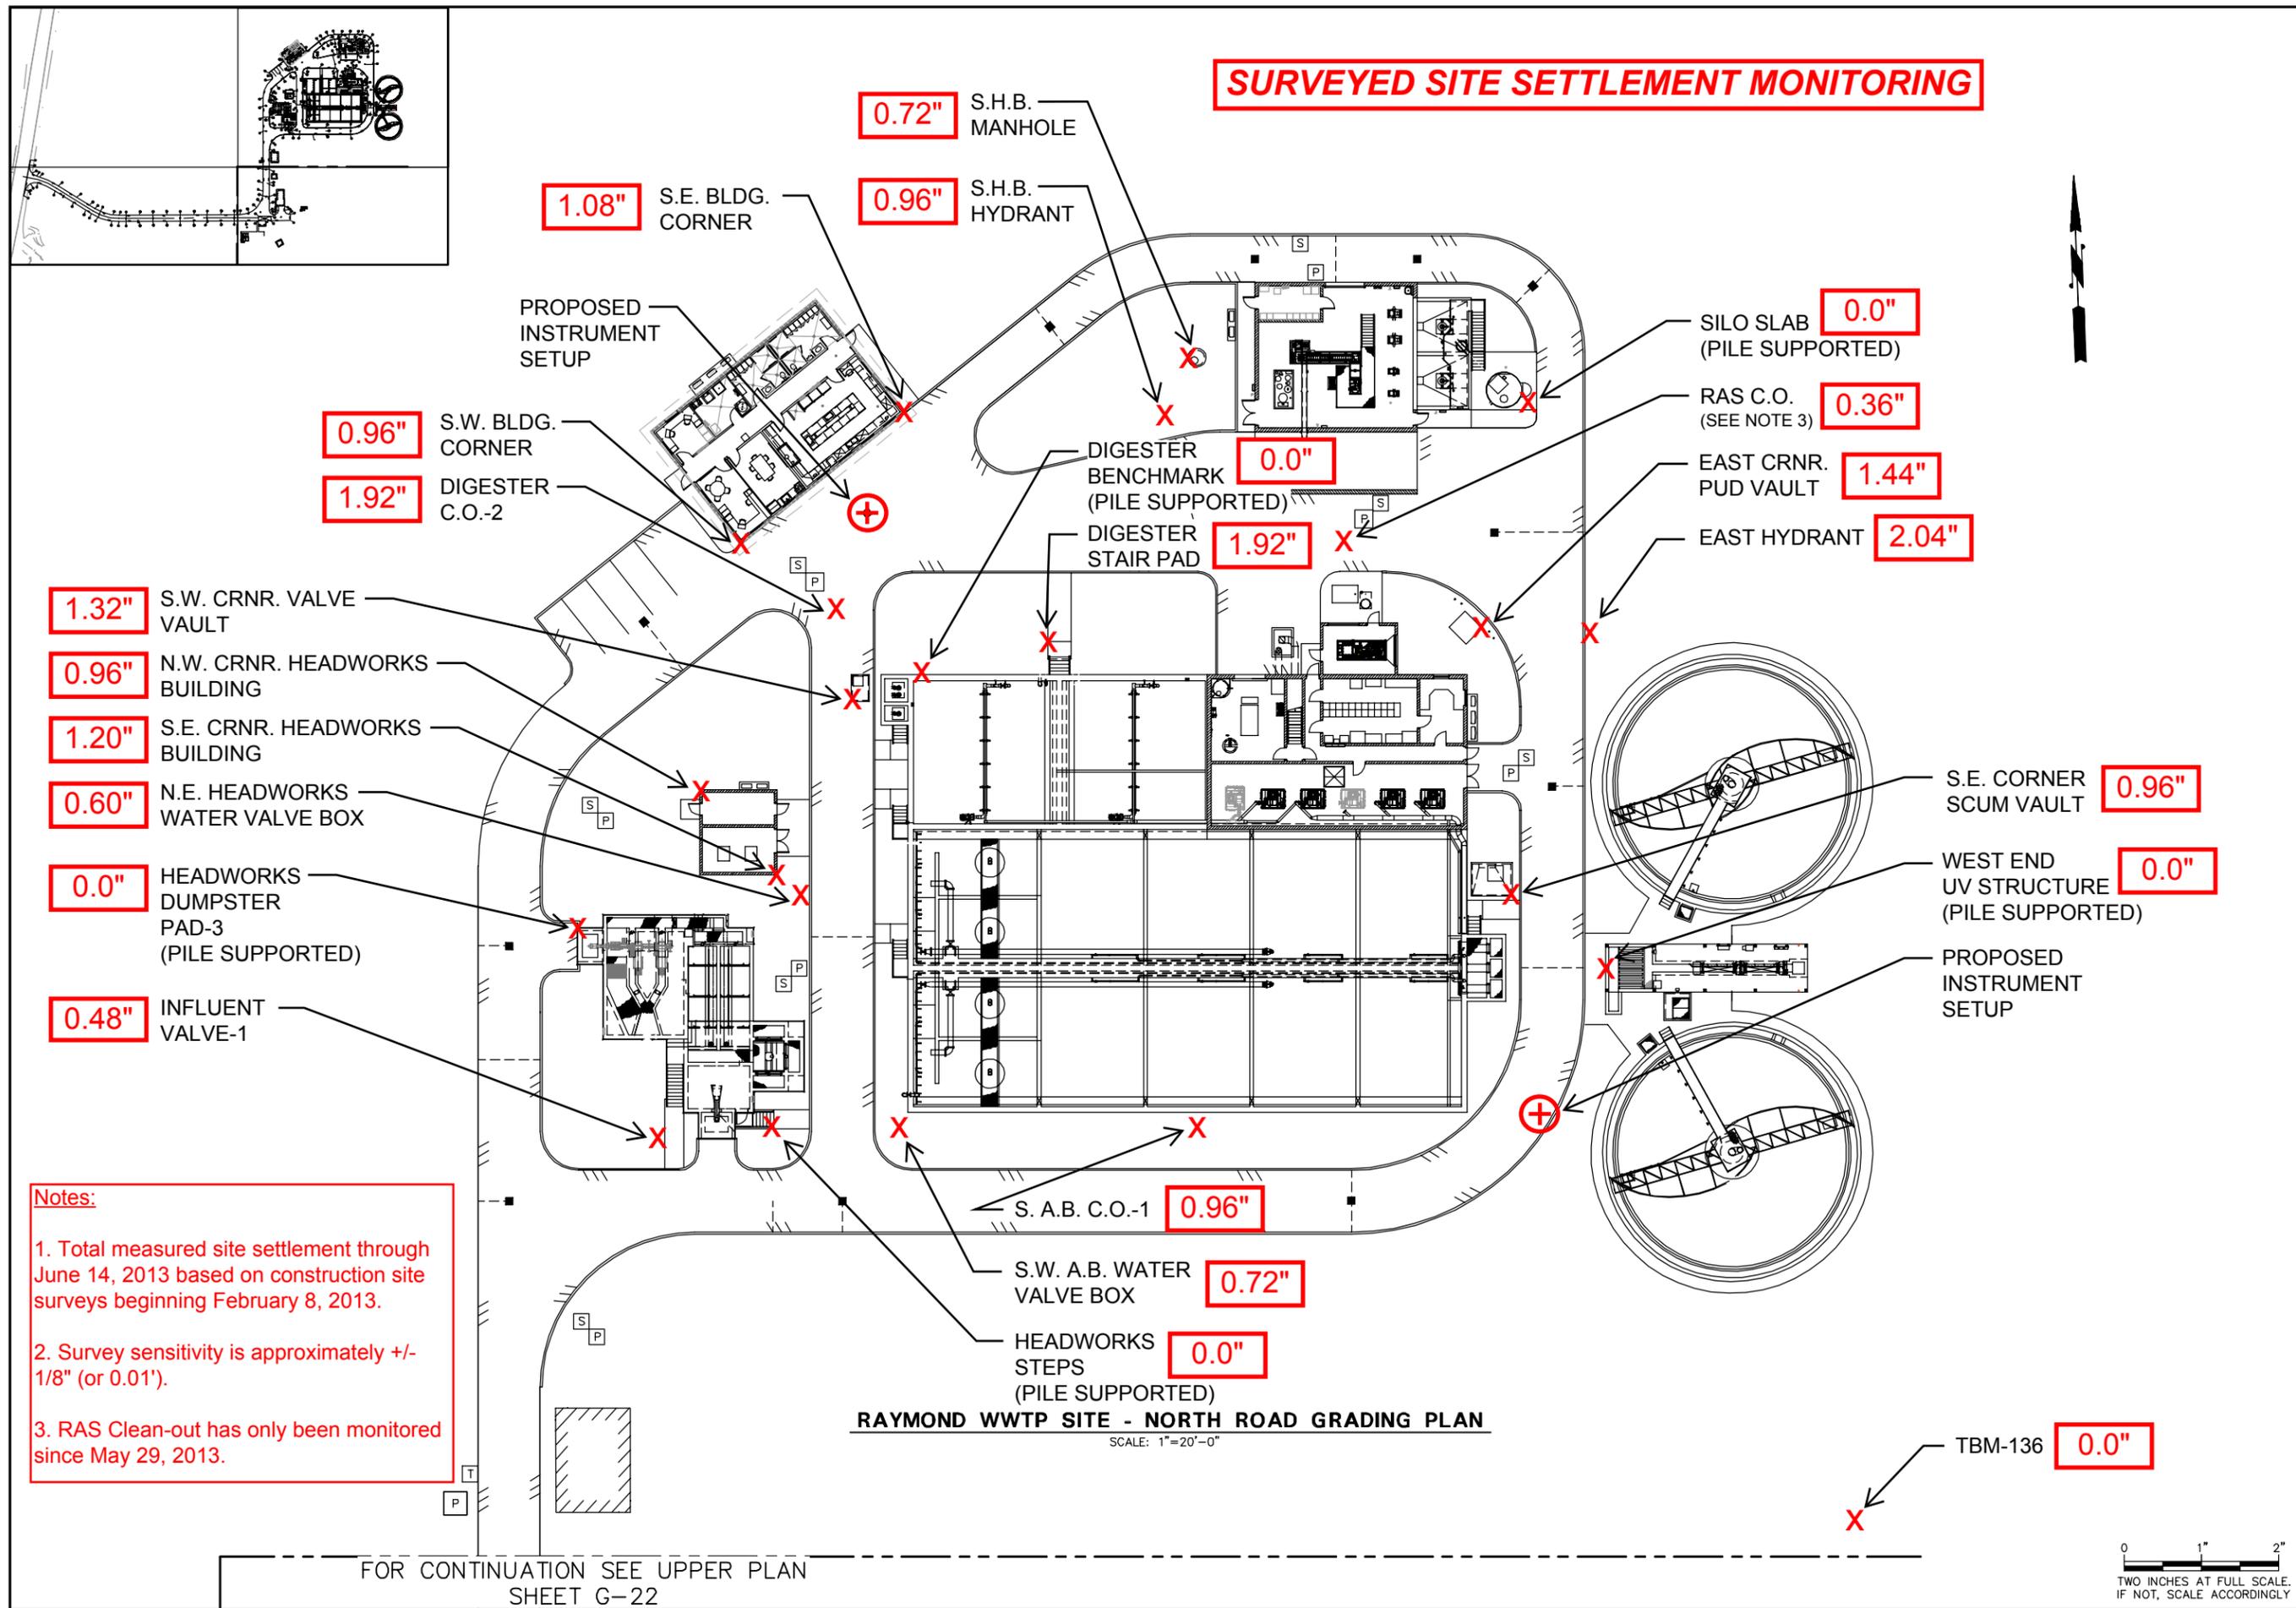
SHEET:	G-23
OF:	27
JOB NO.:	08593
DWG.:	PRO_ROAD

Attached is a drawing of the site showing the total settlement at 21 long-term monitoring points across the site. Five of these locations are pile supported and will serve as a baseline for settlement in the other 16 locations. All 21 locations can be surveyed from two different instrument setup locations, also shown on the drawing. After the Rognlin's contract is closed out, Gray & Osborne's surveyors will continue to monitor these points, two to three times per year until the rate of subsidence slows to the point where the frequency can be reduced. Monitoring results will be reported to the RWCC as they are available. In areas where ground subsidence eventually exceeds 2 inches or more, we

Figure 1 presents a plan showing the locations of the 88 points at which elevation measurements have been made since February 2013. Figure 2 presents elevation plots of 8 selected locations. These eight include points that appear to have the highest rates of settlement (East Hydrant and AD Pad). Lines have been drawn on several of the plots on Figure 2 to indicate what future settlements might occur. Straight line extension of the AD Pad plot indicates that the pad could settle as much as 2 inches over the next year. Another $\frac{3}{4}$ inch could occur a second year from now with perhaps 2 more inches over the following 10 years. Extensions of most data plots indicate settlements on the order of an inch over the next year. With more measurements, better predictions should be possible in about 3 months.

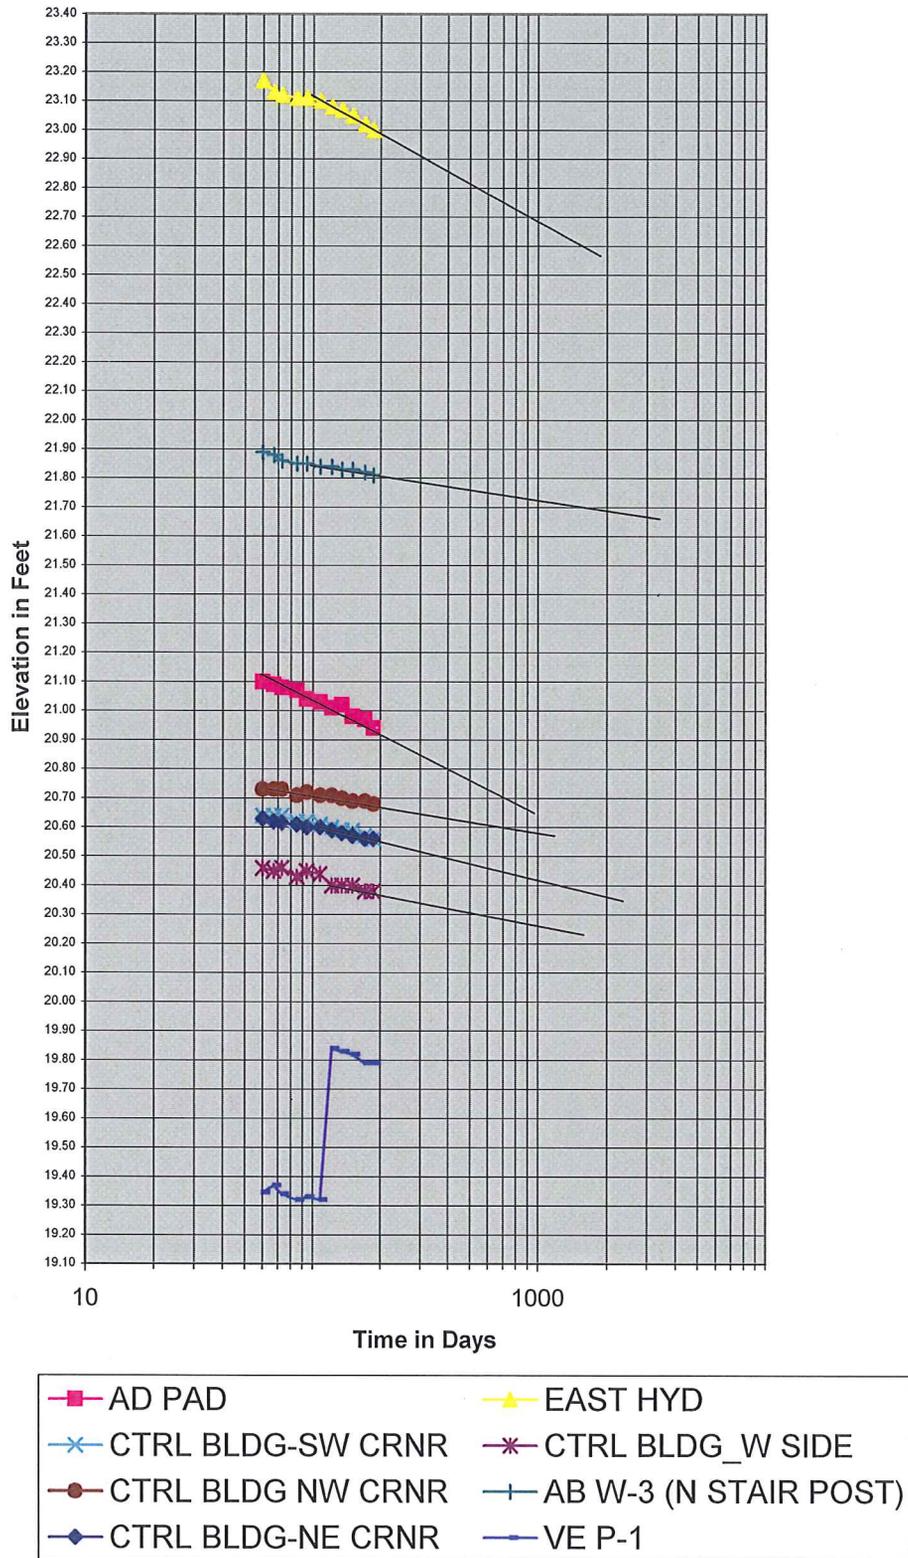
Figure 2

The straight-line extensions of the current settlement plots over-estimate future settlements at many locations. There has not been sufficient time since the last loads were placed for the time-settlement curves to fully develop. Fill and roadway pavement has been placed since February 2013, and many of the time-settlement curves now plot steeper than they will in a few months. We expect the settlement magnitudes discussed in the previous paragraph to be maximum values, and plots using future elevation measurements should predict less settlement.

We recommend that additional elevation measurements be made at approximately three month intervals for the next six months and at 6-month intervals for another year. These additional data points would be added to the current plots to create better estimates of future settlement. We will provide updates to anticipated settlement as future measurements become available.
