Technical Memorandum

Subject: **Hydraulic Analysis at Mary's River Lumber Mill, SR 107 Bridge, and the Wastewater Treatment Plant on the Wynoochee River**

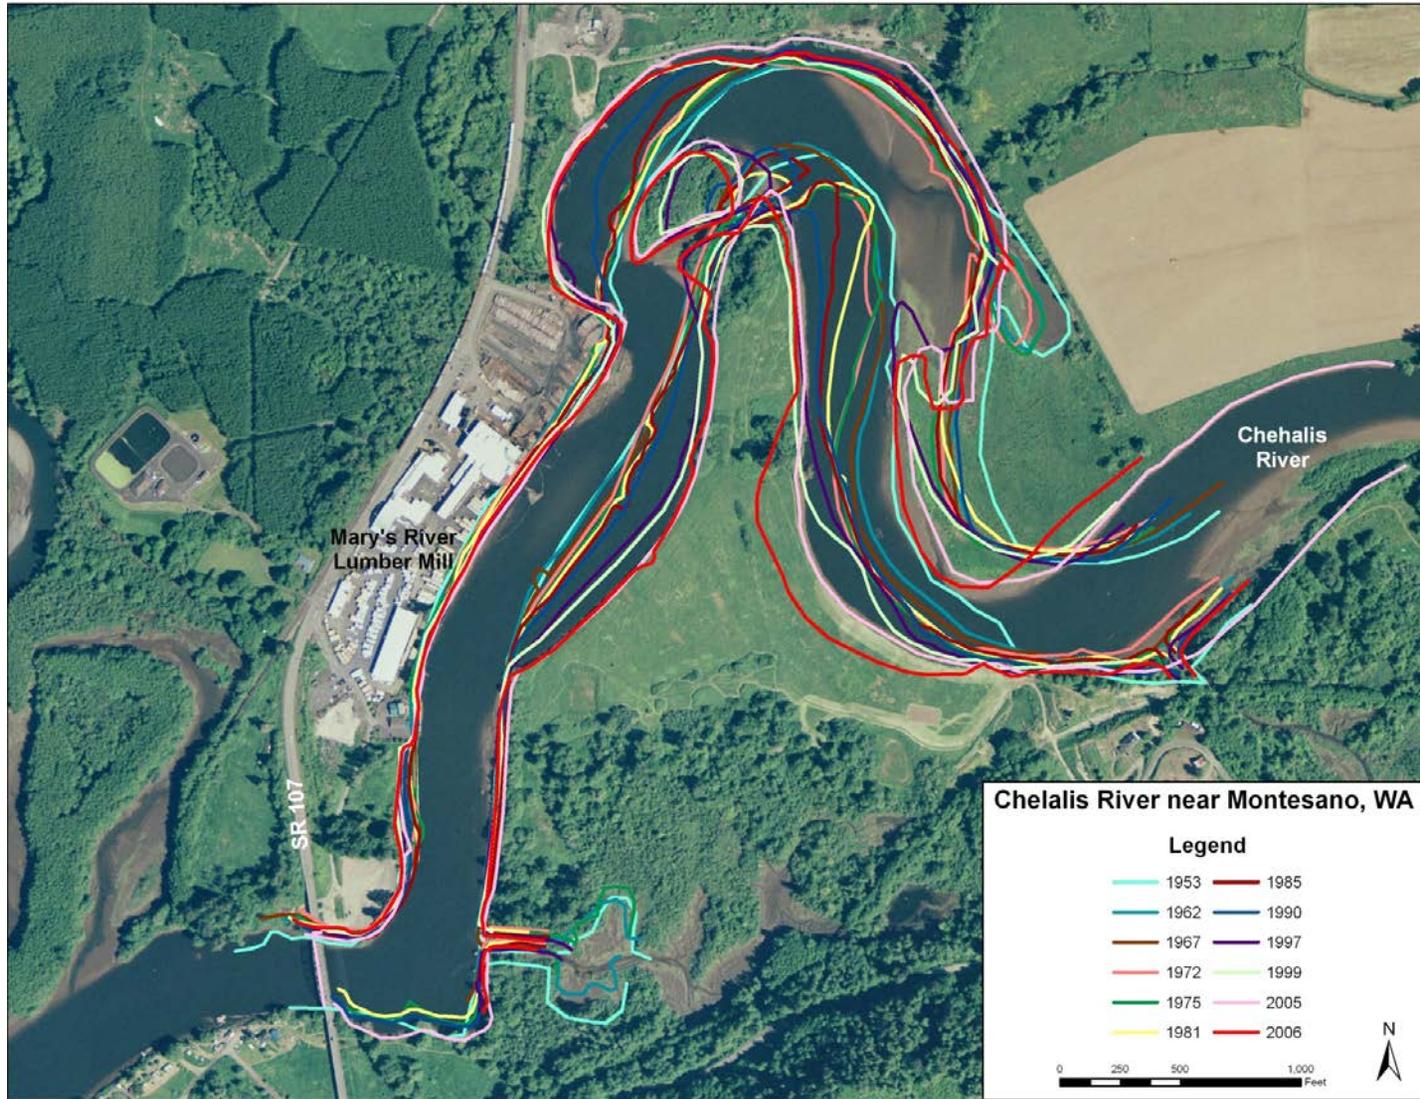
The active channel alignments delineated from each of the historic aerial photographs from 1953 to 2006 are shown in Figure 2. Figure 3 shows the active channel alignments for years 2006 to 2011. The figures show that the bank adjacent to the mill has not experienced significant erosion, while the land across the channel from the mill has been eroding due to the migration of the meander bend. It is apparent that the meander immediately upstream of the mill will be cutoff in the near future. A meander cutoff will likely result in more direct flows impinging against the bank adjacent to the mill. Observations made from these figures and the aerial photographs are summarized in Table 1.

Figure 2. Historic alignments of the active channel for the Chehalis River between 1953 and 2006 (2005 aerial used as background)

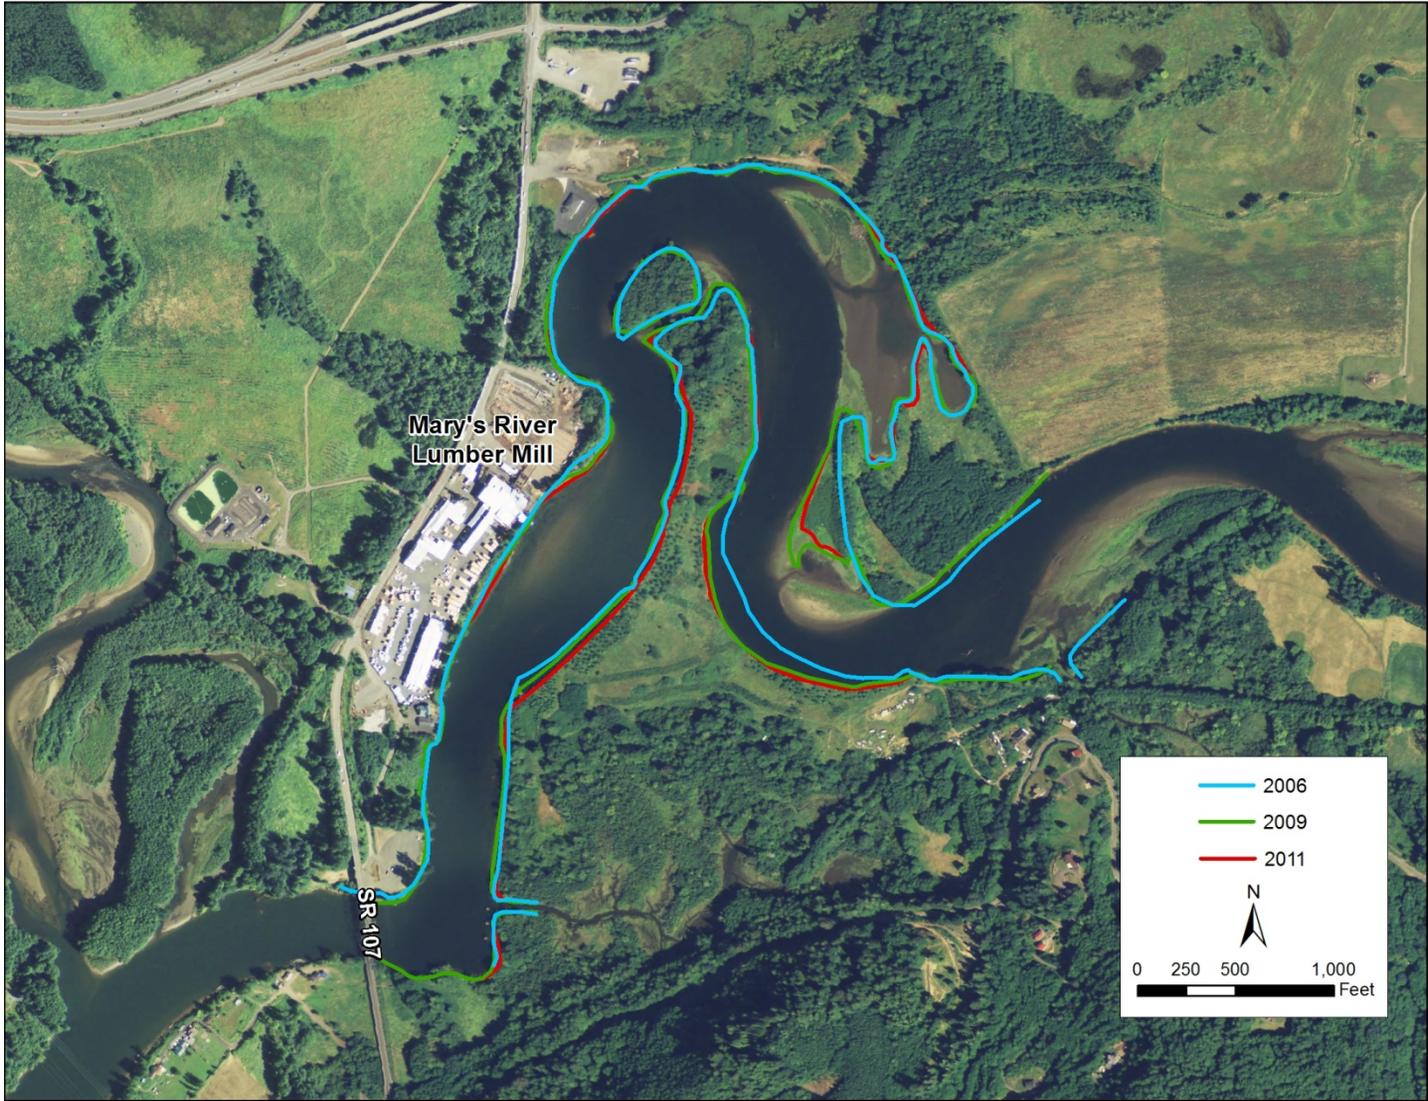
Figure 3. Chehalis River channel alignment for 2006, 2009, and 2011 (2011 background aerial)

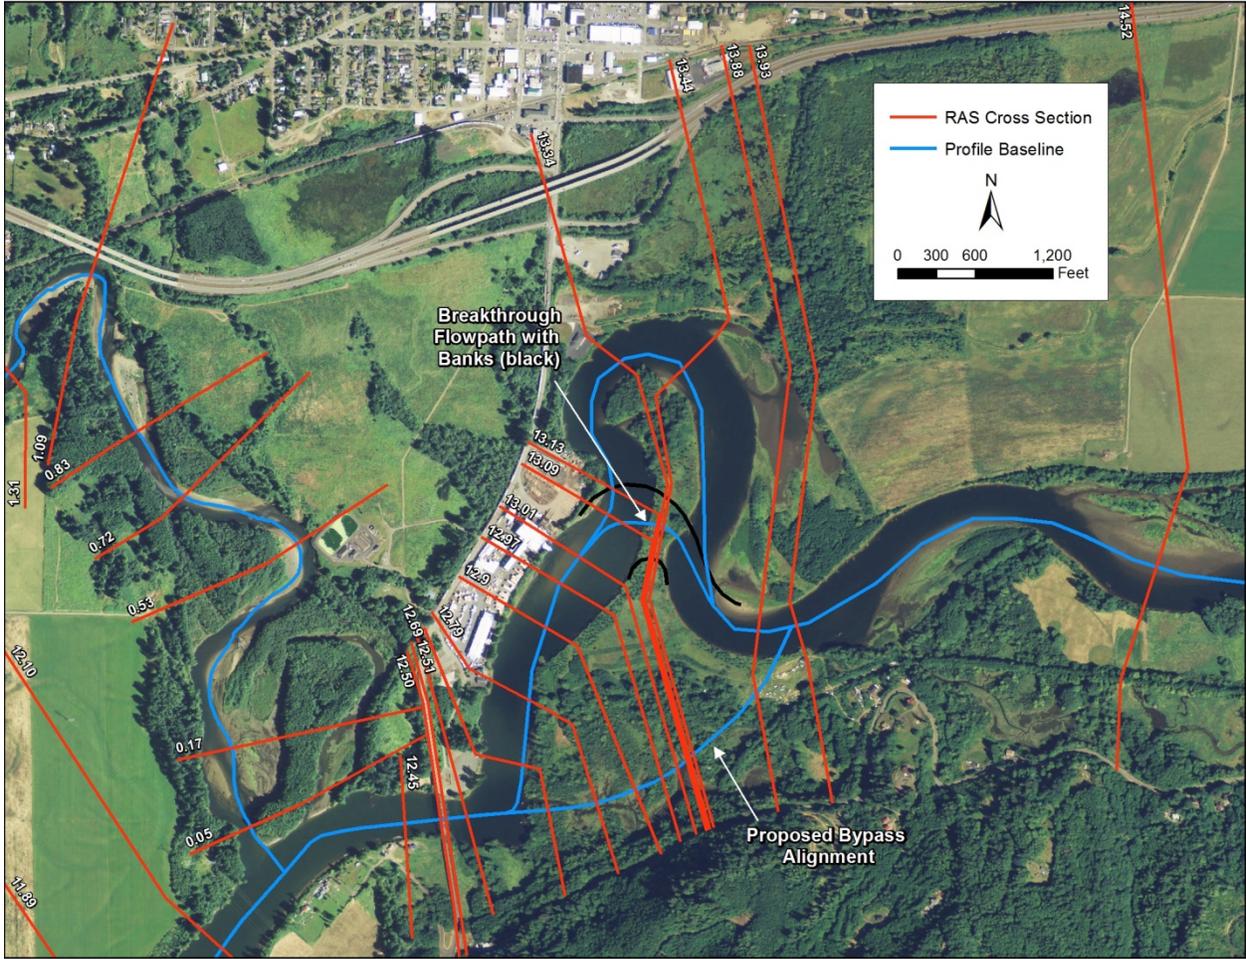
An analysis was completed to estimate the maximum scour depth anticipated near the proposed bank protection. The analysis was conducted assuming that the river had cutoff the meander as reflected by the alignment shown in Figure 6.

Figure 6. Assumed breakthrough scenario.

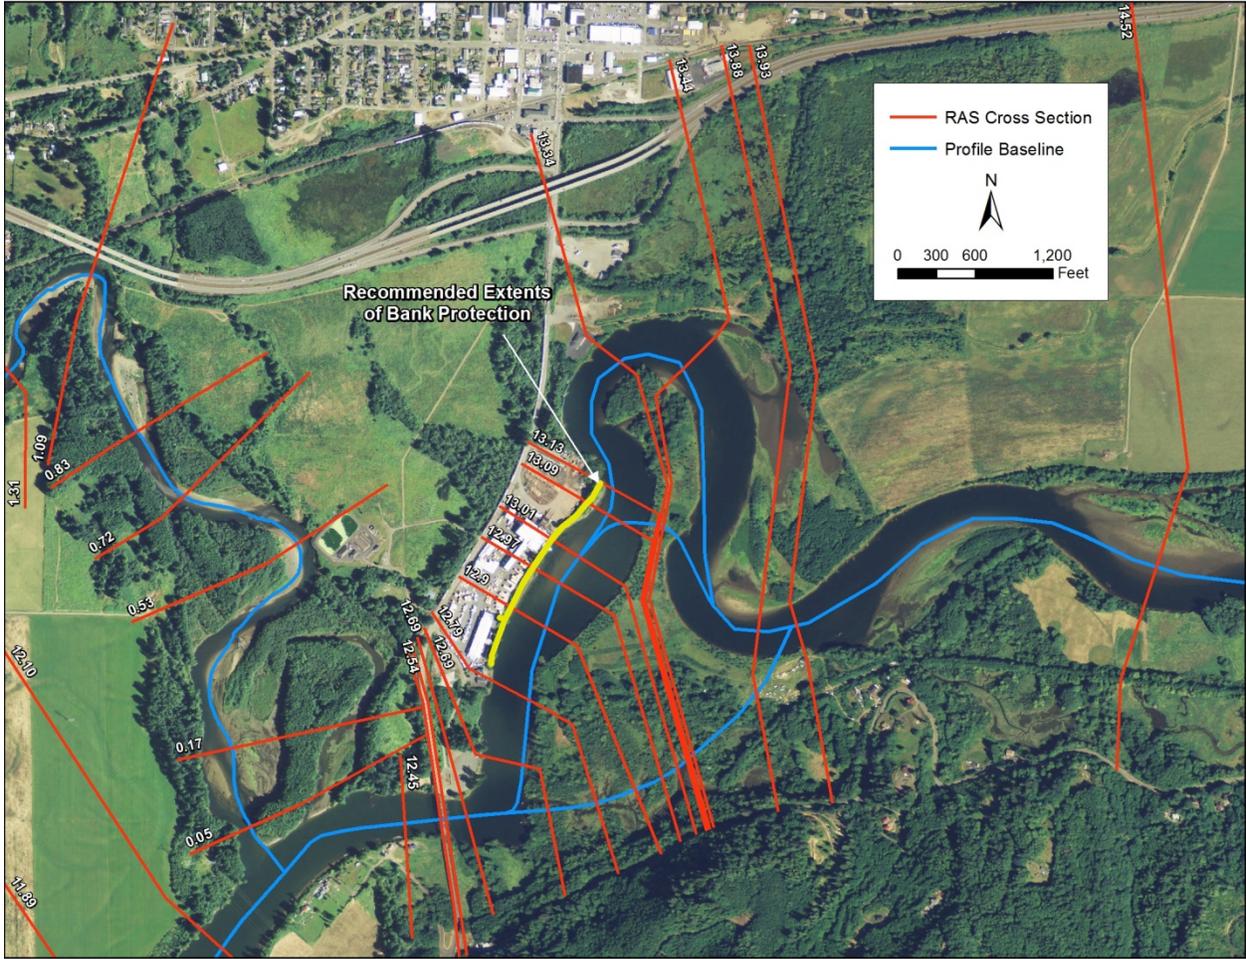
Figure 7. Recommended extents of bank protection.

If the Full Channel Bypass is not implemented, the recommended extents of the bank protection measures are shown in Figure 7. In general, the erosion protection measure would be located along the portion of the bank from near the upstream extents of the lumber mill to approximately 1700 feet downstream to tie into existing bank protection. This would cover most of the bank adjacent to Mary's River Lumber. If the breakthrough did occur, the entire length near the lumber mill would be on the outside of the bend, making it susceptible to erosion. Currently, the upstream portion of the bank is on the inside of the bend, and the downstream portion on the outside of the bend. Potentially, extending the bank protection to tie into existing protection near the downstream end of the mill site could also protect SR 107 from future right bank erosion by keeping the channel aligned with the bridge opening. If the entire bank is not protected, the protection should start at the upstream end and proceed downstream as far as feasible. Any remaining unprotected bank should be monitored periodically, and after large flow events to see if measures are needed to prevent further erosion. If the specified rock size cannot be placed under the deck, than a smaller size should be utilized or a resistive turf reinforcement mat should be utilized.

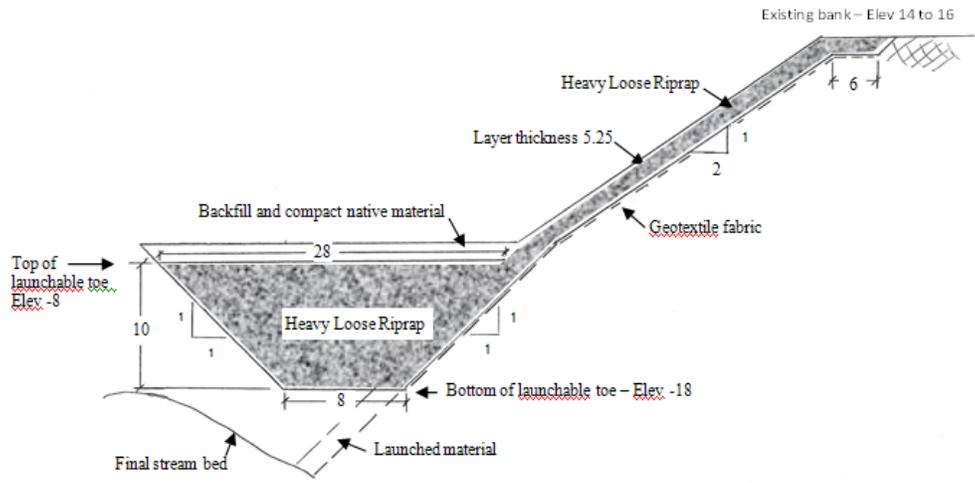
Figure 8. Riprap protection configuration (distances and elevations in feet).

Details of the erosion control measure are provided in Figure 14. It is recommended that the top of the revetment extend to the top of the bank. The riprap revetment should consist of Heavy Loose Riprap (based on WSDOT specifications, D_{50} of 2.2 feet) along the bank and along the toe of the embankment. Recommended layer thickness is 5.25 feet with a geotextile fabric filter. To prevent failure of the structure from undermining, a launchable toe should be placed along the toe of the bank. The volume and dimensions of the launchable toe are based on the recommendations provided in EM 1110-2-1601, *Hydraulic Design of Flood Control Channel* for an estimated scour elevation -42 feet. The volume per foot of bank protection is 700 ft^3 . If the entire 1,700 is protected a volume of approximately 44,074 cubic yards would be required. The configuration of bank protection is shown in Figure 8.
