# ***CONDITION REPORT***

## ***Dillenbaugh Creek Culvert Assessment***

***January 2017***

**City of Chehalis**

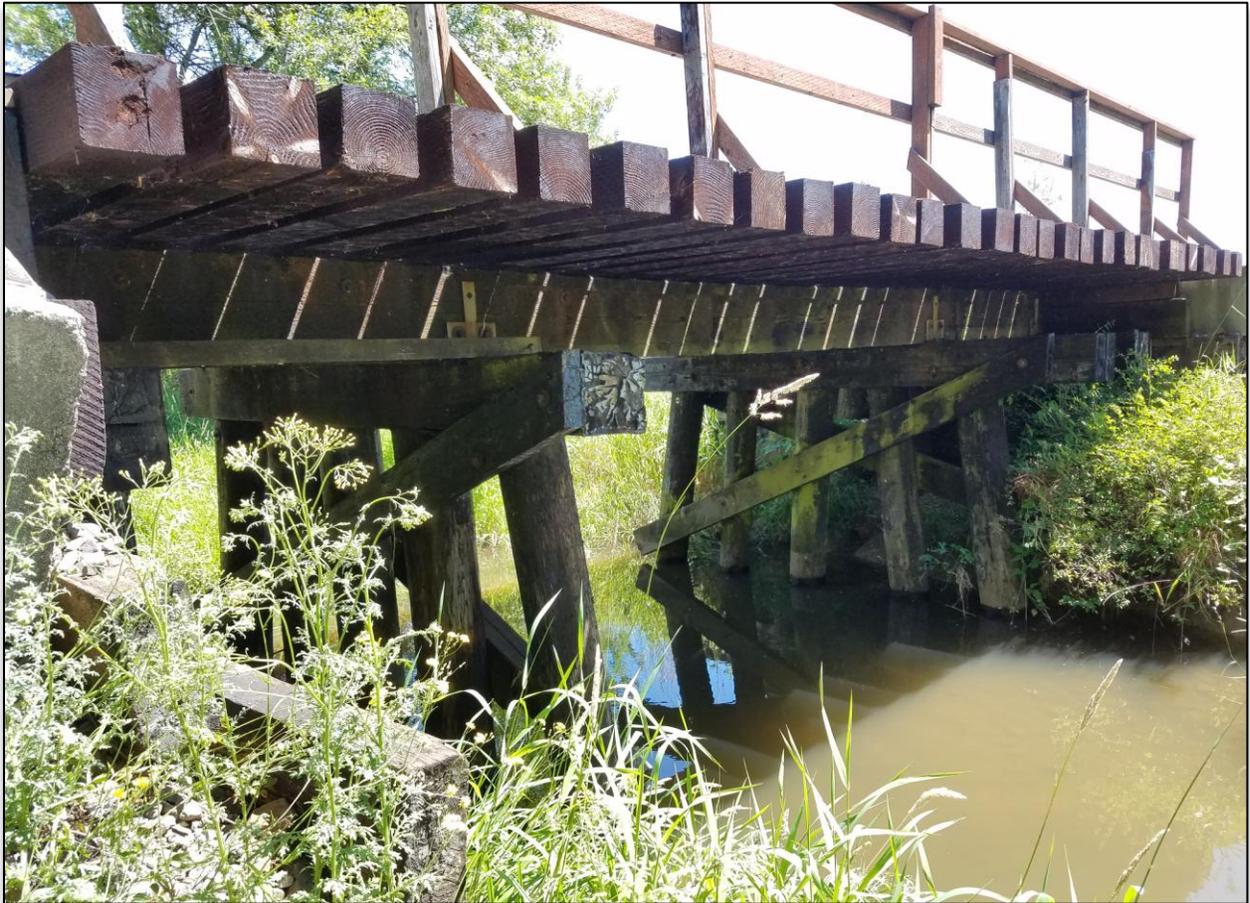
Image 3: DB16 Railroad Bridge Near Exit 74

The timber truss railroad bridge over Dillenbaugh Creek near Bishop Road is a single track structure. There are no obvious signs of serious deterioration above the current water line. There are typical cracks often associated with timber beams and pilings but as the timbers are creosote<sup>18</sup> treated, there is minimal impact from the freshwater creek. The metal hardware has typical signs of surface rust, but none of the bolts appear to be missing or compromised. This visual inspection was conducted through image and video analysis. Typical inspection for a more detailed inspection would include the following methods:

Based on the base flood elevation values observed in 2007, the depth of flow is 3.82 feet with an allowable depth of 8.83 feet. For this method of analysis, the bridge is suitably sized and not an area of concern.

The timber railroad bridge of DB16 is hydraulically sized for the 25 and 100-year storm events. The flow velocity for both evaluated rain events is just above the preferred values, but site conditions do not indicate an issue with bridge scour or erosion downstream. If future site conditions show indications of deterioration, energy dissipaters or embankment protection could be considered. The bridge is currently undersized to provide adequate fish passage. Should future development be considered, the bridge span should be sized at a minimum of 33.8 feet.

- Conduct initial visual assessment with hammer sounding.
- Obtain moisture content measurements in suspect and decay prone areas.
- Establish baseline NDE data by collecting stress wave and resistance micro-drilling data from areas of suspected sound wood
- Investigate marked areas to measure the extent of internal deterioration by utilizing stress wave timer and resistance micro-drilling tool as needed.

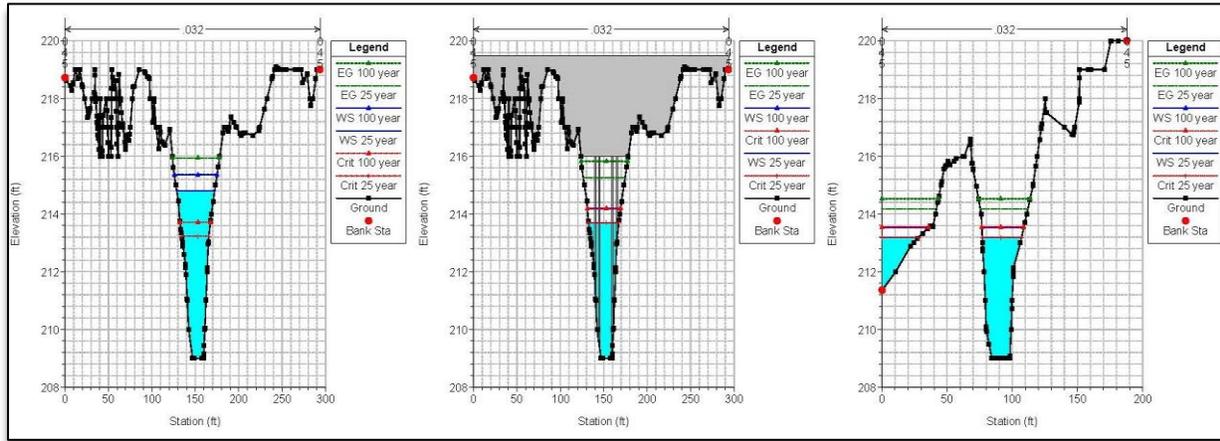
Figure 2: HEC-RAS Upstream, Bridge, and Downstream Cross Sections

The final method analysis used the United States Army Corps of Engineers modeling program HEC-RAS. The topographic model was constructed using LIDAR files from the Puget Sound Lidar Consortium (Martinez, 2012), survey data taken by Skillings Connolly, Inc on August 4<sup>th</sup>, 2016, and measurements taken by Skillings Connolly, Inc on July 13<sup>th</sup>, 2016. Using this method of analysis, the topography surrounding the bridge could be taken into account. The model not only showed a base flood elevation similar to the 2007 observed values, but showed the expected flood storage in the adjacent pond.

Based on the modeled values, the 25-year rain event has a flow depth 3.14 feet less than the allowable value and the 100-year rain event has a flow depth 3.64 feet less than the allowable value. These values are in the range expected given the observed flows of 2007. The downstream cross sections show tailwater<sup>21</sup> elevations of 3.68 feet and 3.90 feet for the 25 and 100-year event respectively. The velocity values for both the 25 and 100-year

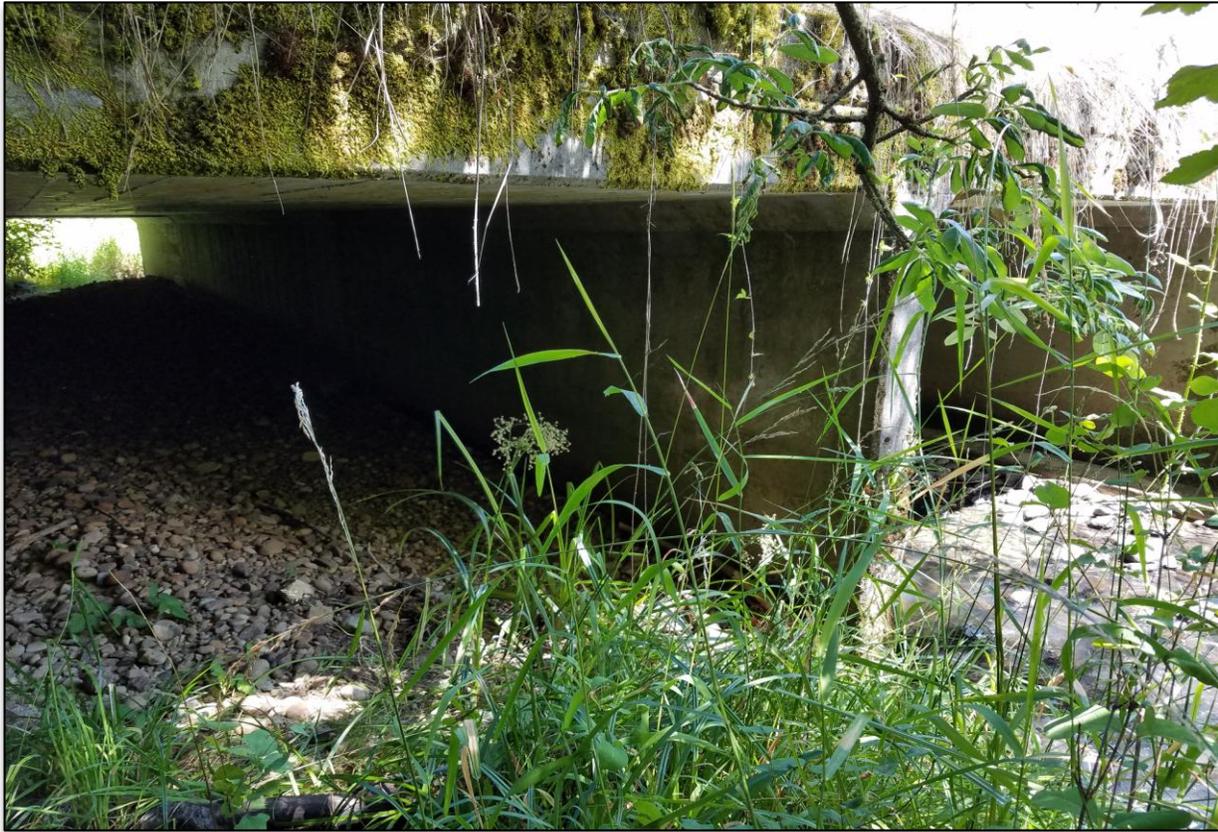
Image 5: DB15: Double Box Culvert under Bishop Road

The double box culvert over Dillenbaugh Creek at Bishop Road is a bottomless, concrete structure in an established creekbed. A visual inspection of the box culvert was completed through field documented photographs and video. The box culvert shows no signs of cracking, corrosion, spalling or exposed rebar in any sections of the culvert. However, signs of water penetration, water stained concrete and light spalling can be seen in and around the joints. Typical inspection for a more detailed inspection would include the following methods:

Based on the base flood elevation values observed in 2007, the depth of flow is 5.34 ft with an allowable depth of 6.5 ft. For this method of analysis, the culvert is suitably sized and not an area of concern.

- Obtain the culvert's length, size, age, height of cover, wheel loading and material type.
- Document type and condition of end treatment, including end sections, headwalls, rip-rap, nothing, etc.

- Document waterway condition, such as inlet blockage/debris affecting hydraulic performance.
- Investigate inlet and outlet scour condition, including erosion parallel to the culvert

- Take detailed measurements of geometry of flexible culverts.
- Analyze culvert wall thickness and condition: cracking, extent of corrosion, spalling, and exposed rebar.

- Investigate infiltration and loss of structural backfill through joints, cracks or inlets.
- Document evidence of roadway settlement or repair including pavement distress, cracks or signs of recent repairs and repaving efforts, and guardrail sagging over the culvert.

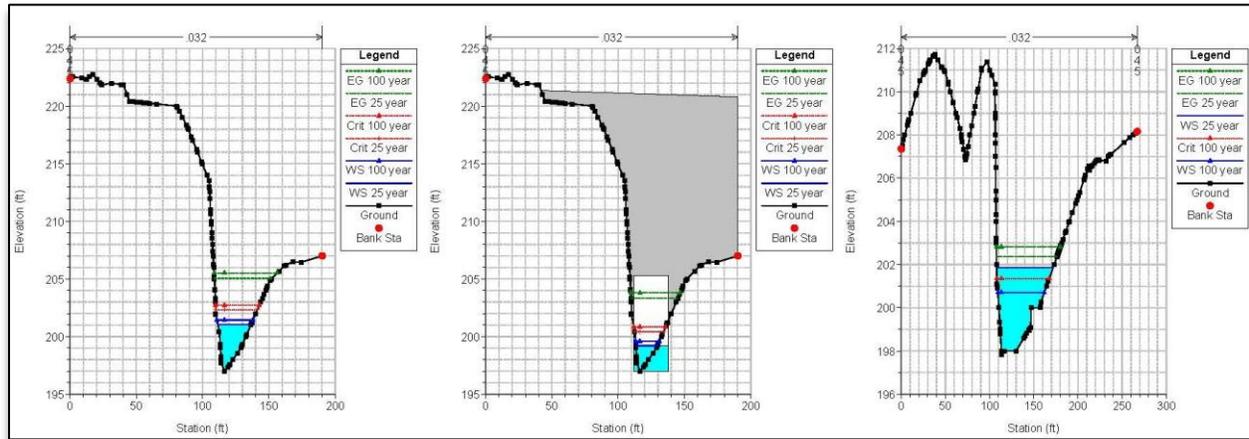
Figure 6: HEC-RAS Upstream, Bridge, and Downstream Cross Sections

These calculations were based using the outlet control box culvert method. Based on the calculated values, the 25-year rain event has a flow depth 0.94 ft less than the allowable value and the 100-year rain event has a flow depth 1.48 ft less than the allowable value. The velocities calculated by this method are within the allowable range and are not a cause for concern. Based on Manning's calculations this culvert is hydraulically sized.

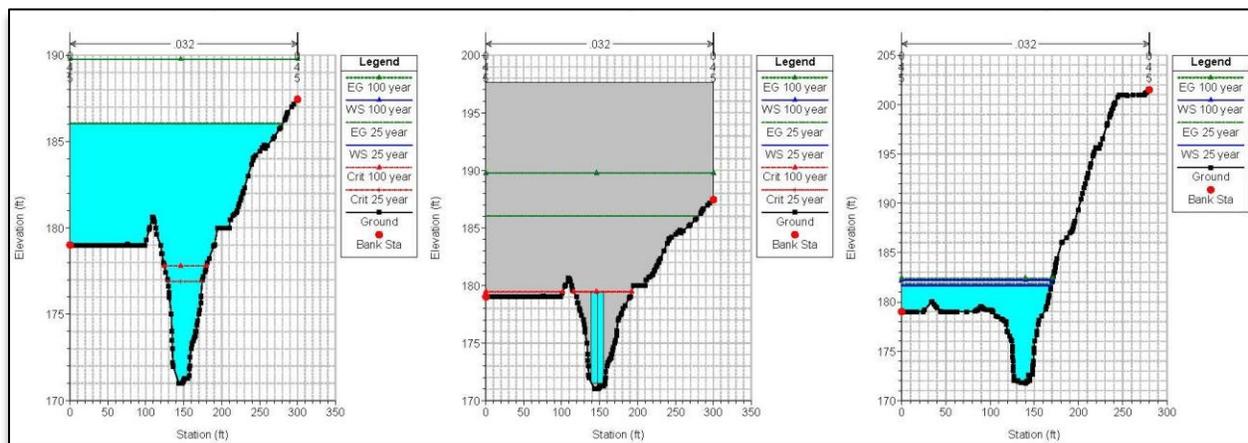
**Figure 8: HEC-RAS Upstream, Bridge, and Downstream Cross Sections**

downstream from site DT1, the double box culvert under I-5 that carries flows from the Dilly Twig Creek tributary. The flow restriction at this site may indicate that the calculated values for site DB10 are slightly higher than actual flows as the calculated values assume natural flows from the Dilly Twig Creek sub basin. Additionally, the high downstream velocities of culvert DB10 are calculated assuming natural flows from the Dilly Twig Creek sub basin and the actual velocities may be higher. As the calculated velocities exceed the allowable values by as much as 100%, a higher than assumed upstream velocity would only exacerbate the potential for scour, undermining, and downstream erosion.

and 182.21 for the 25 year and 100-year rain events indicate a natural channel elevation that would still overtop the 181 ft elevation of Rice Road. In order to bring the creek crossing into compliance, the culvert would need to be increased in size and portions of Rice Road would need to be raised. The culvert is currently undersized to provide adequate fish passage. Should future development be considered, the culvert span should be sized at a minimum of 25.60 feet.
