## **Attachment J**

### **Hydraulics Technical Memorandum**

July 30, 2021

**Re:** **Lower Satsop Right Bank Conservation Project**  
**Site Assessment and Design Alternatives Draft Report, Rev. 1**

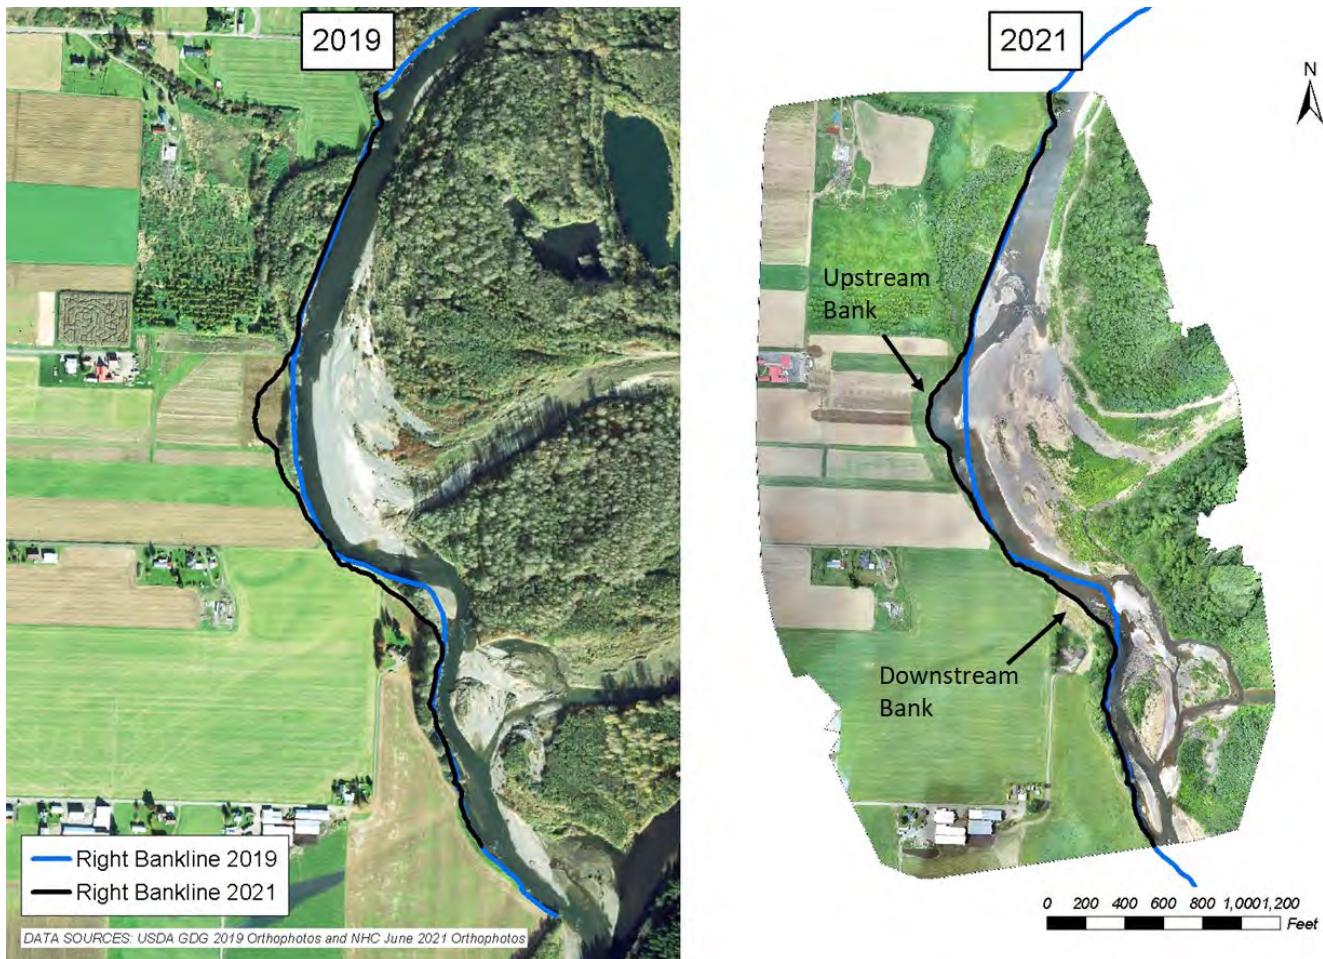
Since the 2018 avulsion, the right bank of the channel has been rapidly eroding. Figure 1 compares the right bank line location in 2019 and 2021. Prior to the avulsion, vegetation on the right bank was limited to grasses and a narrow band of trees; since the avulsion, the remaining trees along the right bank have fallen into the channel as the bank continued to erode. During a site visit on June 15, 2021, NHC observed that the eroded bank comprises very silty, easily erodible material. Gravel was visible at the toe in only a few locations. The right bank is near vertical, ranging from 10 to 25 feet high, and the minimal bank vegetation has relatively shallow rooting depth.

**Figure 1 Right Banklines in 2019 (blue line) and 2021 (black line) overlaid on 2019 (left) and 2021 (right) orthophotos**

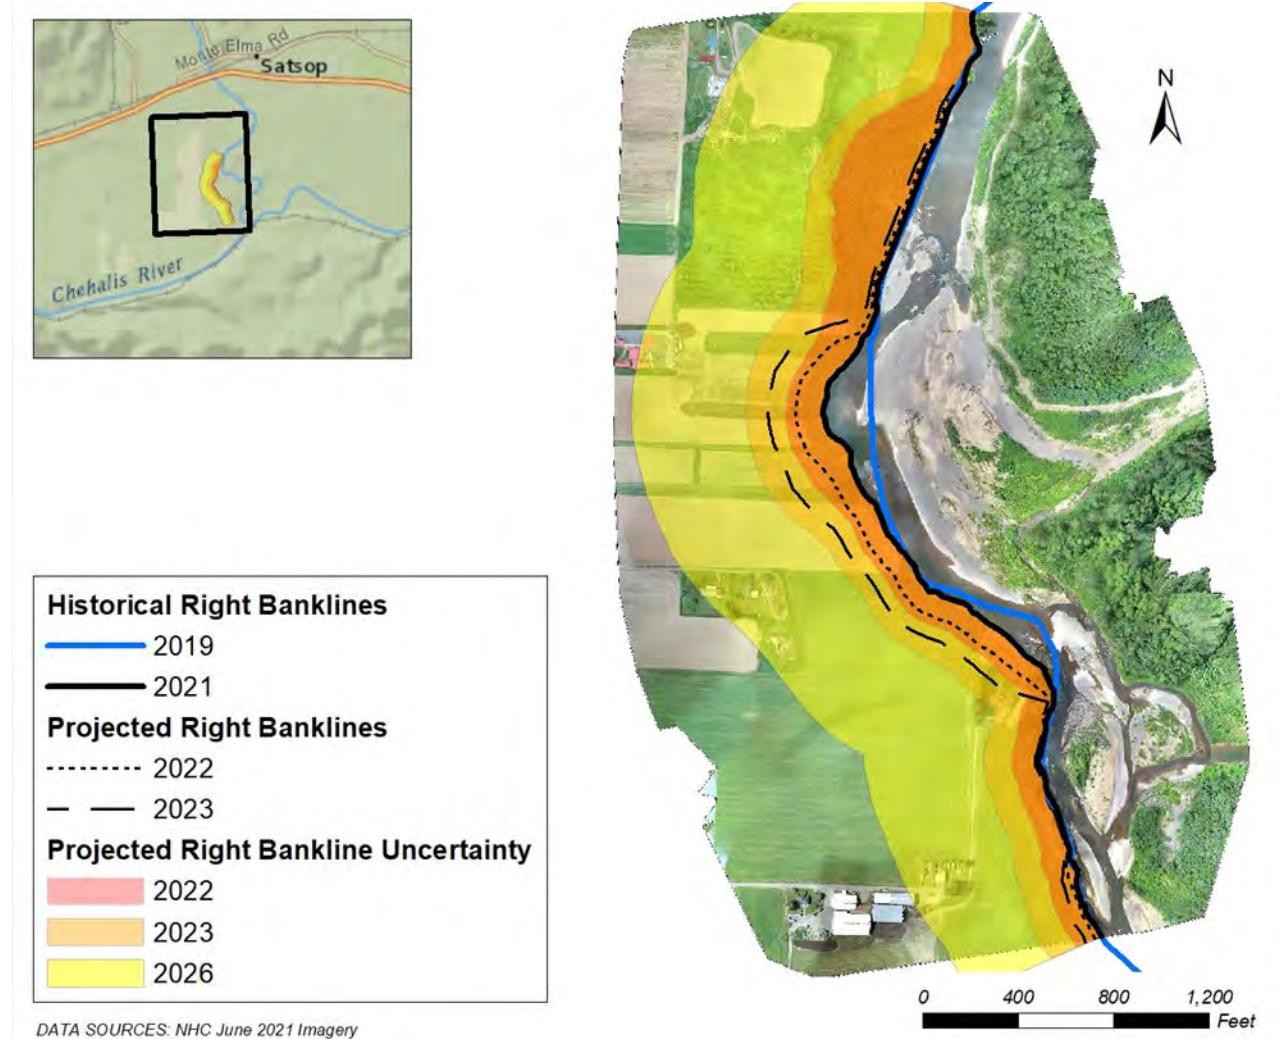
Following the 2018 avulsion, the Lower Satsop River corridor migrated westward, eroding substantial portions of the right bank. Natural Systems Design (NSD) determined historical erosion rates of 92 ft/yr for the upstream bank and 73 ft/yr for the downstream bank along the Lower Satsop River meander bends (NSD, 2019). Between 2019 and 2021, the rate of bank erosion at the upstream bank substantially increased compared to historical rates. Between 2019 and 2021, the maximum displacement of the right bankline at the upstream and downstream banks was 230 ft and 132 ft, respectively. Based on the maximum displacement of the bankline, the maximum rate of erosion between 2019 and 2021 was calculated as 115 ft/yr at the upstream bank and 66 ft/yr at the downstream bank.

The erosion rate between 2019 and 2021, local geomorphology, and modeled shear stress was used to project the future channel migration trajectory in 2022 and 2023. Figure 2 shows projected right banklines for 2022 (dotted line) and 2023 (dashed line) along with the uncertainty bands associated with these estimates. A projected right bankline was not estimated for 2026 due to the high degree of uncertainty associated with projecting five years into the future, but an uncertainty band for the 2026 right bankline projection is shown. For all years, including 2022 and 2023, there is a high degree of uncertainty about the future location of the channel.

**Figure 2** Historic and Projected Right Bank Locations of the Lower Satsop River in which there is a high degree of uncertainty about the projected right bank locations

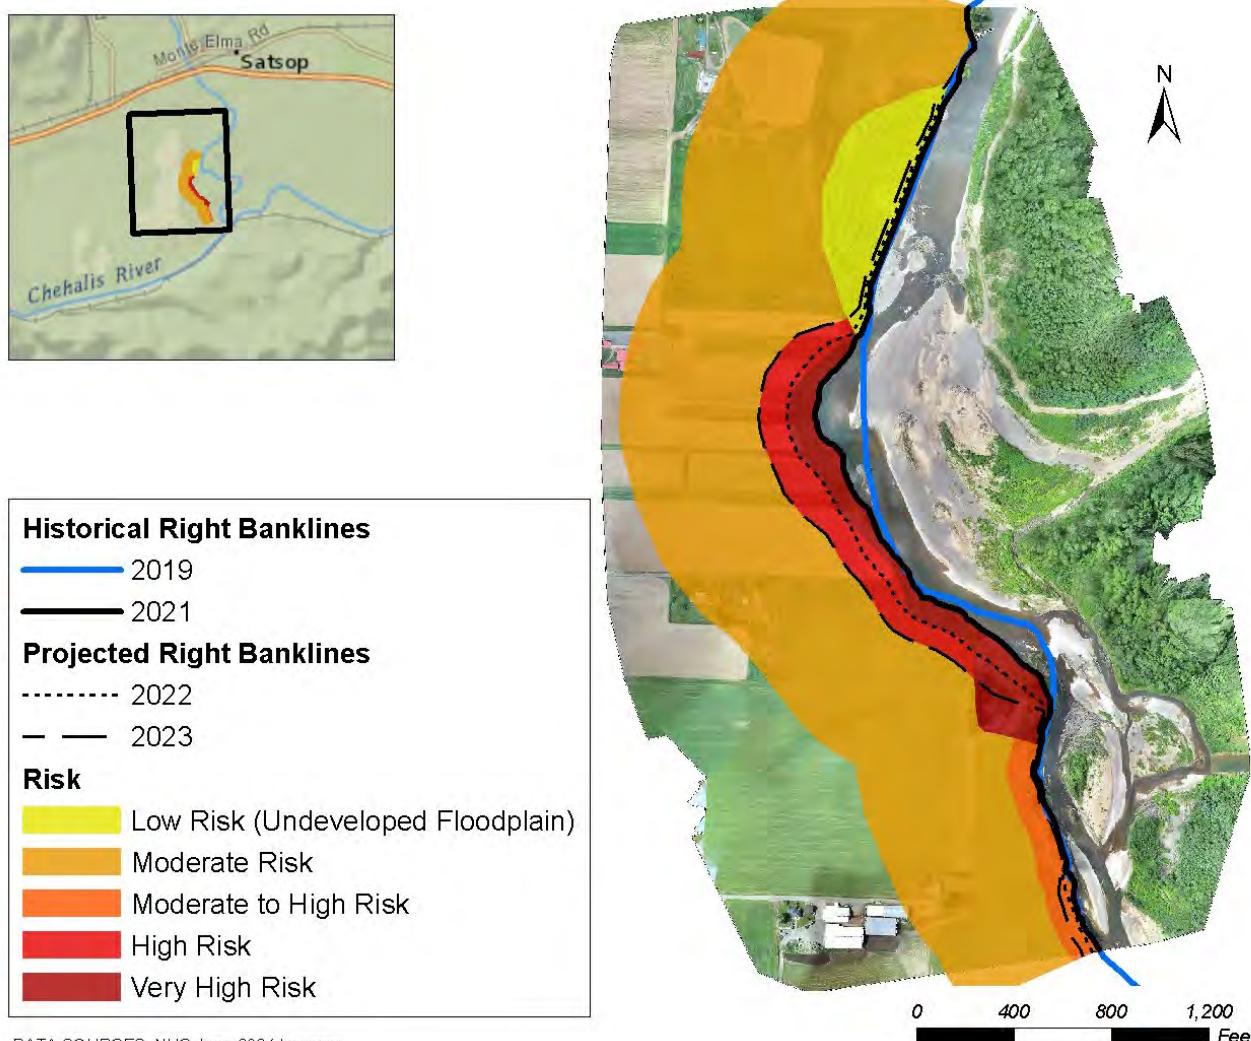
Projected channel erosion and local geomorphology were used to delineate predicted at-risk areas for the Lower Satsop River. For the purposes of this analysis, the magnitude of risk can be defined as the product of likelihood of occurrence and consequence. For example, upstream areas of undeveloped floodplain are categorized as low risk, while the downstream area occupied by a house is categorized as high risk – due to the relative consequence of erosion in each area. Figure 3 shows predicted at-risk areas classified in five categories: low risk (undeveloped floodplain), moderate risk, moderate to high risk, high risk, and very high risk. The areas at highest and most imminent risk (very high risk category)

correspond to the upstream and downstream banks where the highest rates of erosion occurred between 2019 and 2021. Near the downstream bank, there is a house that falls within the very high risk area.

**Figure 3 Predicted At-Risk Areas for the Lower Satsop River based on projected channel erosion and local geomorphology**

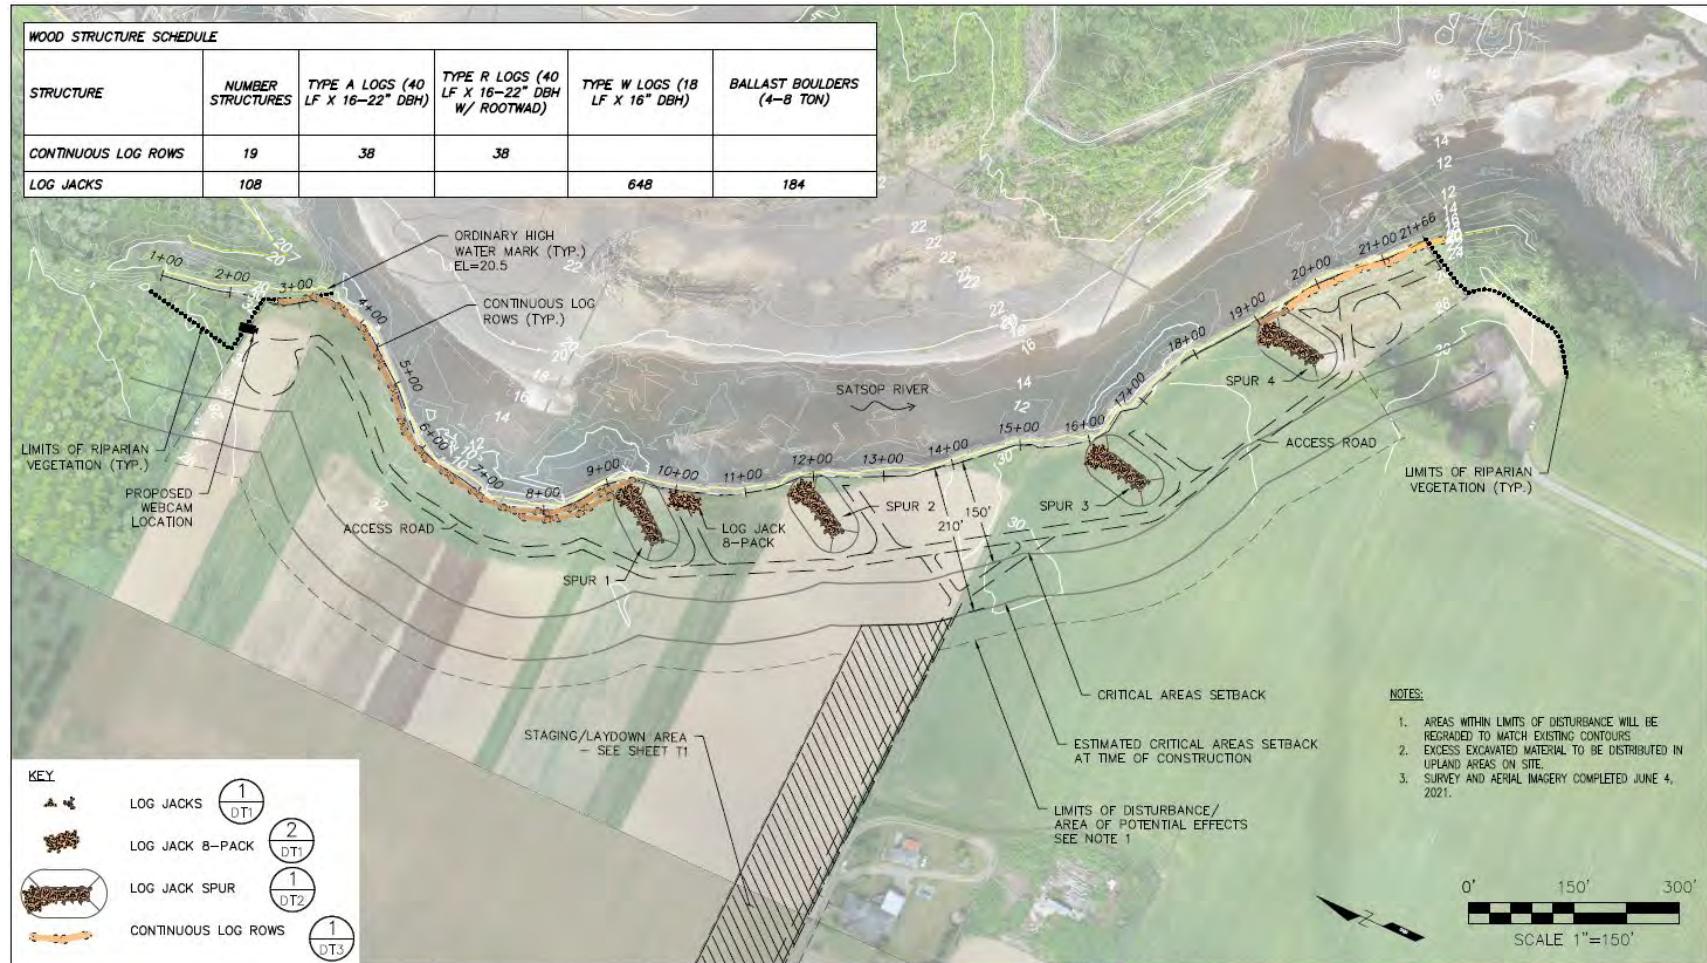
Figure 11. Preferred alternative layout

- In the upper reach, continuous log rows are proposed to address toe erosion and jet scour within the short-radius bend (station 2+50 to 9+00). The log rows are connected in bundles of four log structures, which are independent of other bundles to allow for individual bundle deployment. The rows are wrapped around the upstream bend at the project to prevent flanking, but are not keyed into the slope as they are meant to deploy to the bank toe if erosion occurs.

- In the middle reach, a hybrid design combining the log jack and log spur alternatives is proposed. A relatively lower risk in the middle reach, and the larger bend radius made spurs an appropriate treatment for this area. The need for flexibility and compatibility with future phases of restoration work led to the design, in which log jacks are installed in a spur configuration, providing similar function with the ability to be repositioned later as needed. Four jack spurs are proposed, with approximately 25 jacks per spur and a length of approximately 100ft per spur. At station 10+00, a standalone grouping of eight self-deploying log jacks is proposed with the intention of recruiting and wracking native woody debris across a short width of the channel to an existing apex jam. If the recruitment is successful, woody debris could bridge to the existing apex jam, providing function similar to a spur.

- At the lower reach, continuous log rows are proposed to provide additional toe protection at the existing residence. The lower reach is also protected by the most downstream of the four spurs in the middle reach.

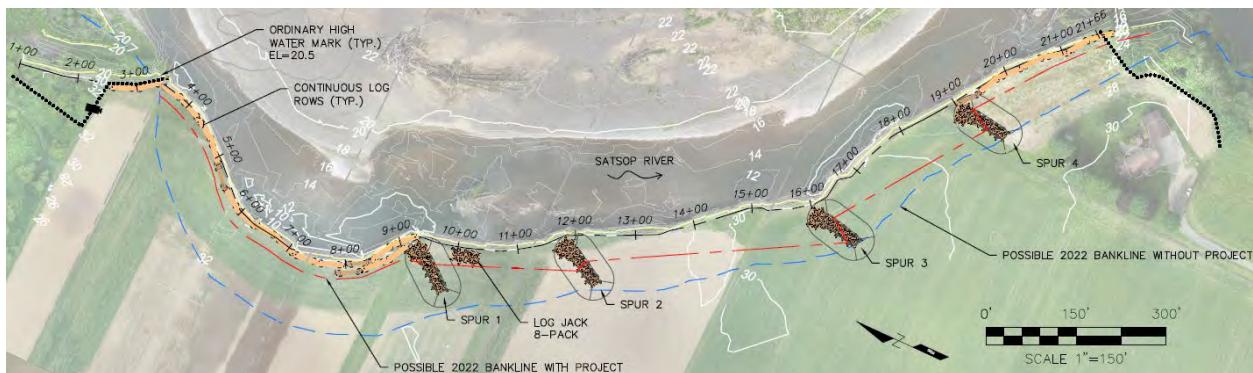
In the upper reach the hydraulic model results indicate that embayment near bank velocities are low during floods. With the upper stable vegetated hardpoint at Station 3+50 remaining in place, upstream sheltering from Spur 1, and the log rows deploying, erosion in the upper reach is expected to be reduced. In the middle reach erosion will need to expose 60 feet or so of the 100 ft long spurs in order for them to provide erosion protection for the bank in between them. In the lower reach, downstream of Spur 4, the combination of spur and log row protection is expected to decrease erosion rates.

Figure 12. Anticipated 2022 bankline
