Attachment K

Representative Photographs

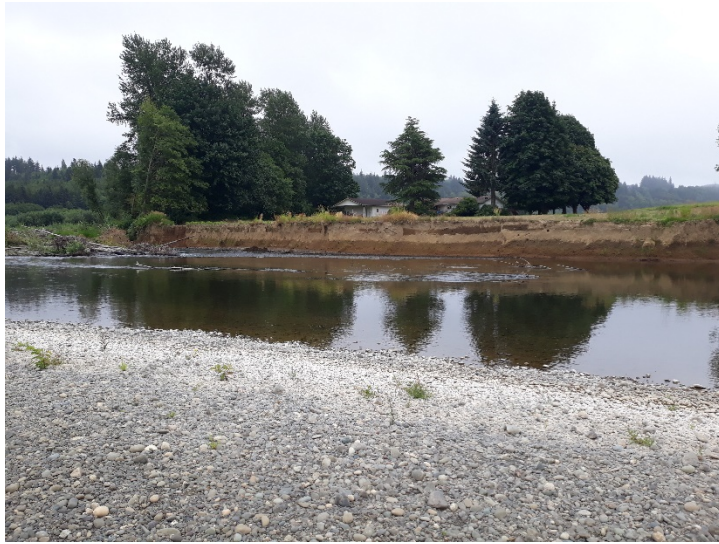
Photograph 1. Willis house. Downstream end of erosion. Photo taken from in-stream gravel bar. View S.

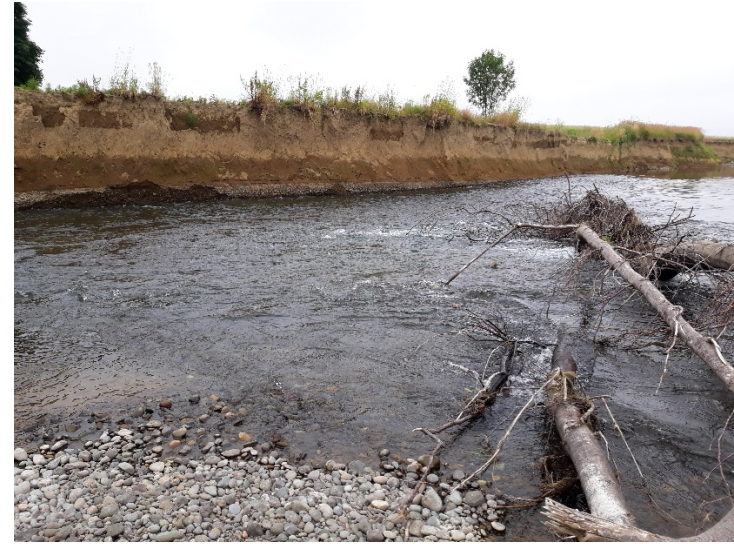
Photograph 2. Bank erosion at downstream end. Note slightly undercut bank and some cobbles below deep silt loam layer and in-stream wood. View W.

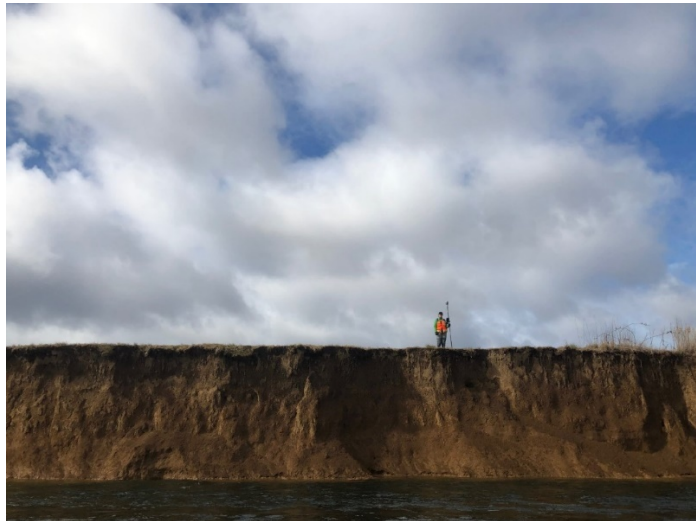
Photograph 3. Tall cutbank in central portion of study area. View W. (Photograph taken by Parametrix survey crew, June 2021)

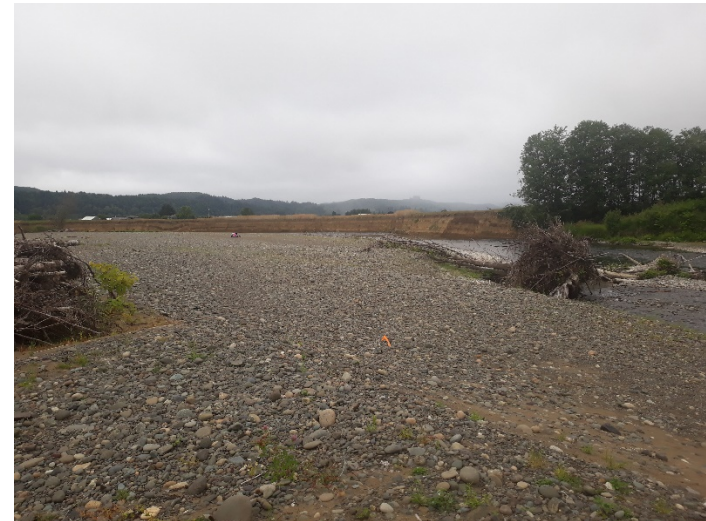
Photograph 4. Gravel bar and large wood in foreground. On-site riparian vegetation and cutbank at north/upstream end of project area in background. View SW.

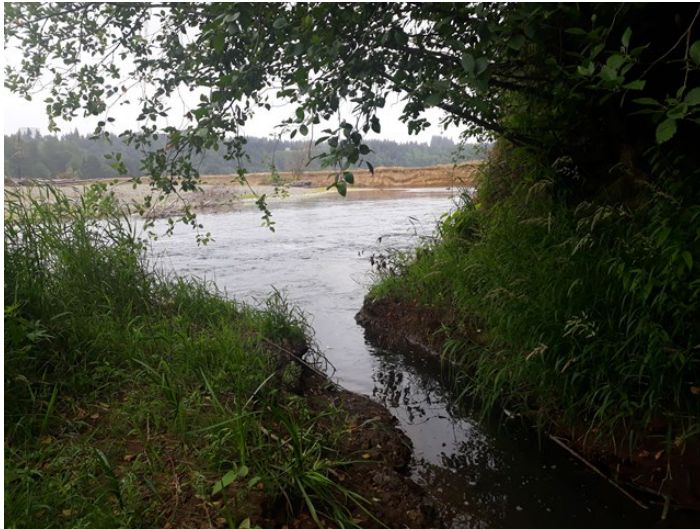
Photograph 5. Satsop River side channel and riparian vegetation (red alder, reed canarygrass, Himalayan blackberry). View SE.

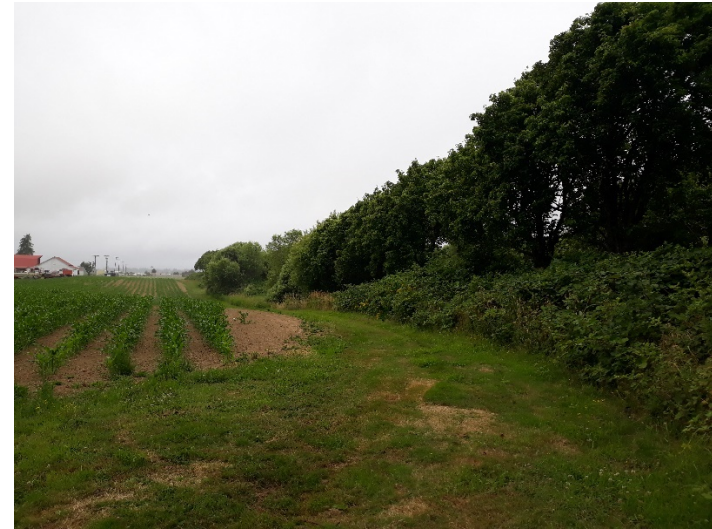
Photograph 6. Riparian vegetation and typical farmed upland conditions (planted corn with grassed field edges). View W.

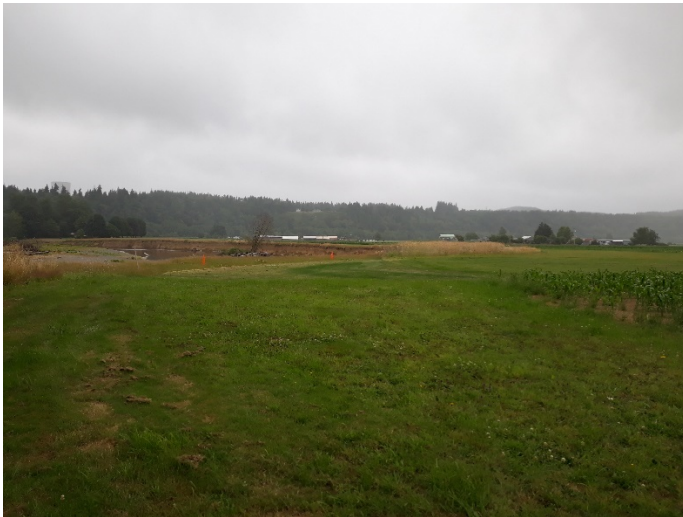
Photograph 7. Typical upland farmed conditions (corn and pasture areas) where structures will be placed. Conditions also typical of staging area. River cutbank in background. View SE.

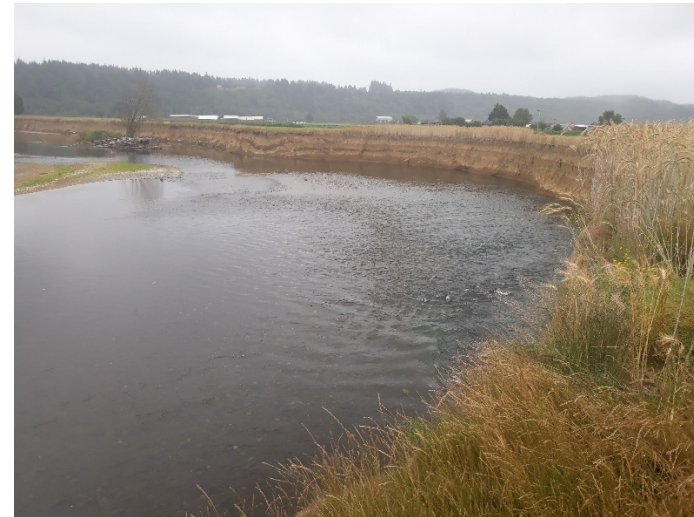
Photograph 8. River cutbank viewed from top of bank. View S.
