Sponsor	Project	Additional Information Request
1. Cosmopolis	Mill Creek Multi Objective Implementation Plan: Channel and Culvert Improvements for Flood Reduction and Fish Passage/Habitat Restoration	<p>a. Please describe and provide map showing how the City of Aberdeen’s proposed Farragut Street Pump Station Rebuild project benefits Cosmopolis and Mill Creek. <i>A downstream analysis will be required for the new Farragut Street Pump Station to ensure that discharge from the new station does not create a new downstream hydraulic problem or add to any existing downstream hydraulic problems in the lower Mill Creek basin. The downstream analysis will be completed during the design phase and will be closely coordinated with the City of Cosmopolis’ Mill Creek Multi Objective Implementation Plan for the Mill Creek system. Through the downstream analysis and coordination with Cosmopolis, there is the potential to optimize pump station discharge relative to existing conditions and improve downstream hydraulic conditions for the lower Mill Creek basin.</i></p> <p>b. Please describe how barriers identified here (https://geodataservices.wdfw.wa.gov/hp/chehalisprioritization/index.html) will fa

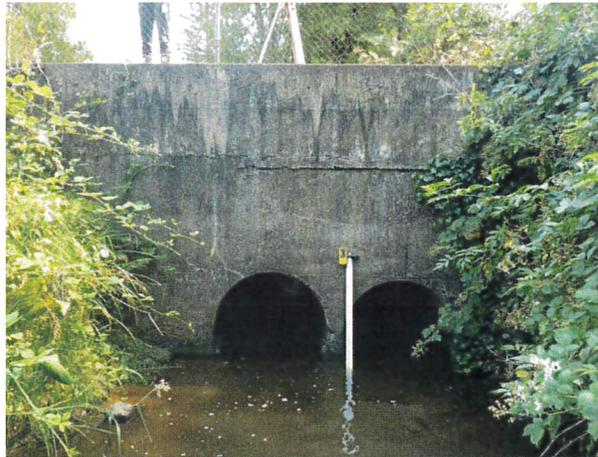
Comments
 Wingwalls at US end and concrete headwall both ends. Internal grade breaks caused by separation of pipe extensions (~1m long) at both ends. Debris build up at both inlets. All inverts badly rusted.

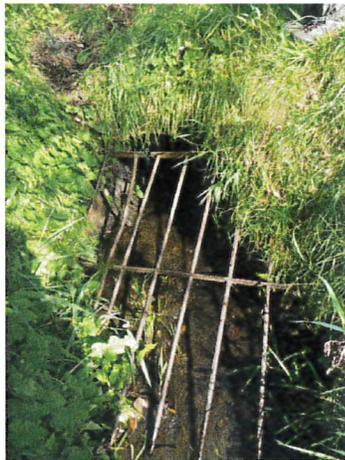
Comments
 Couldn't find outlet, WSD and countersunk status not collected. Culvert has bituminous lining and a rack on US inlet. US Rack Gap=0.23m, Headroom=0.08m. WDIC measured on upstream end. US stormwater input on RB.
