Subject: Aquatic Species and Habitat Inventory
Wishkah Road Floodwall

Kersh-Wishkah Flood Wall

Existing Features

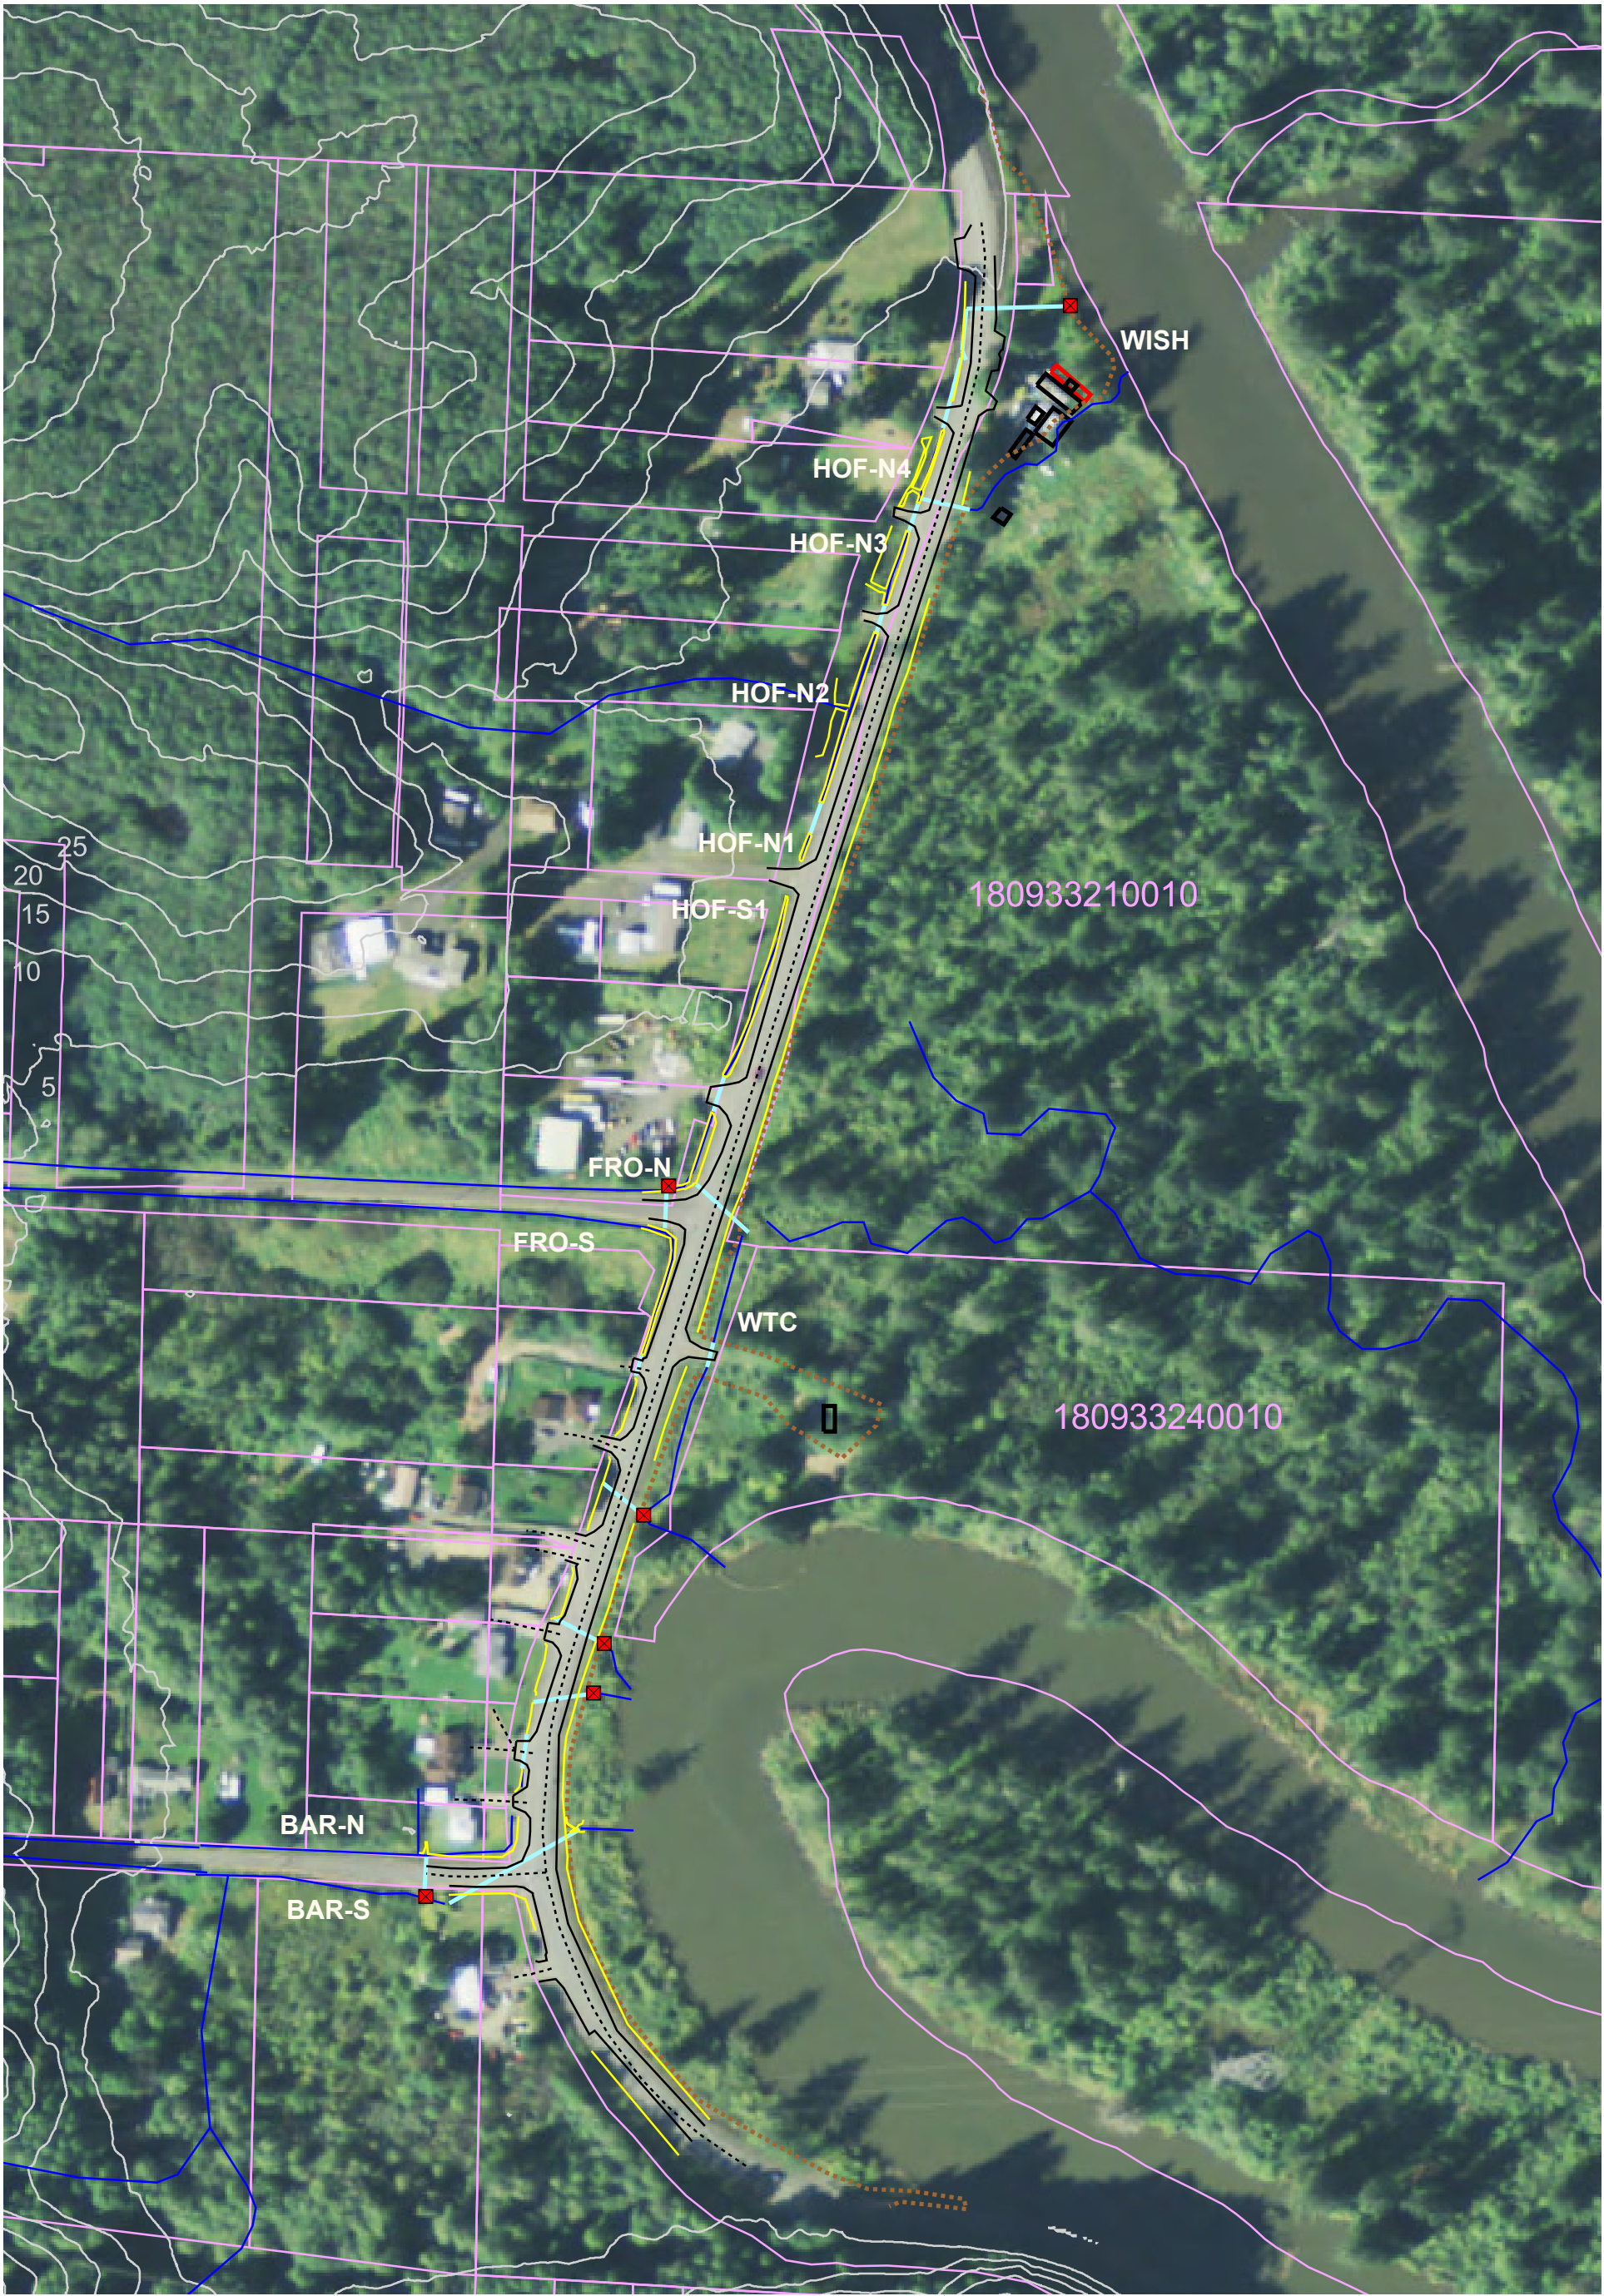
Figure 1

On April 28, 2014, AMEC field biologists conducted a reconnaissance level pedestrian survey of the areas east and west of Wishkah Road, investigating stream and off-channel aquatic habitat features, as well as culverts that may impede fish migration. These features were sketched on a base map and annotated (Figure 1).

On April 29 and 30, 2014, a fish survey was performed to document fish use of these habitats. In addition to simple visual observations of fish, a variety of capture methods were used depending on site-specific conditions. Methods included: baited minnow traps, backpack electrofishing, and a small seine net. Based on observations of flow direction and connectivity, the study area was divided nominally into discrete sampling sites (Figure 1). The results of the fish survey at each sampling site are fully described in Table 1.
