Appendix F

Environmental & Permitting Documents

Mill Creek Park Dam Improvements Project

The City of Cosmopolis proposes to replace the damaged Mill Creek Dam, located in Mill Creek Park in Cosmopolis, Washington, which was breached during an intense storm in November 2008. The breach was caused by a large alder tree that fell from the hillside above the dam after several days of heavy rain. The fallen alder caused the hillside to become unstable and to slide into the sheet piling of the dam, breaching the structure. As a result, the dam was no longer operational, and the upstream impoundment was drained.

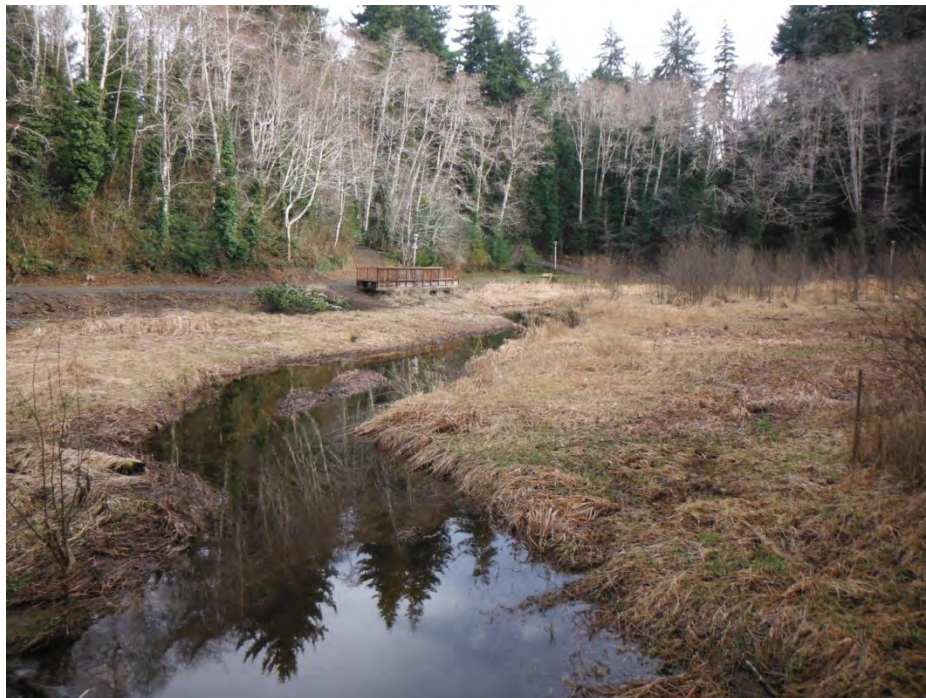
Figure 3: Photo of Mill Creek upstream of the dam through the former ponded area showing the existing channel, footpath, and pedestrian bridge at the south end of the park.

In the park area upstream of the dam, Mill Creek has formed a single low gradient (<1% slope) main channel through the area where the pond formed by the dam was previously located. The majority of the streambed in the reach upstream of the dam is comprised of sand and silt substrate with some organic debris. This area would provide functional rearing habitat for juvenile salmonids such as coho, with pools interspersed in the reach along with the cover and structure provided by the LWD. Suitable spawning gravels are not present in the surveyed project reach upstream of the dam (HDR 2014a).

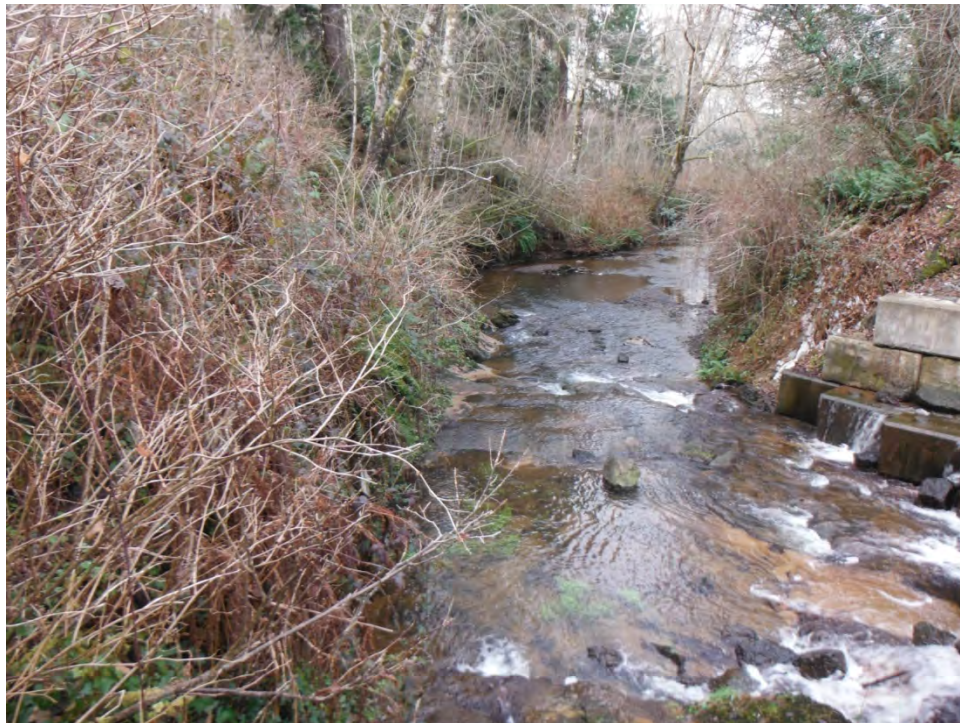
Figure 4: Photo looking downstream from the dam at the reach of Mill Creek that flows through the park area

park. The riparian vegetation downstream of the dam is predominantly deciduous forest cover with alder being the main component. There is a dense shrub understory along the left bank of the creek predominantly comprised of salmonberry (*Rubus spectabilis*) and willows (*Salix* spp.) along the bank. The right bank of the stream between the dam and the culvert under C Street contains areas of mowed lawn in the park and several mature conifers with little to no shrub understory and a few willows along the bank. Three small wetlands also occur in the forested riparian areas in the park downstream of the dam. Surface water from the wetland on the right bank discharges to Mill Creek via a culvert under the Mill Creek park trail; subsurface water from Wetland 2 also reaches Mill Creek under the trail (HDR 2014b).

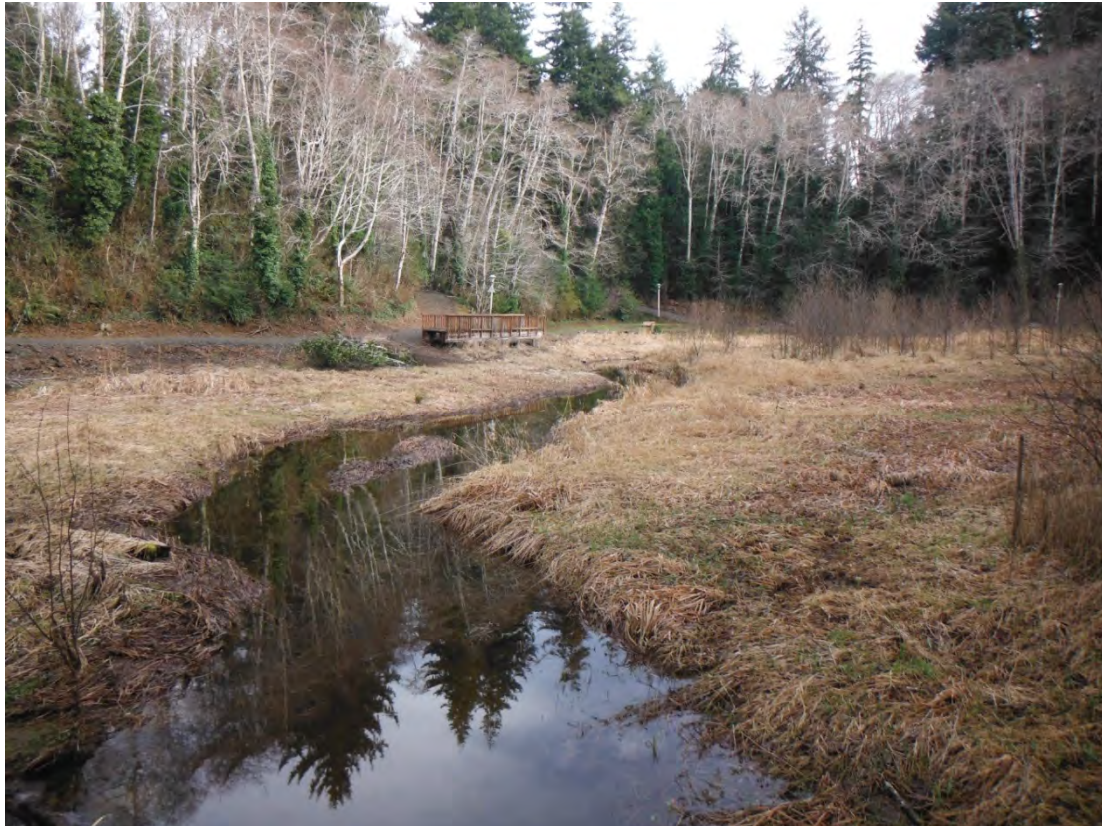
Stream channel looking upstream from the dam through the former pond.

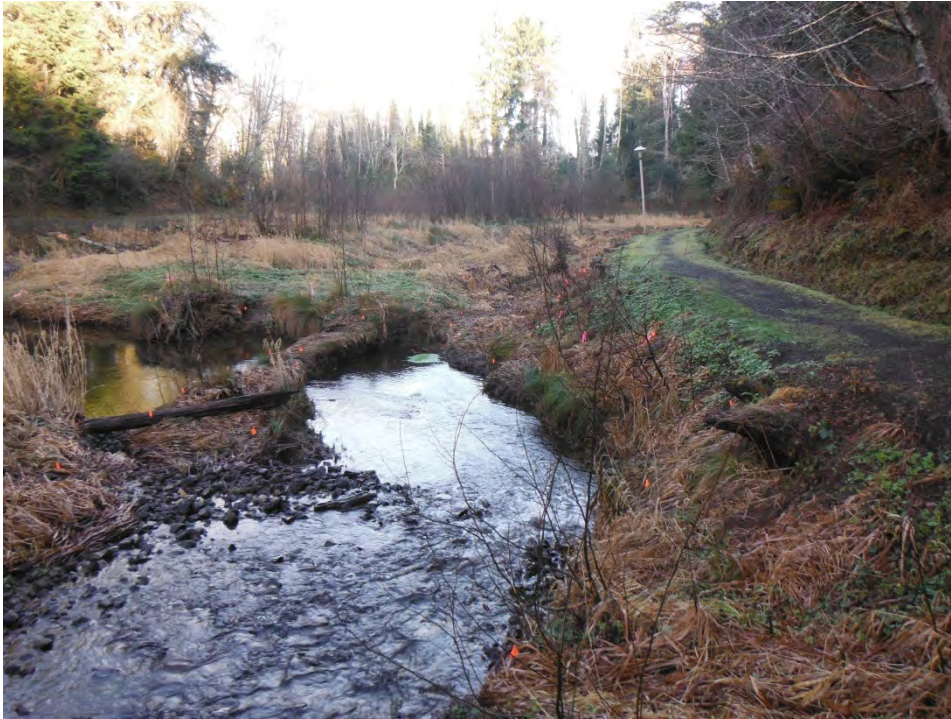
Riffle over spill by footbridge at south end of the former ponded area.

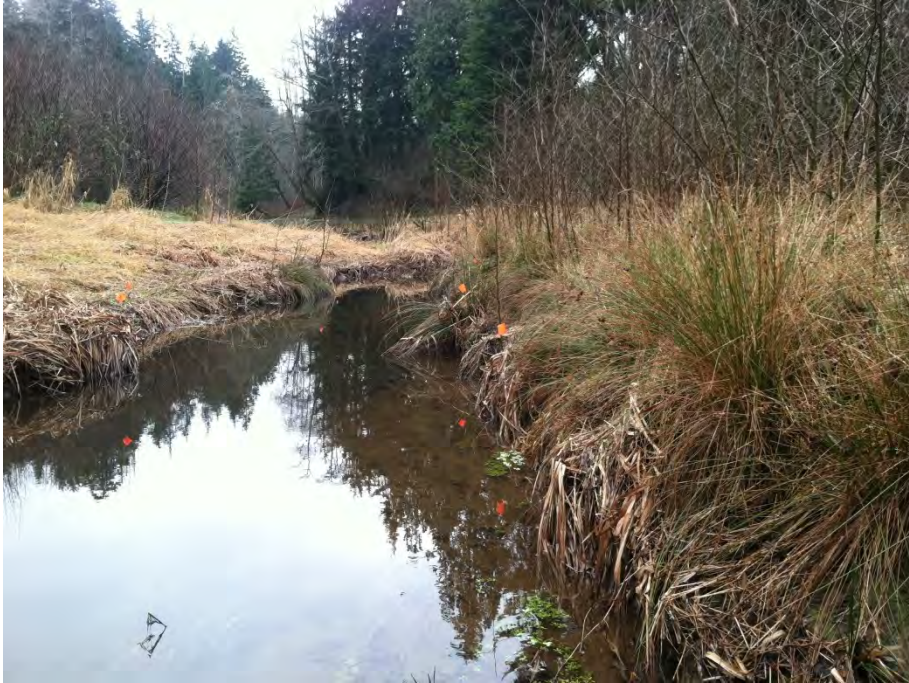
The stream channel within the former pond area in the park is predominantly glide habitat with reed canary grass and sedges along its banks.

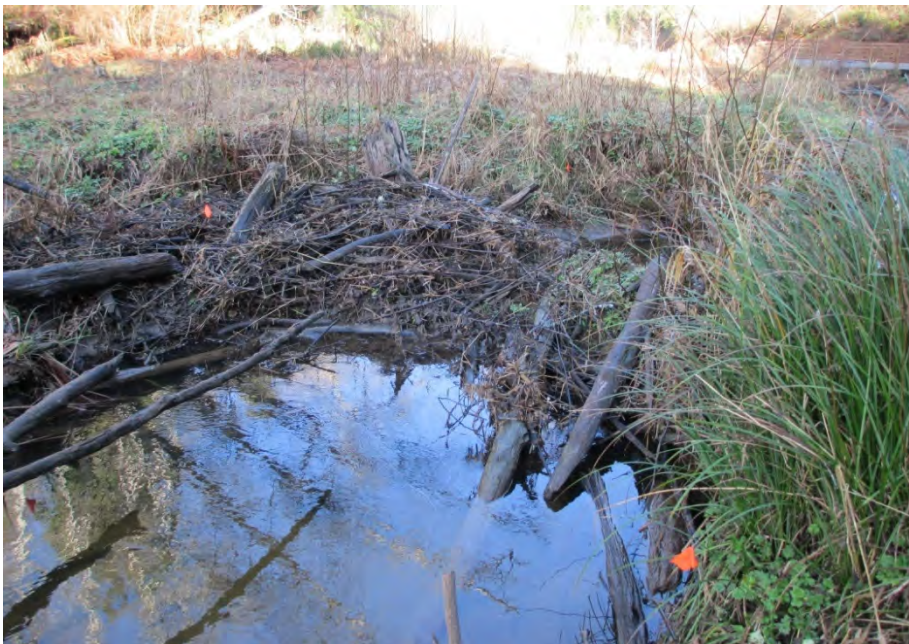
Beaver dam located south (upstream) of the footbridge.

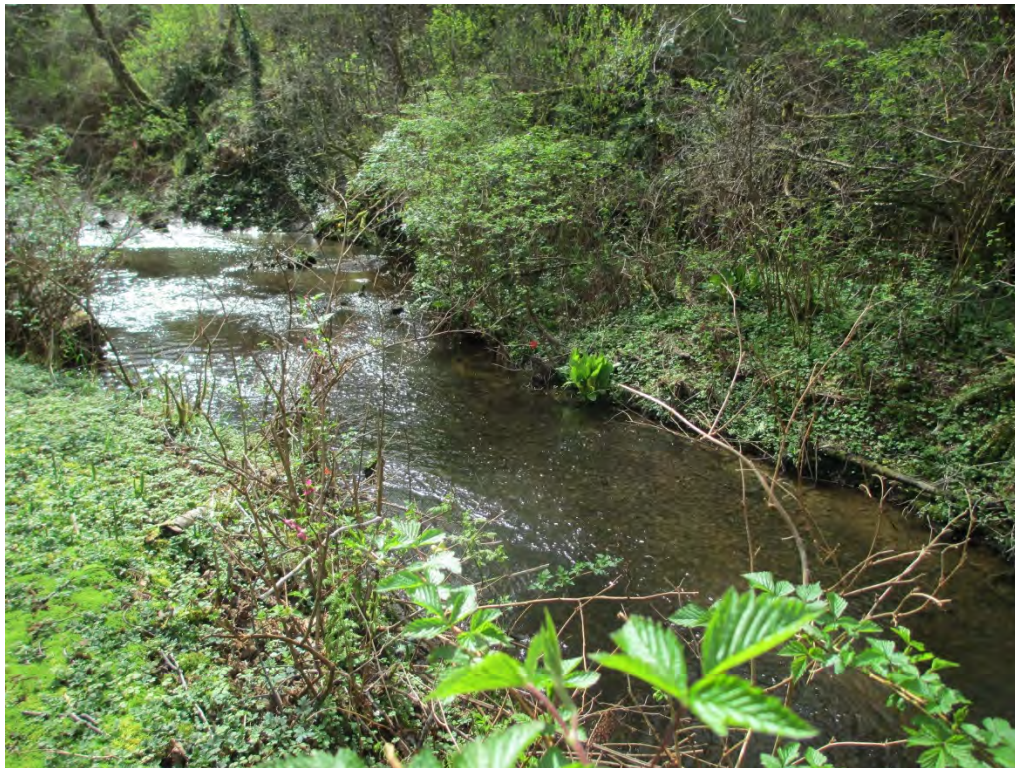
The stream channel downstream of the dam contains gravel areas used by spawning coho.

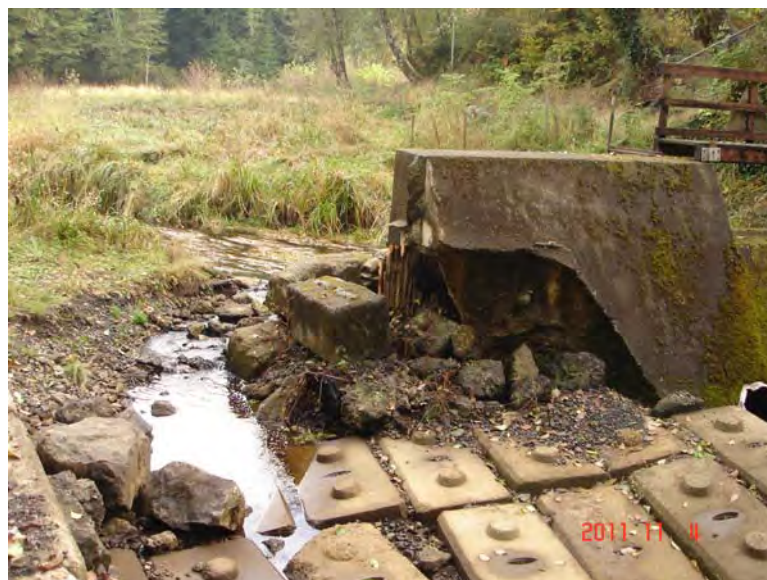
Photo 4: Mill Creek Park Dam temporary repairs after breach, facing upstream (HDR 2013).

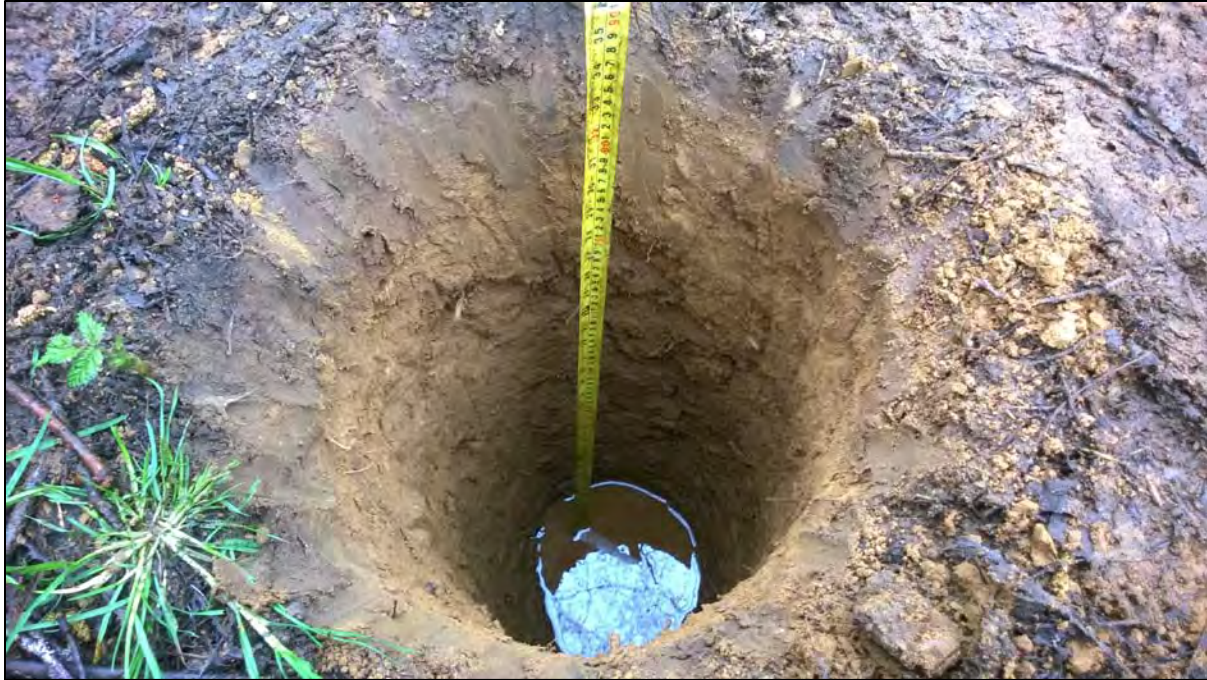
Photo 3. Example of subsurface deposits encountered across the APE.

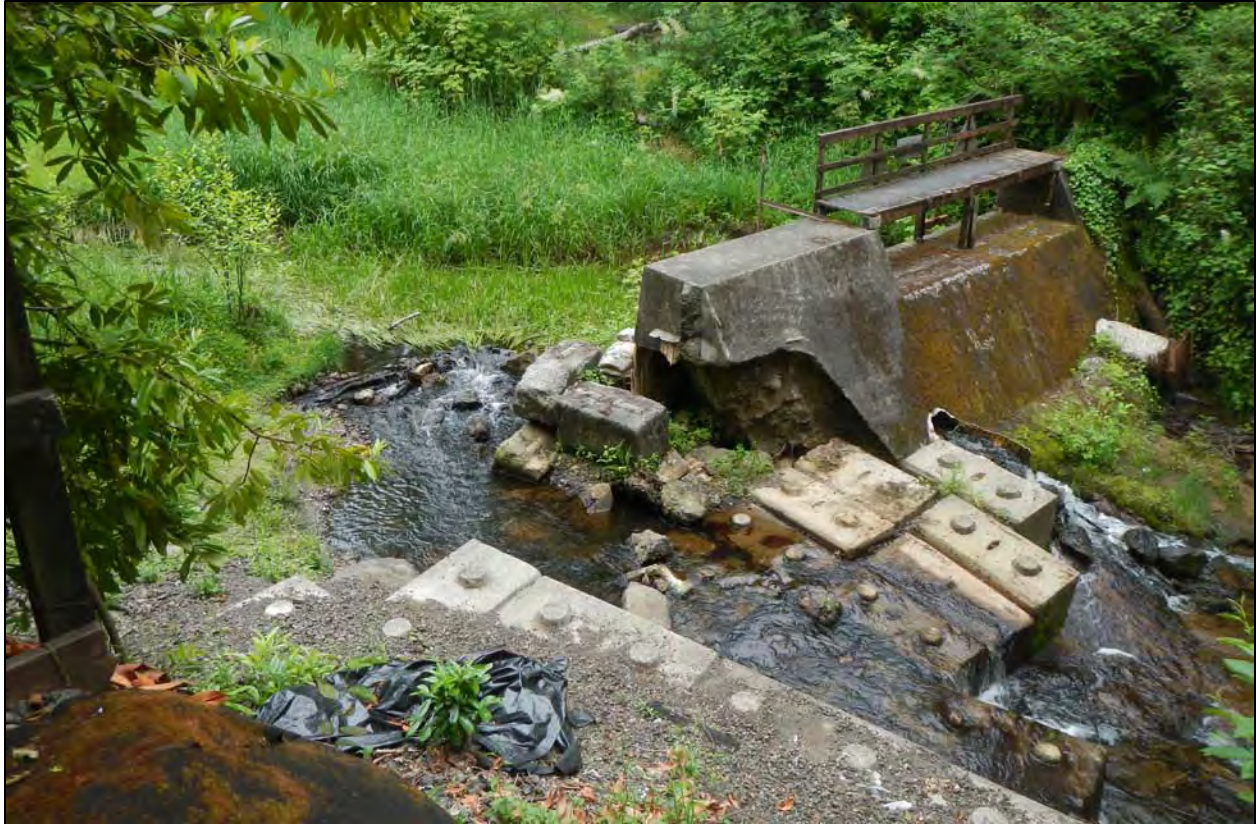
Near the center of the APE is the failed Mill Creek dam (Photo 4). The Mill Creek Dam was constructed in 1930 (Washington State Department of Ecology 2011, as cited in HDR 2012). It is considered an earth-filled concrete gravity dam (HDR 2012). Gravity dams are designed so that every dam section is stable, independent of any other dam section. Prior to the 2008 breach, the dam was 200-feet wide by 20-feet tall (HDR 2012). The profile of the dam appears to be trapezoidal. The dam was breached along the right bank. On the left side of the dam is a concrete spillway and two culverts estimated to be 24 inches in diameter (HDR 2012). Canal gates, manufactured by Waterman Industries, have been installed on the upstream end of the culverts to provide the ability to draw down the reservoir (HDR 2012). Following the breach, sandbags were placed along the upstream face of the dam and ecology blocks were placed along the right side of the dam in an attempt to secure the dam and adjacent hillslope. The wooden footbridge has also since been removed from the location and is set aside offsite.

Photo 4. Overview of Mill Creek Dam.

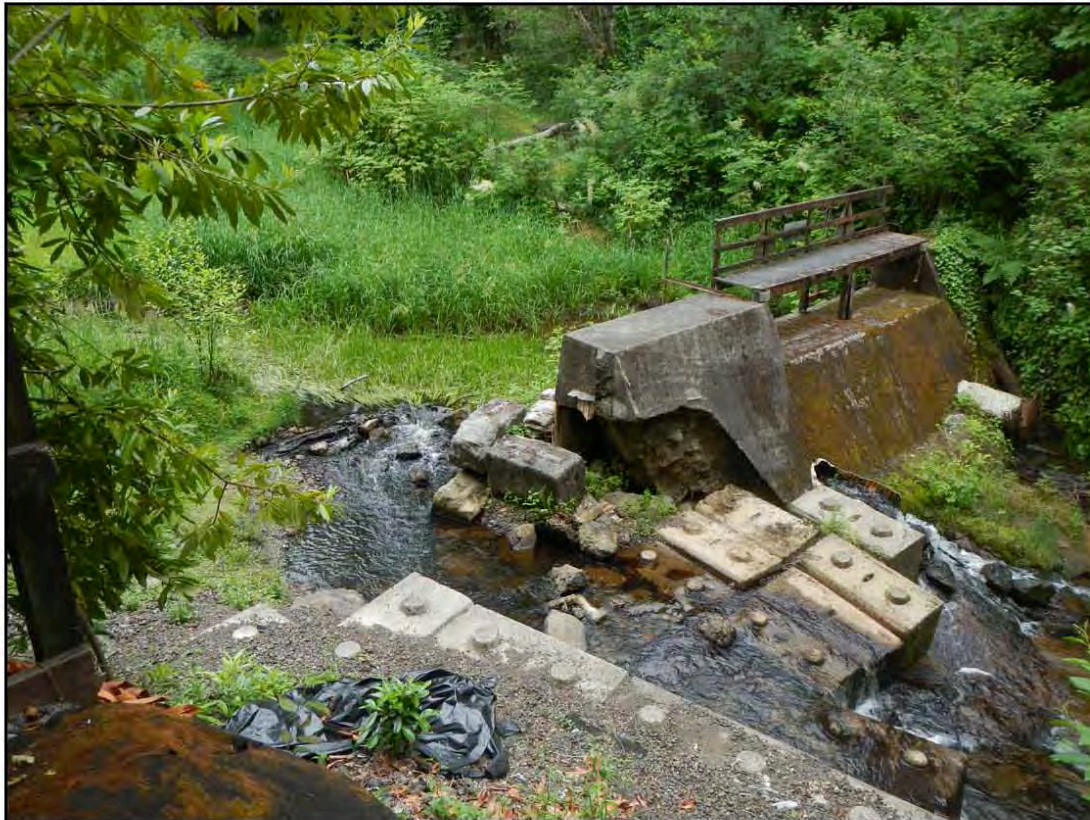
Photo 1. Overview of the Mill Creek Dam, view south.
