# **BURLEY / MINTER WATERSHED**

*2012 Water Quality Monitoring Report  
Kitsap Public Health District*

# BURLEY / MINTER WATERSHED

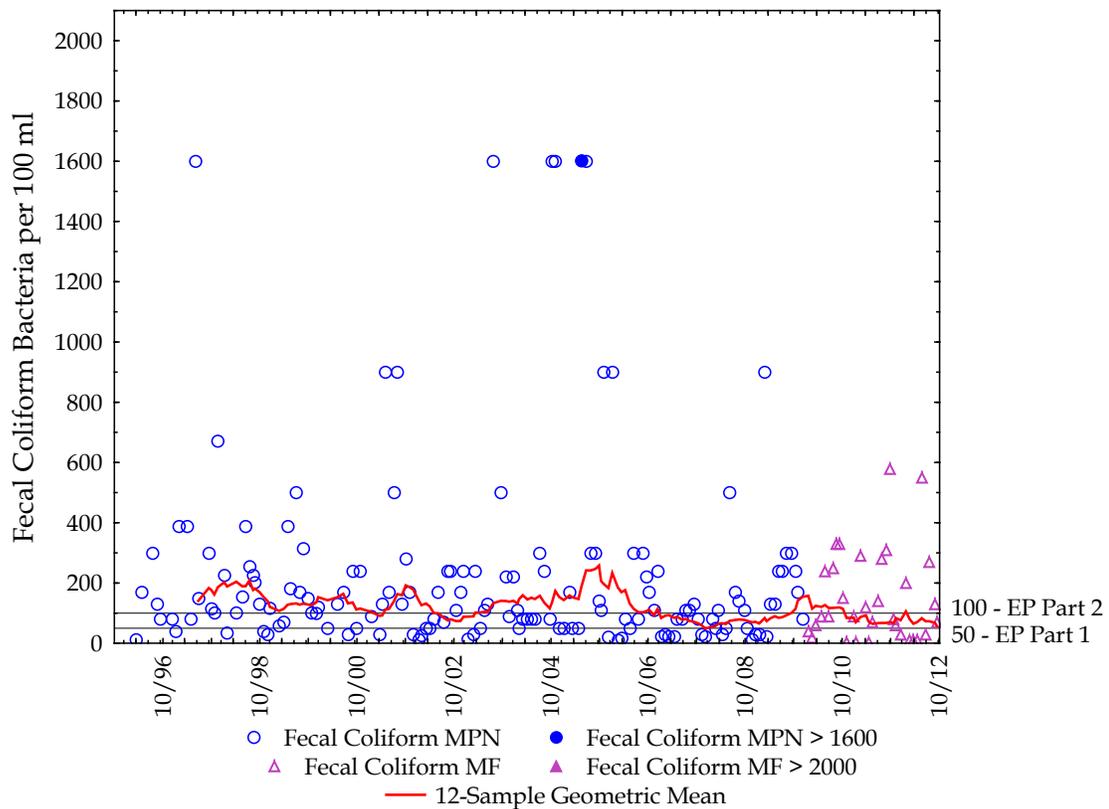
### BURLEY CREEK TREND GRAPH

Burley Creek originates in wetlands just north of Mullenix Road. The main stem and its tributaries combine for over nine miles of stream corridor. It flows south and discharges into Burley Lagoon near commercial shellfish growing areas in Pierce County. Land use in the Burley Creek drainage is a combination of rural residential and agricultural. Although bacteria levels have dropped since 2005, current water quality is still relatively poor with frequent periods of elevated bacteria. Statistical analysis for the creek shows a **stationary trend**. A tributary stream, Bear Creek, had a public health advisory issued in 2010. After a couple years of clean up efforts, the levels of fecal bacteria have decreased, and the advisory has been **lifted** for 2013.

Waterbody	Long term trend	Short term trend	Meets WQ Standard?	2011 FC Bacteria GMV	2012 FC Bacteria GMV	Health Advisory?
Burley Creek (BL01)	→	→

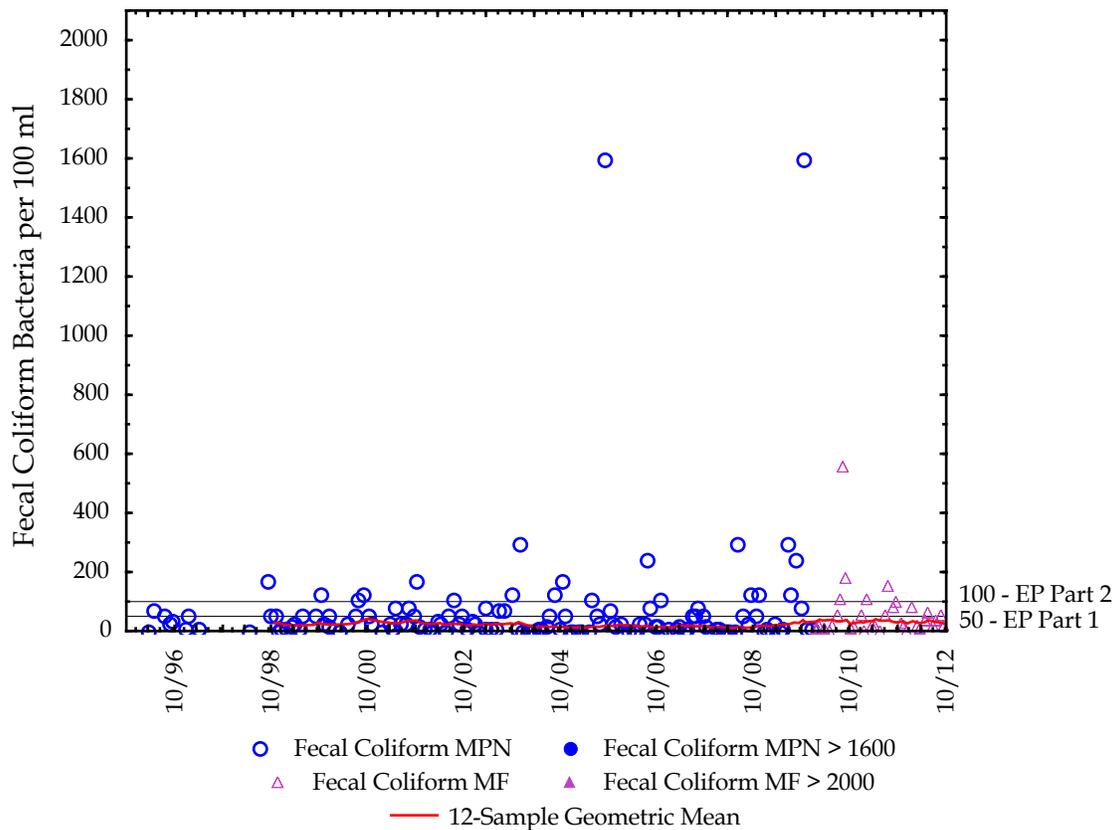
HUGE CREEK TREND GRAPH

Huge Creek originates north of SW Hunter Road in south Kitsap, flows across the Kitsap/Pierce County line, and discharges into Minter Creek. It is approximately 3.7 miles long. Land use in the Huge Creek drainage is a combination of rural residential and agricultural. Even though the creek periodically has elevated bacteria counts, water quality over the last year has been good. Long term trend analysis for the creek has previously shown an improving trend, and since bacteria levels have stabilized, Huge Creek now has a **stationary trend**.

29	25	No
Minter Creek (MN01)	↗	→

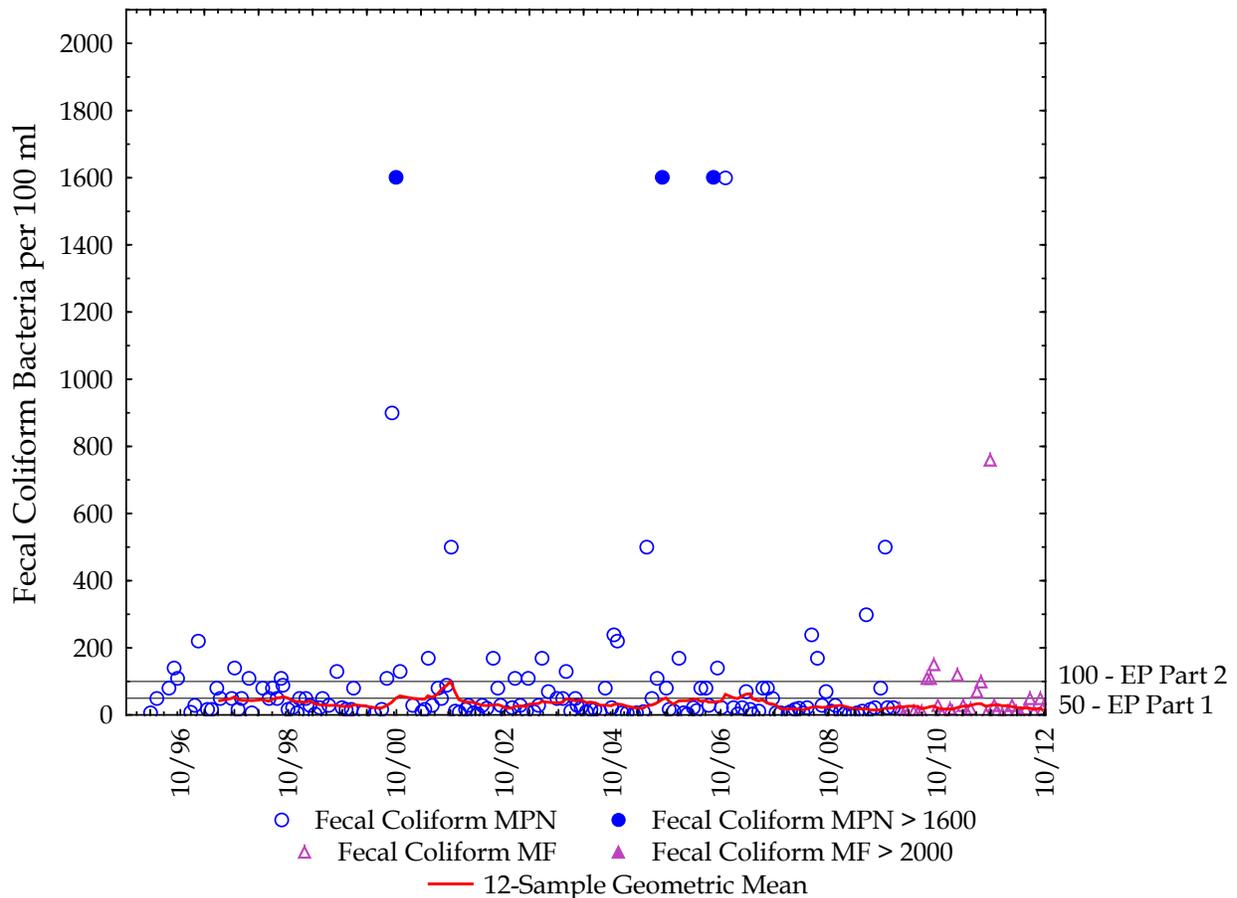
MINTER CREEK TREND GRAPH

Minter Creek originates north of Minterbrook Road in south Kitsap. The main stem and its two major tributaries, Huge Creek and Little Minter Creek, combine to form over 13 miles of stream corridor. Minter Creek flows south into Pierce County where it discharges into Henderson Bay. Land use in the Minter Creek drainage is a combination of rural residential and agricultural. Water quality over the previous year has been good, with only a few periods of slightly elevated bacteria concentrations. Statistical analysis for the creek shows a long-term **improving trend**.

29	15	No
Purdy Creek (PR01)	→	→

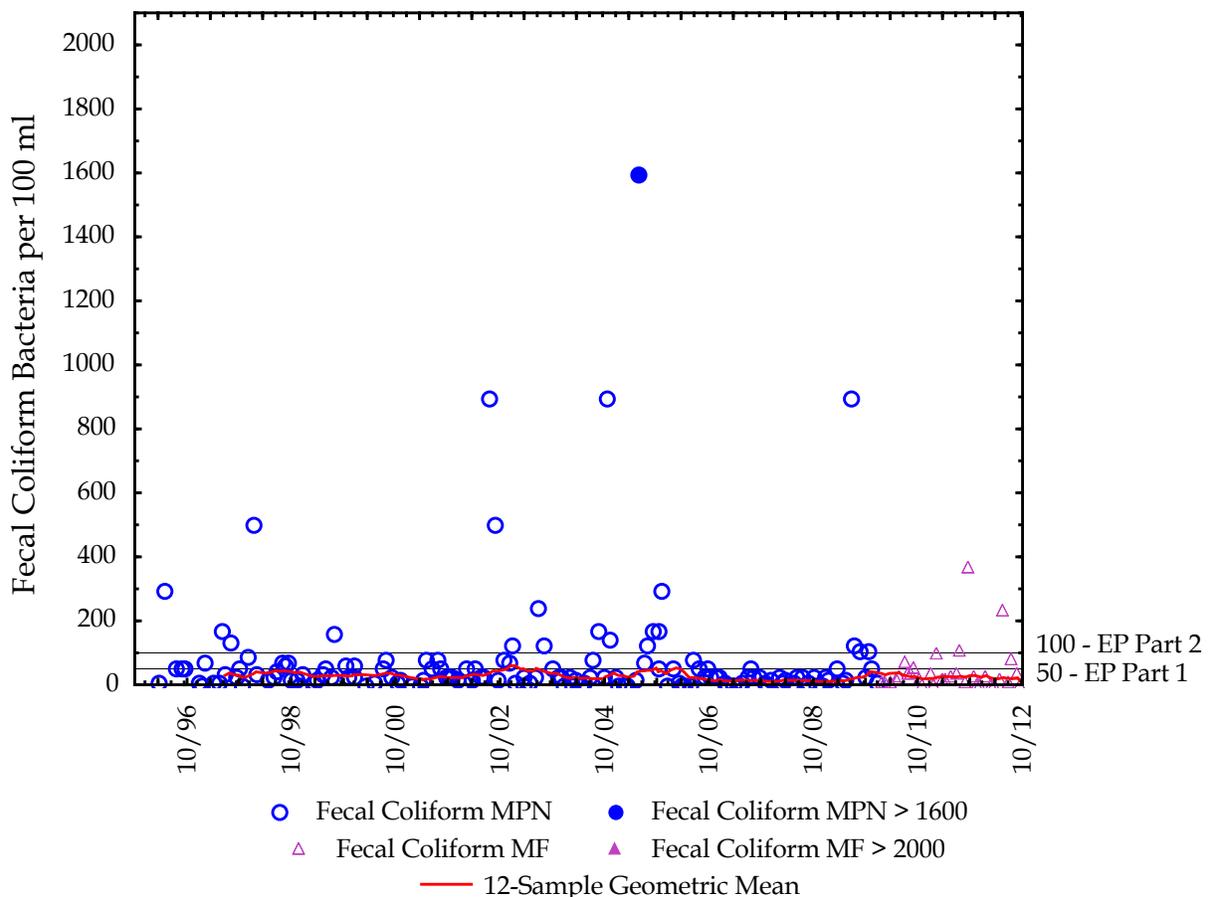
PURDY CREEK TREND GRAPH

Purdy Creek originates north of SE Burley Olalla Road in south Kitsap. The main stem and its tributaries combine for over 5 miles of stream corridor. The stream flows in a southerly direction, enters Pierce County and discharges into Burley Lagoon near the town of Purdy. Land use in the Purdy Creek drainage is a combination of rural residential and agricultural. Water quality over the last year has been good, but the creek periodically had elevated bacteria counts. Statistical analysis for the creek shows a long-term **stationary trend**.

28	15	No
