Flood Retention Facility Project Update

Chehalis River Basin Flood Control Zone District

July 7, 2022

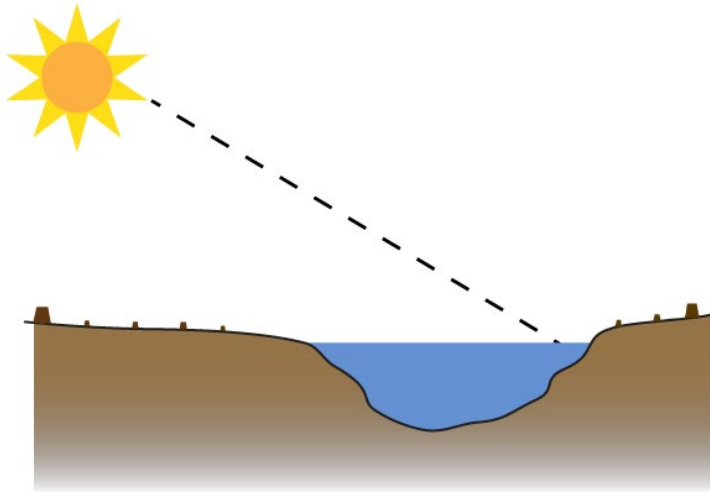
SEPA Draft EIS

Vegetation Cut Down
No Shade

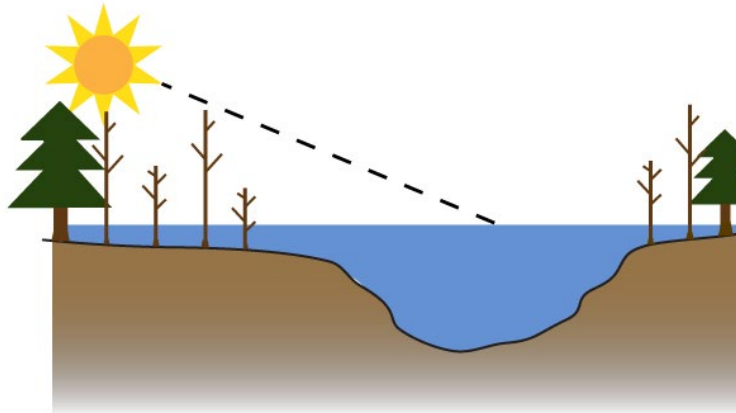
District Study

Flood Operation
Winter Dormant Leaf Off

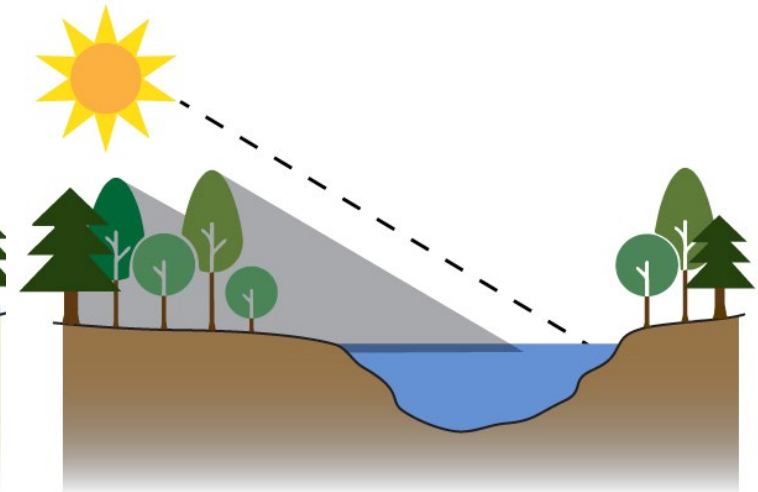
Non-flood Operation
Summer Leaf On
Shade

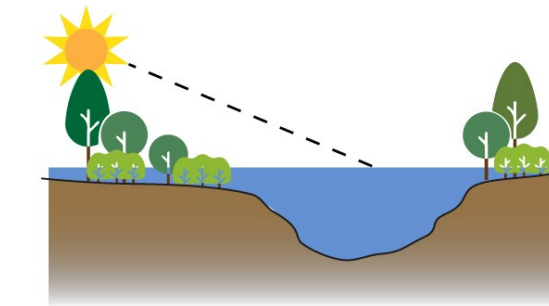
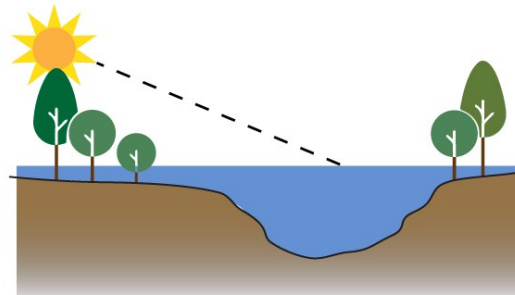
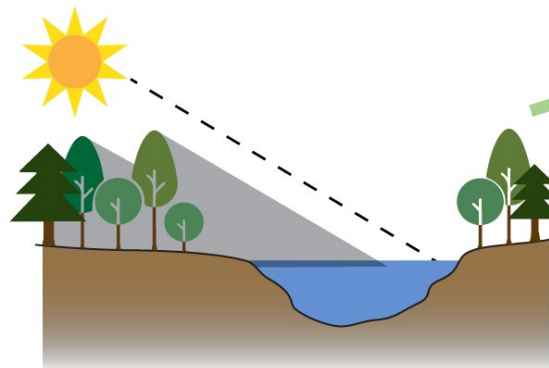
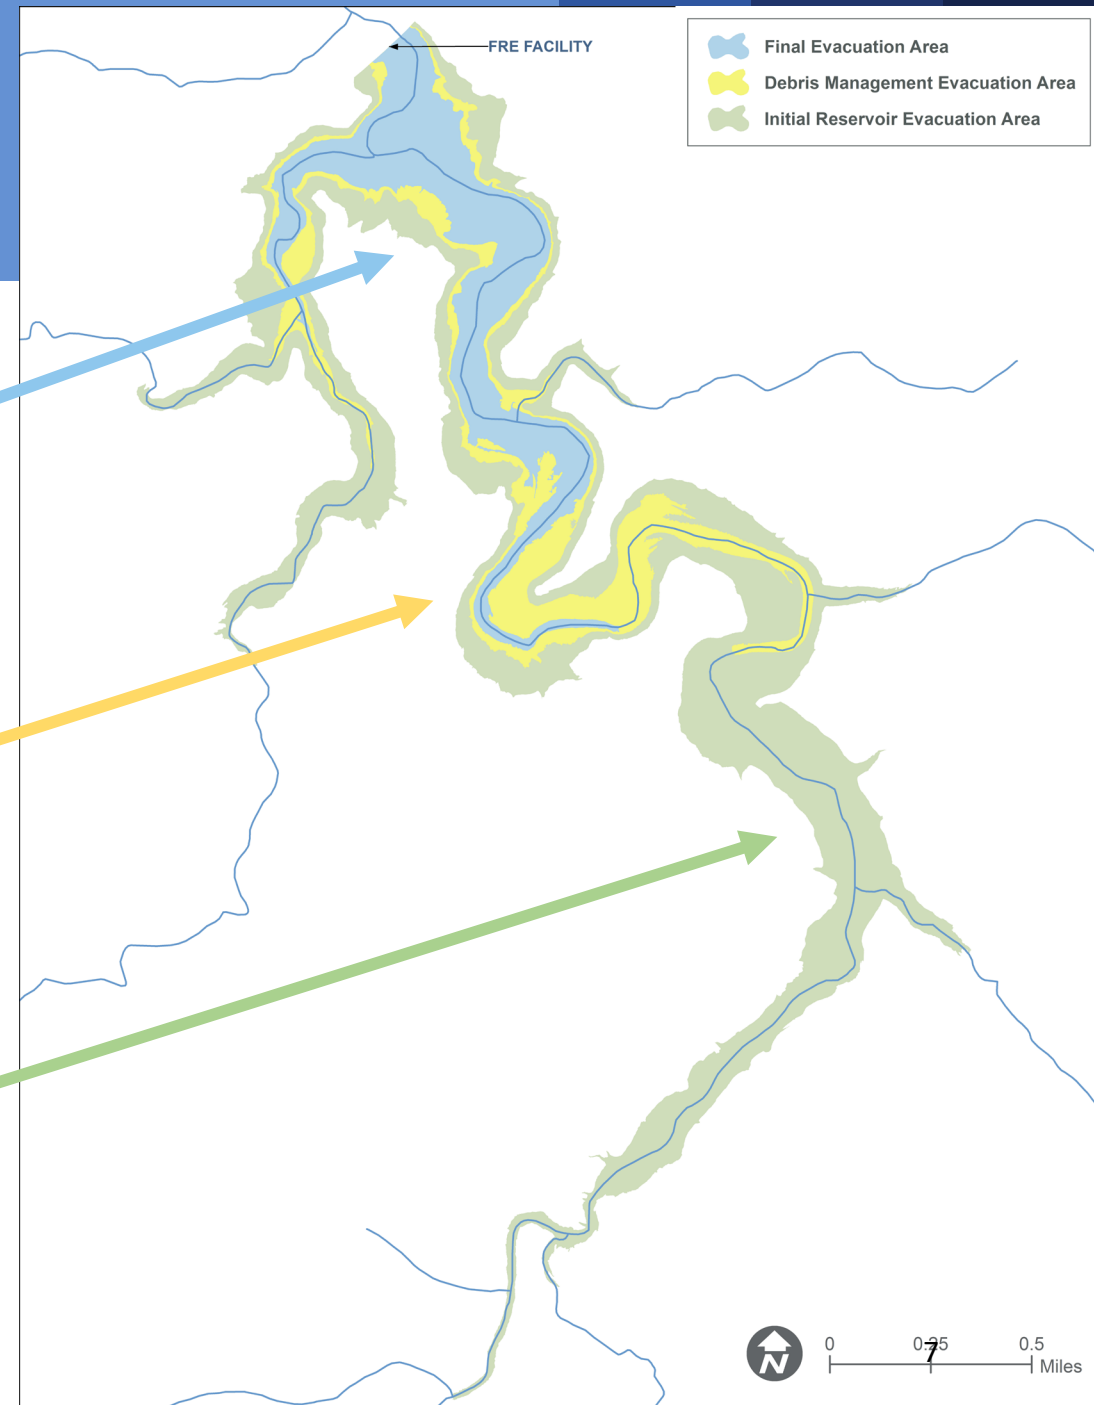
Location Survivability

- Low Survival

- Flood Tolerant

- Natural/High Survival

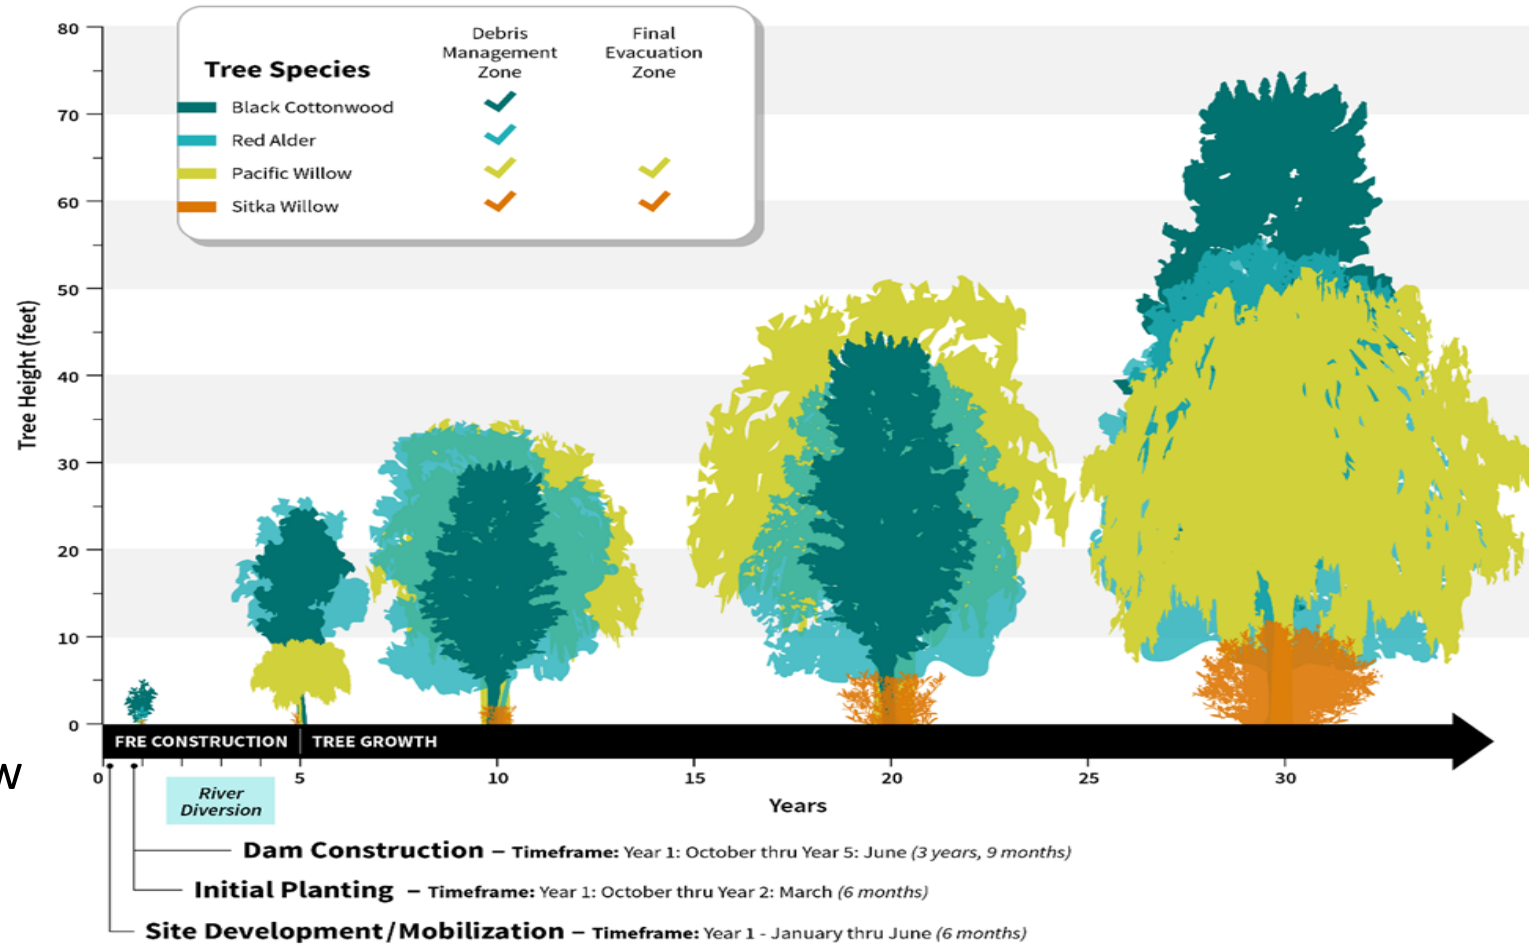
Type and Height Survivability

- Tree Species
 - Black Cottonwood
 - Red Alder
 - Pacific and Sitka Willow
- Tree Height
 - 5 to 20 feet Low
 - 75 to 90 feet High
- Validation
 - Mud Mtn Dam Vegetation
 - Independent Silviculturist Review

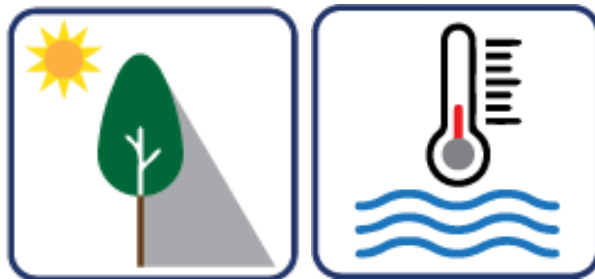
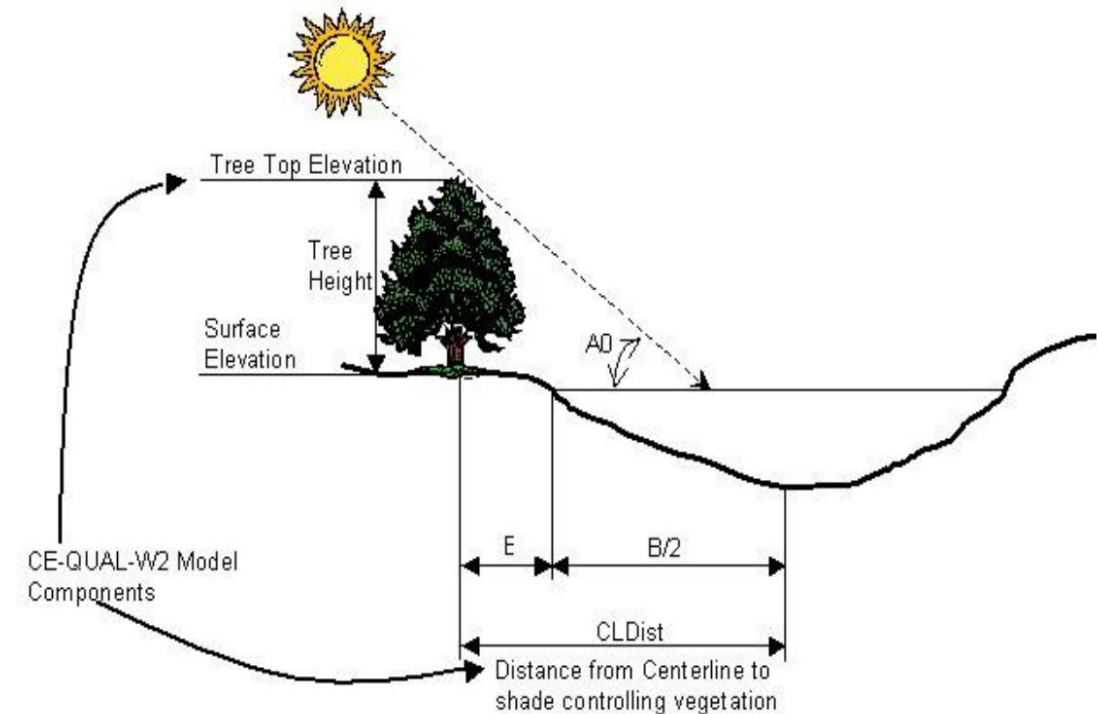
- Taller Vegetation = More Shade
- More Shade = Lower Water Temperature
- Validation
 - Model Predicted Lower Water Temperatures

Figure 40. Tree top elevation and vegetation offset from a river.

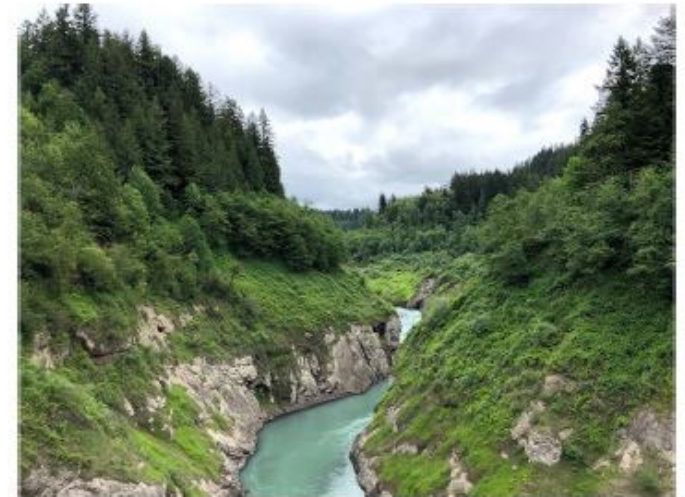
Mud Mountain Example

- Located **70 miles** from FRE Facility
- Constructed in 1947
- The entire reservoir area was cleared of vegetation
- Vegetation seen today has developed since 1947

**Trees Established and
Survive in Reservoir Area**
