Lower Satsop River Reach Assessment and Design
Bank erosion rates on a meander traveling toward Keys Road.
Aerial Imagery 7/21/18 Google Earth

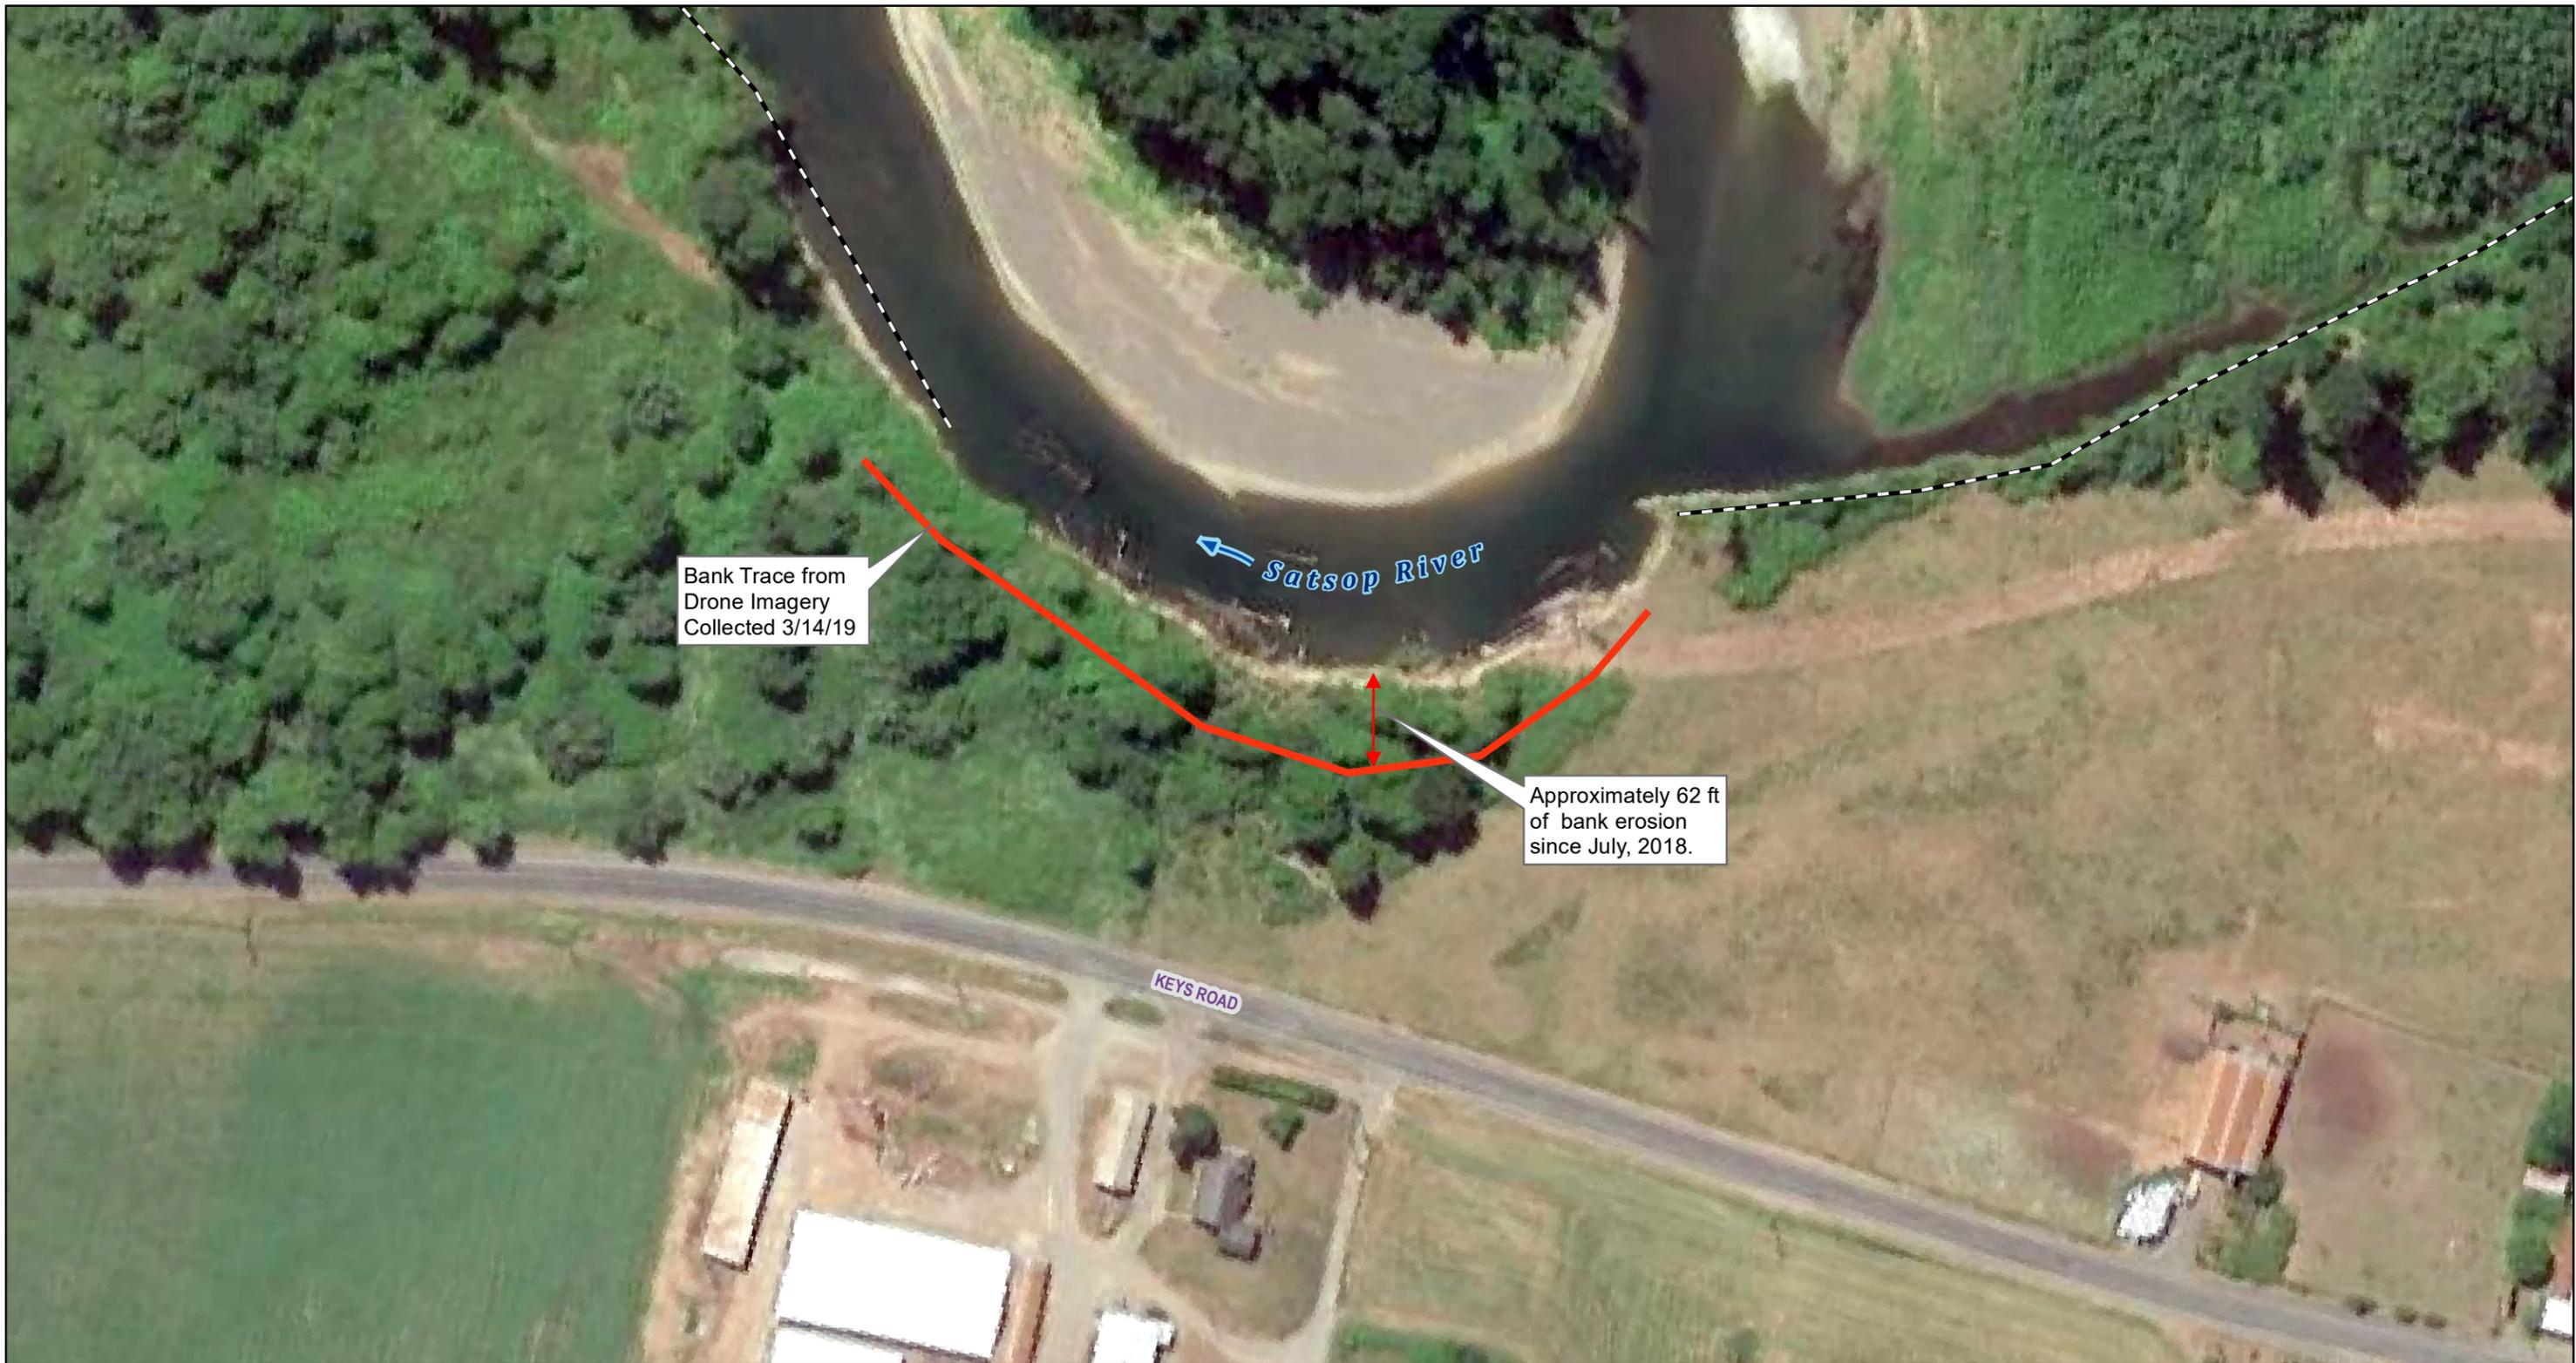
Bank Trace from Drone Imagery Collected 3/14/19

Approximately 62 ft of bank erosion since July, 2018.

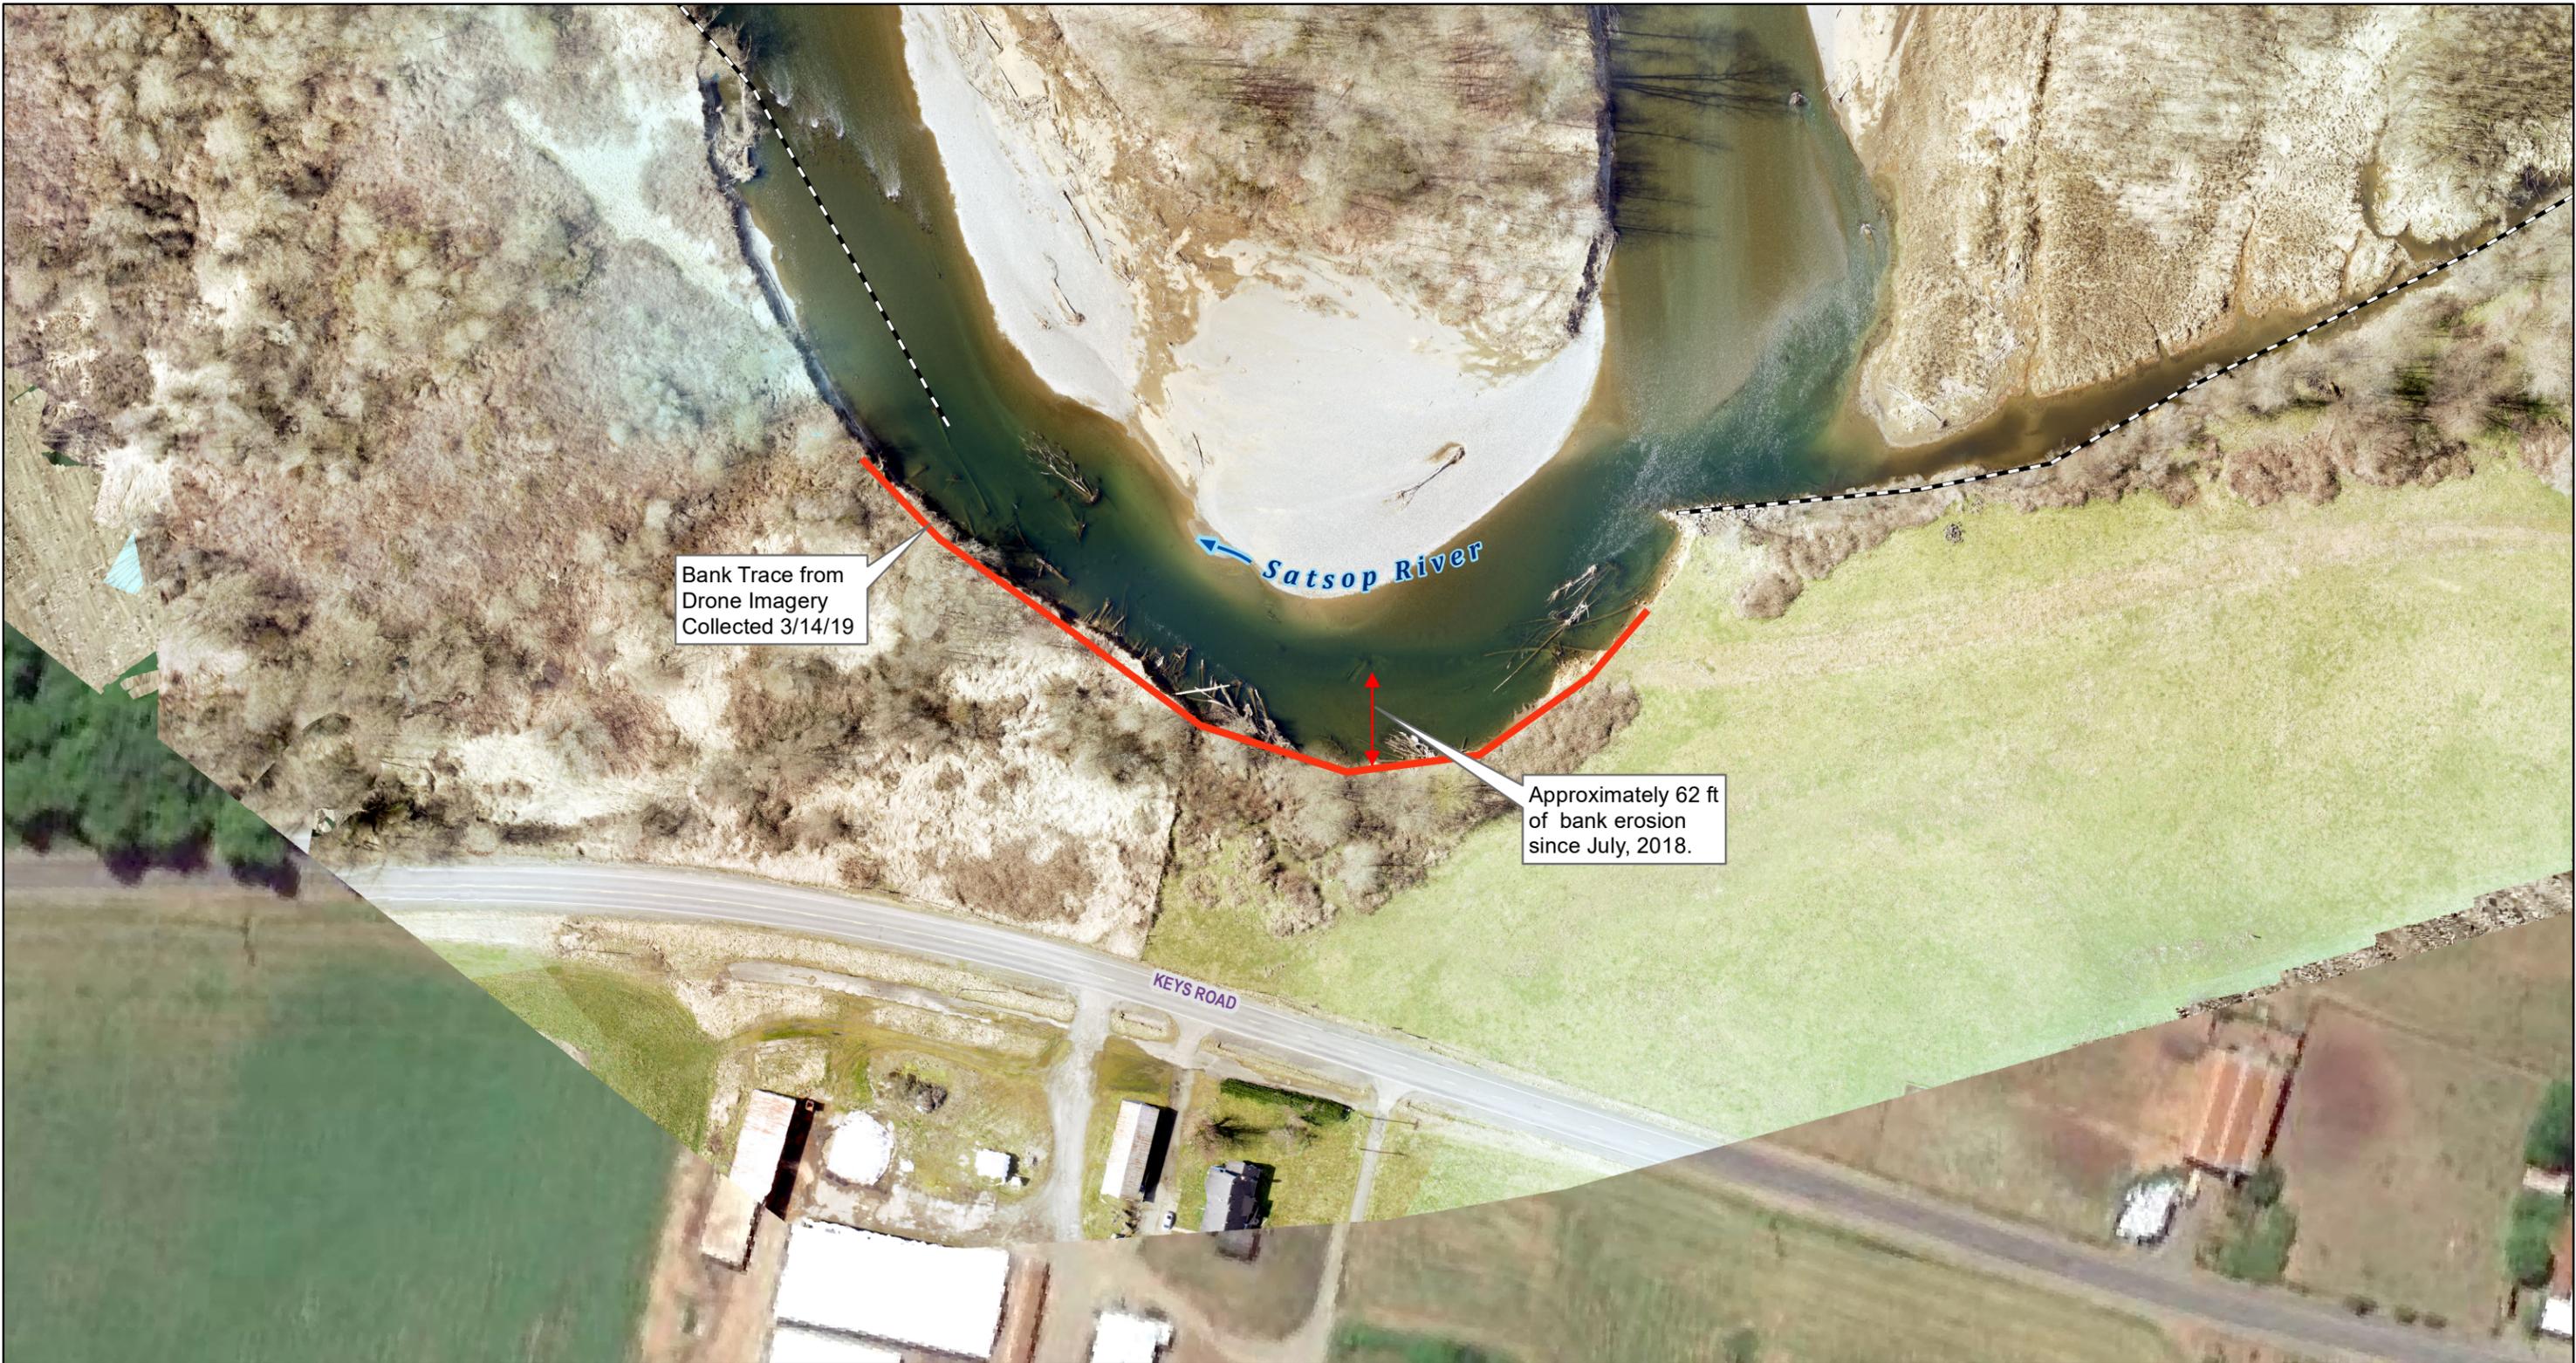
Bank Trace from Drone Imagery Collected 3/14/19

Approximately 62 ft of bank erosion since July, 2018.

Lower Satsop River Reach Assessment and Design
Bank erosion rates on a meander traveling toward Keys Road.
Aerial Imagery 7/21/18 Google Earth

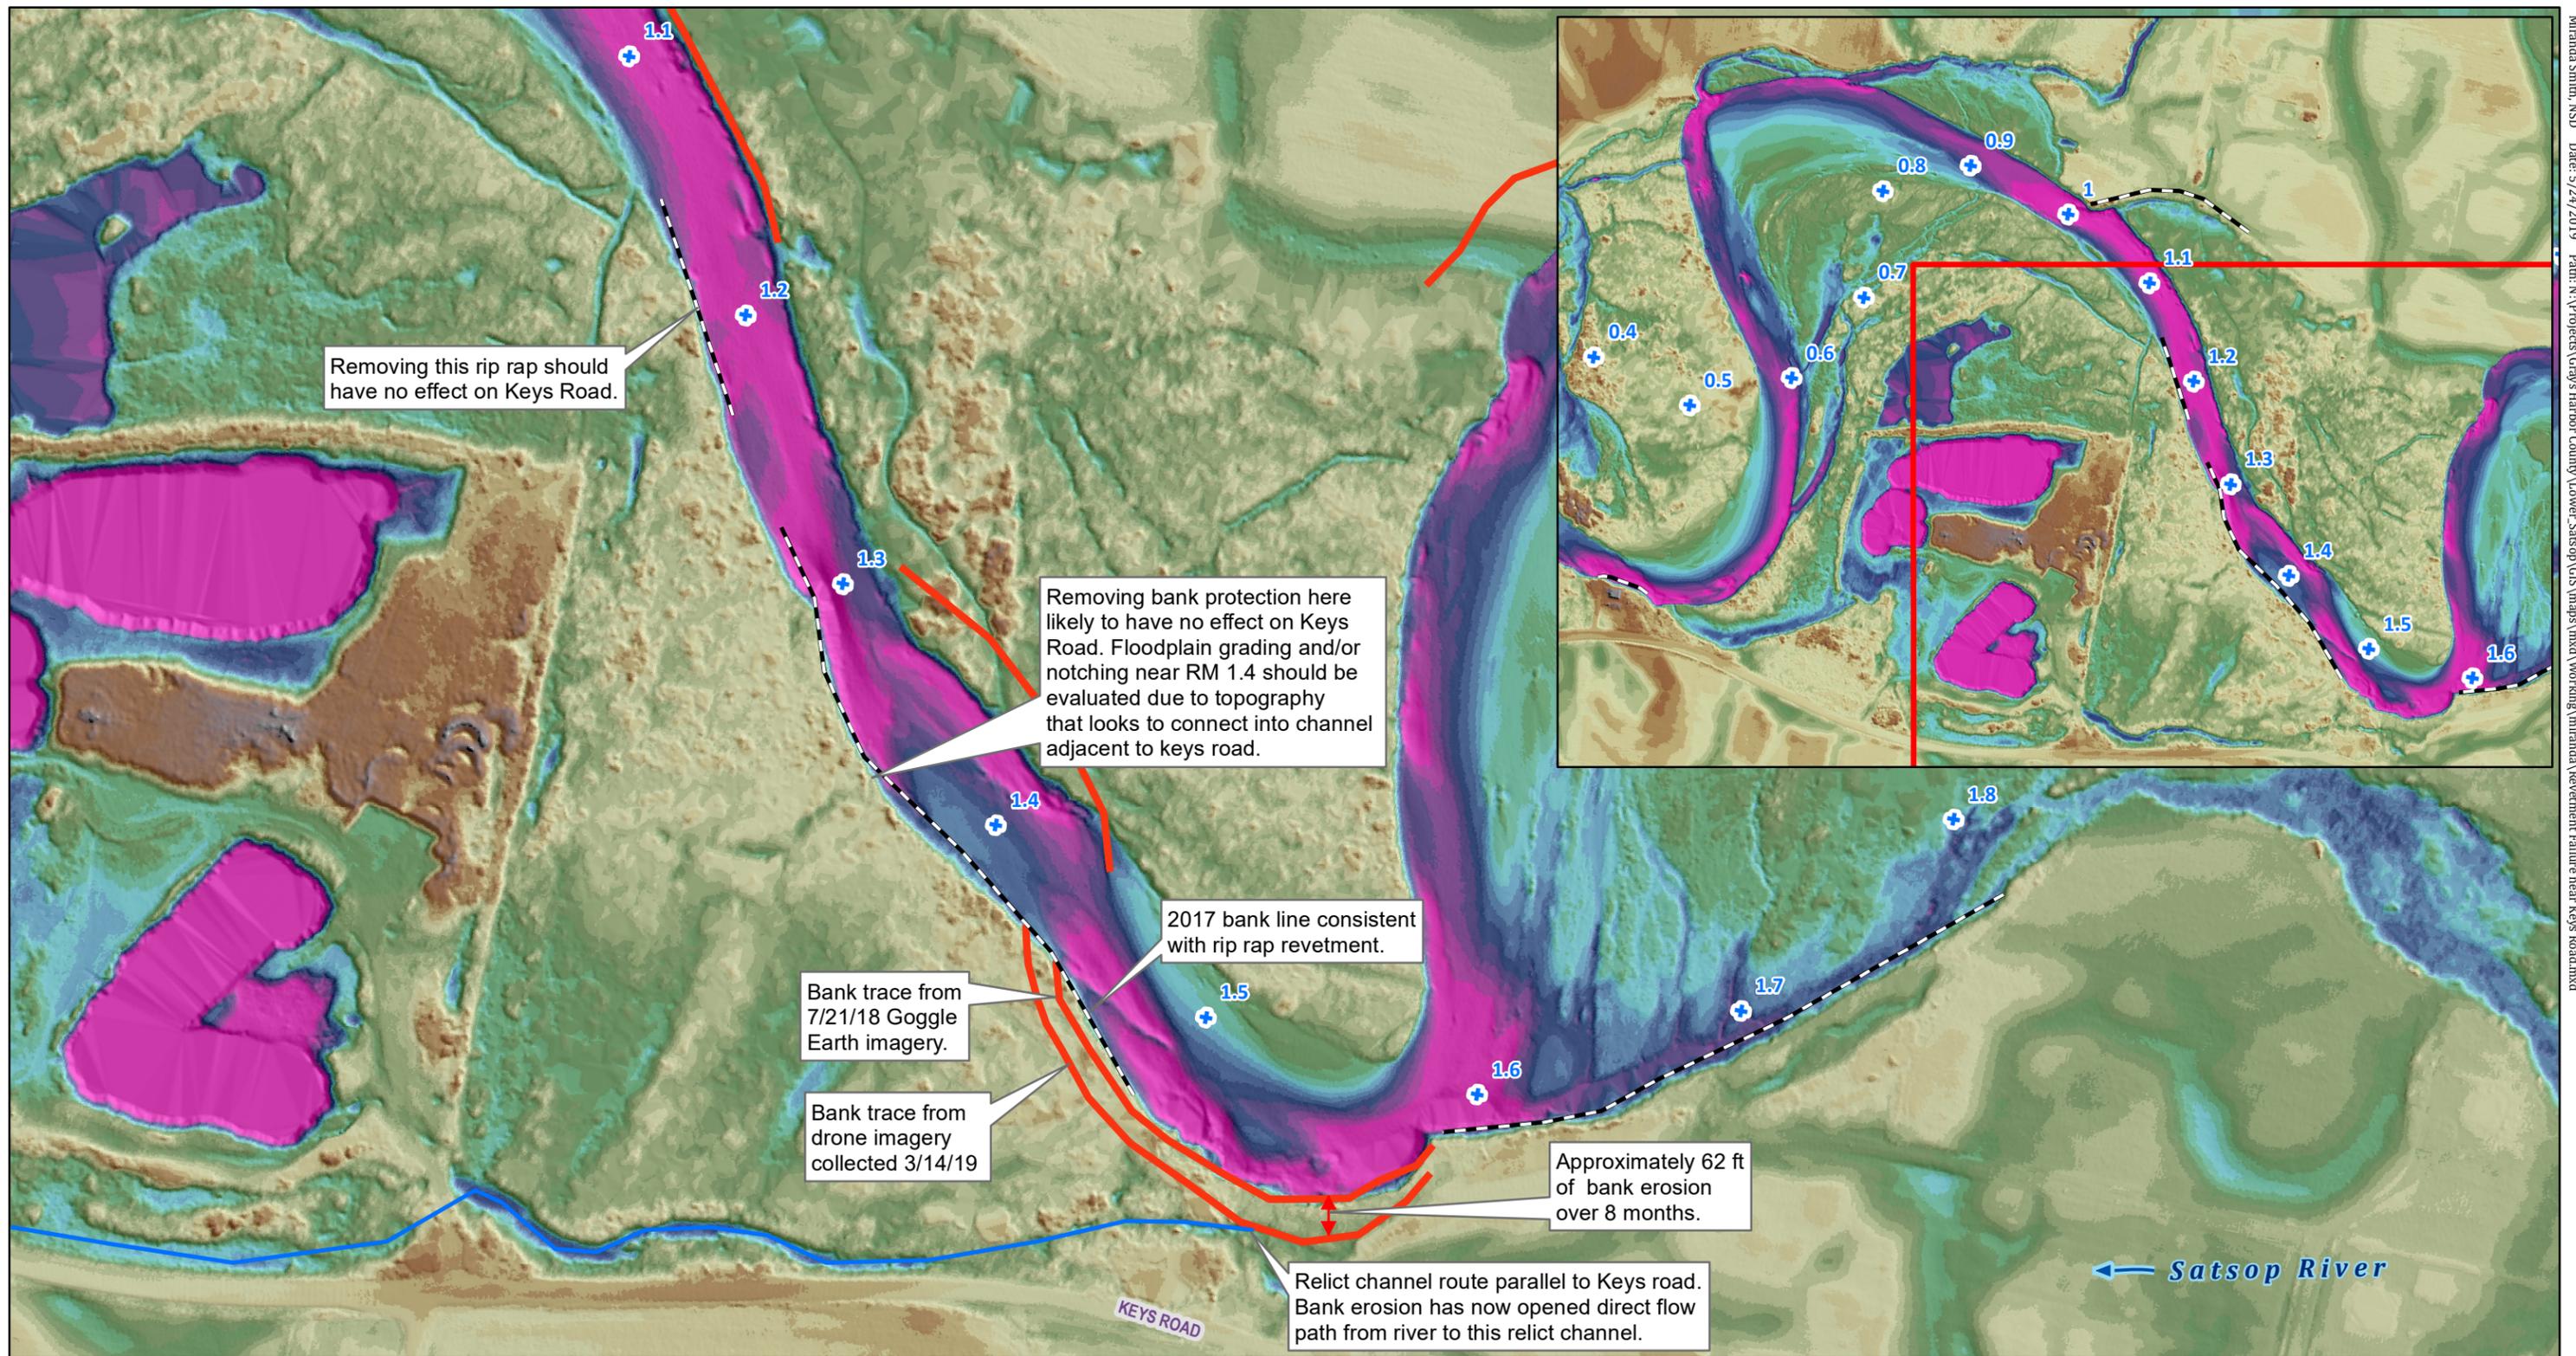
Lower Satsop River Reach Assessment and Design
Bank erosion rates on a meander traveling toward Keys Road.
 Relative Elevation Model generated using 2017 LiDAR topography.

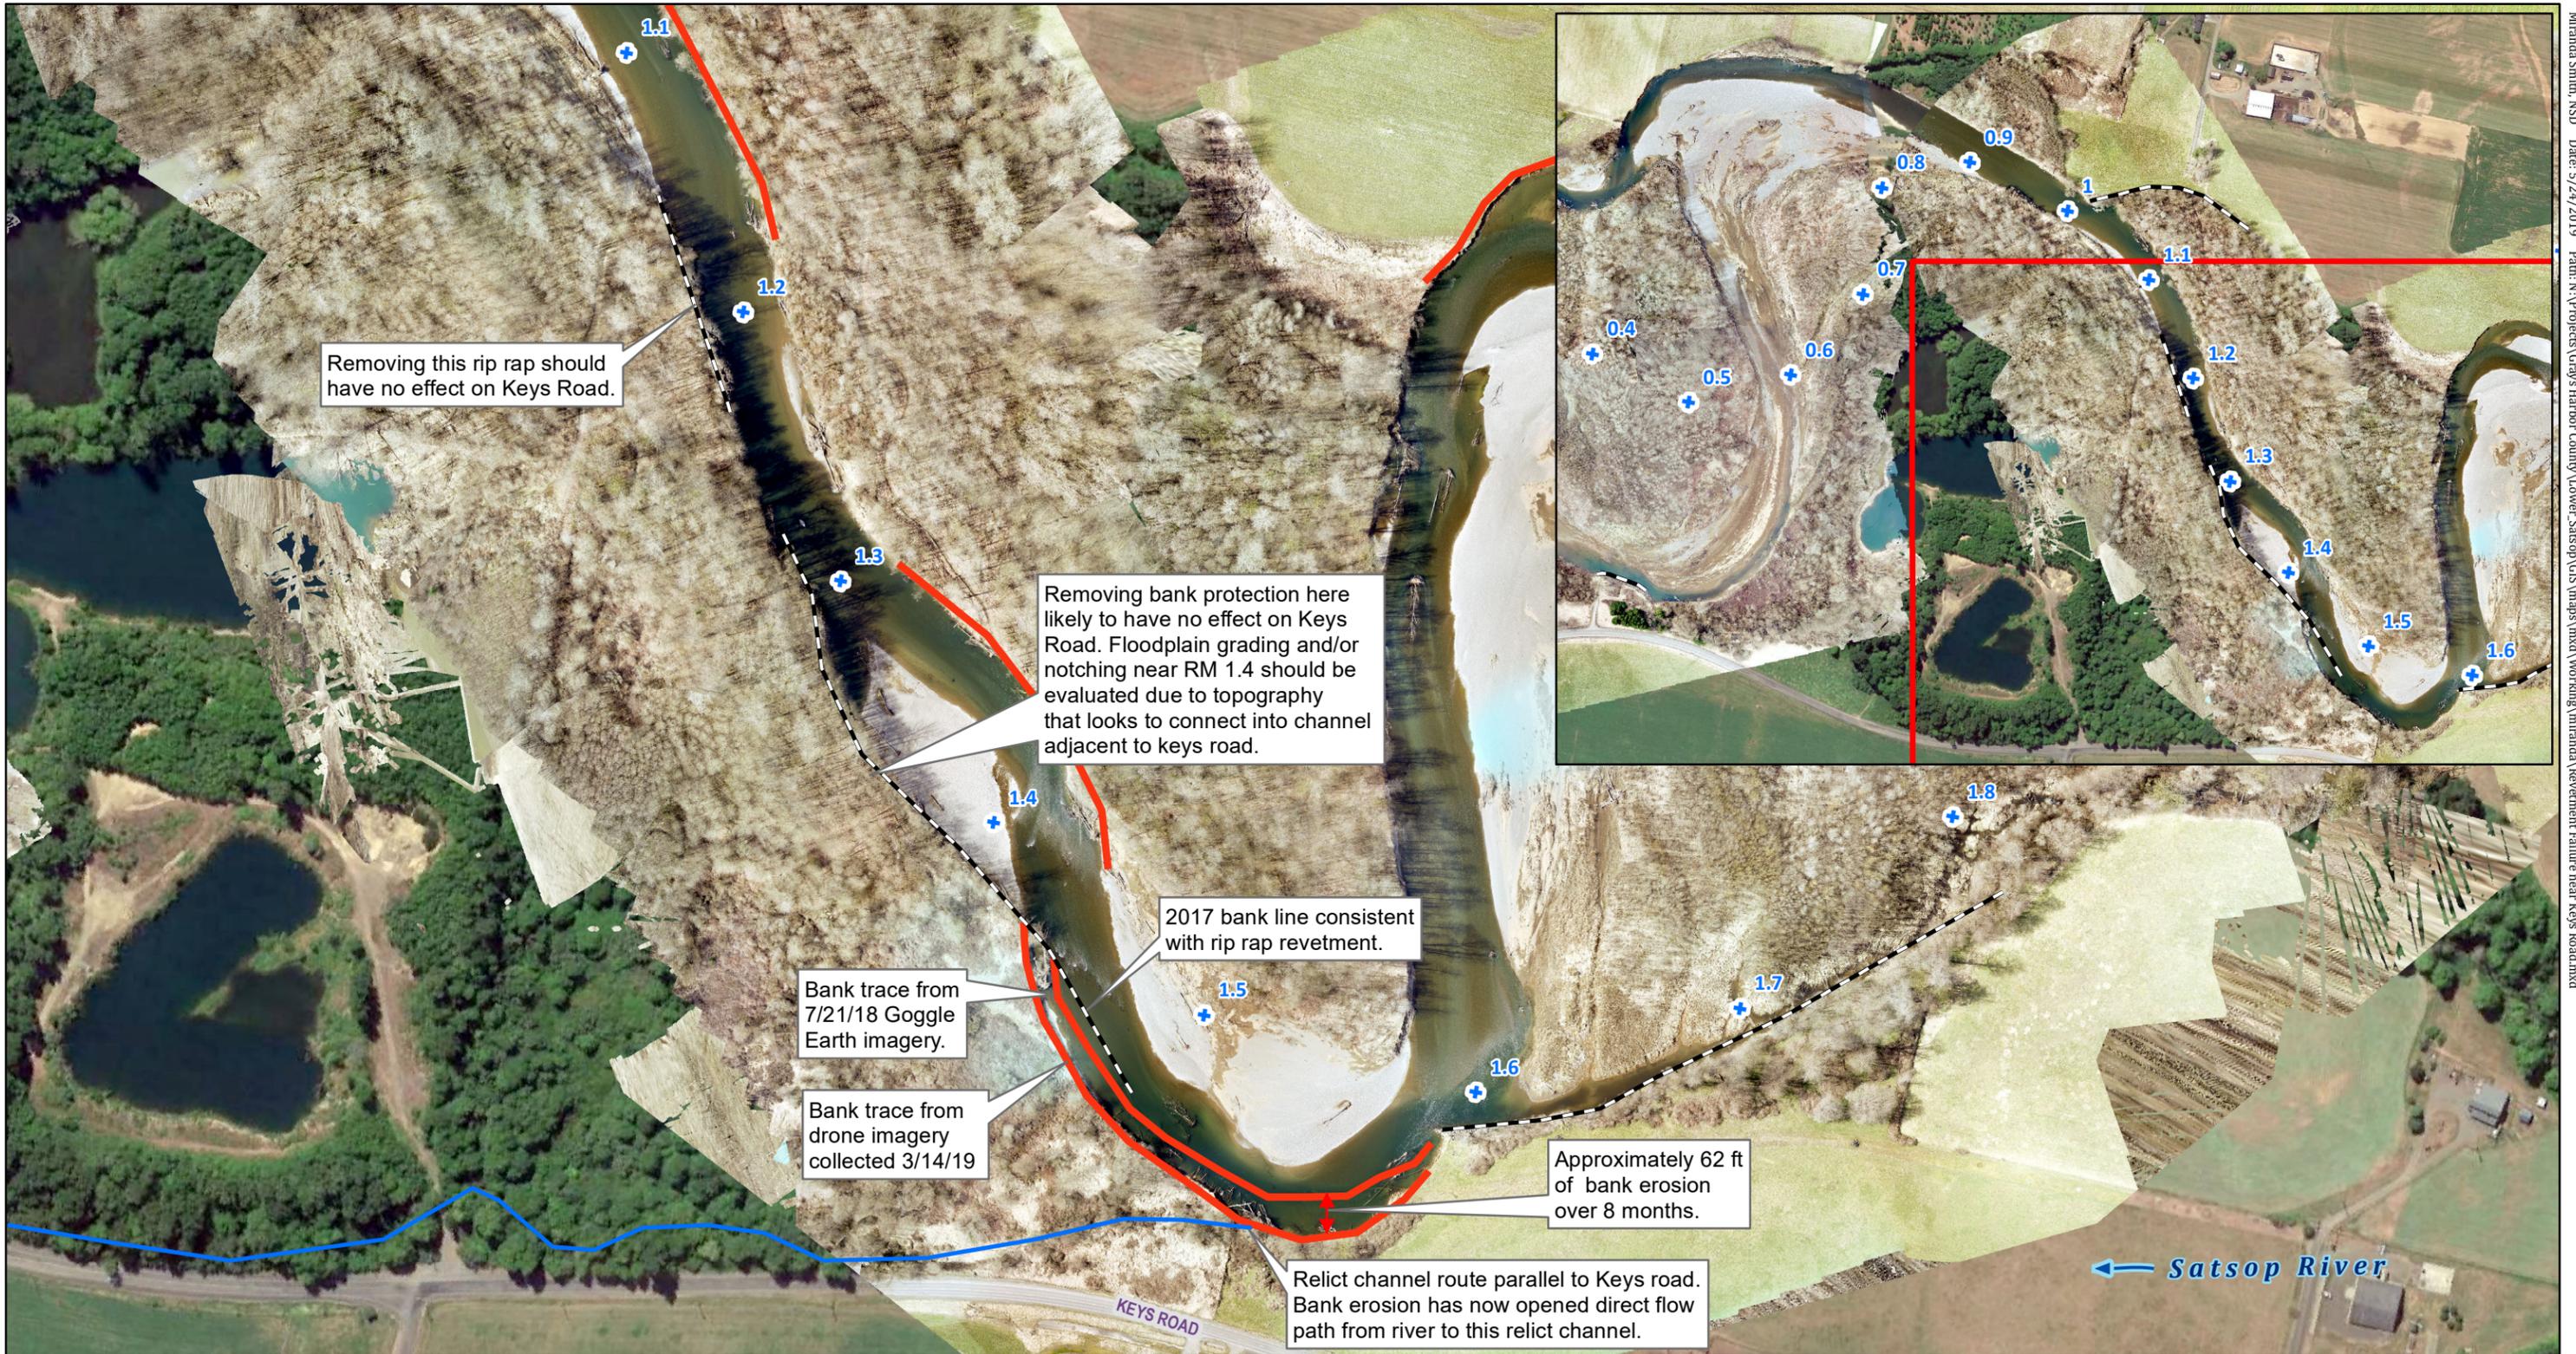
Lower Satsop River Reach Assessment and Design
Bank erosion rates on a meander traveling toward Keys Road.
 Aerial imagery is composite of 2019 drone pasted onto 2018 Google Earth image.
