LOWER SATSOP RIVER ASSESMENT AND DESIGN

BASIS OF DESIGN REPORT AND GEOMORPHIC ASSESMENT

October 7, 2019

Lower Satsop Restoration and Protection Program

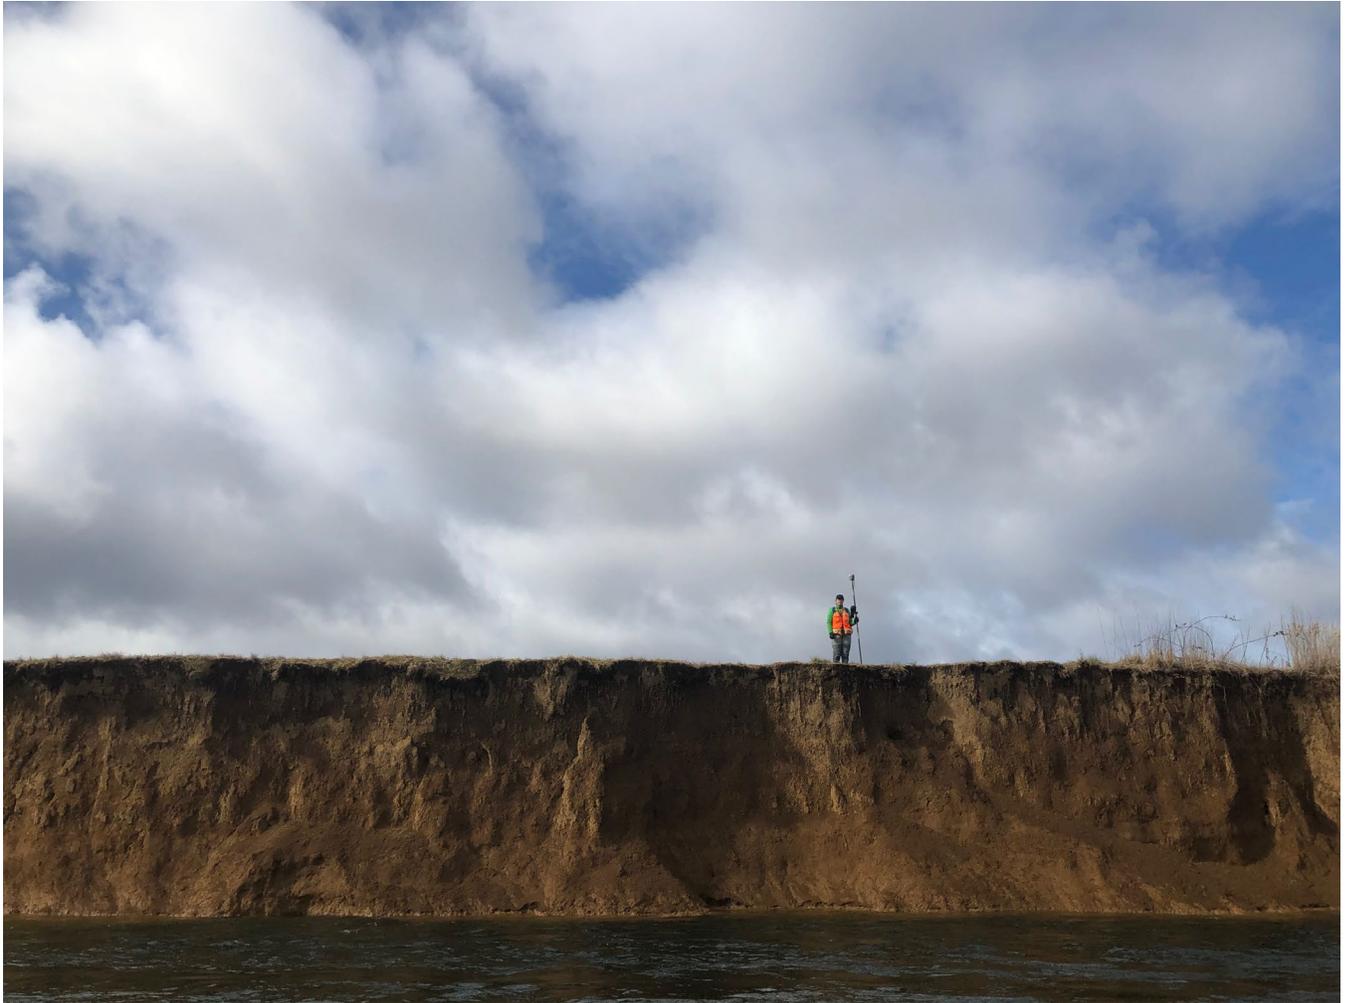
Figure 3. Eroding right bank near RM 0.2 illustrates that much of the material underlying the Satsop/Chehalis River confluence area is composed of highly erodible silts. Similar bank stratigraphic analyses were used throughout the project reach to confirm that most of the confluence area is of similar composition. Photo taken on 3/13/19.

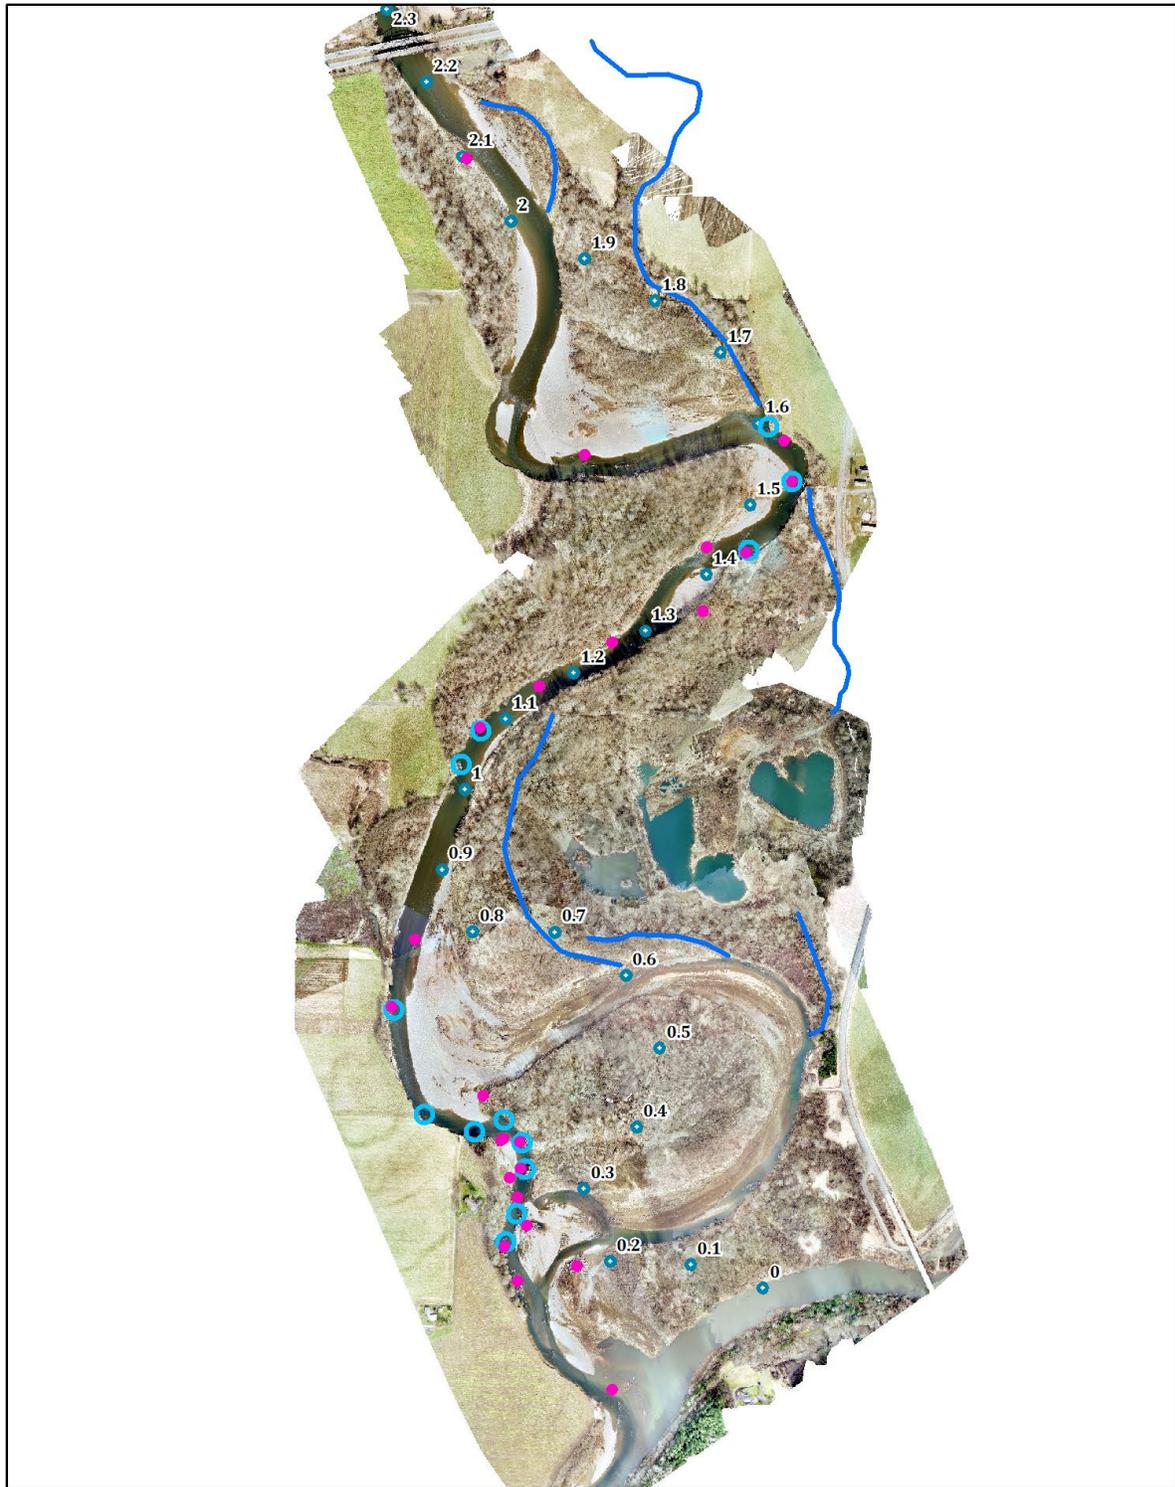
Satsop River, RM 2.2 - 0.0
Habitat Characterization Survey (2019)

Figure 9. Habitat characterization survey, performed by NSD (March 2019).

The quantity, size and location of pools is generally reflective of the hydraulic conditions within the project reach. NSD recorded the number of pools in the Satsop River along with their formative mechanism. Pool depths were not directly measured. Figure 9 shows the location of pools surveyed in March 2019. Of the 13

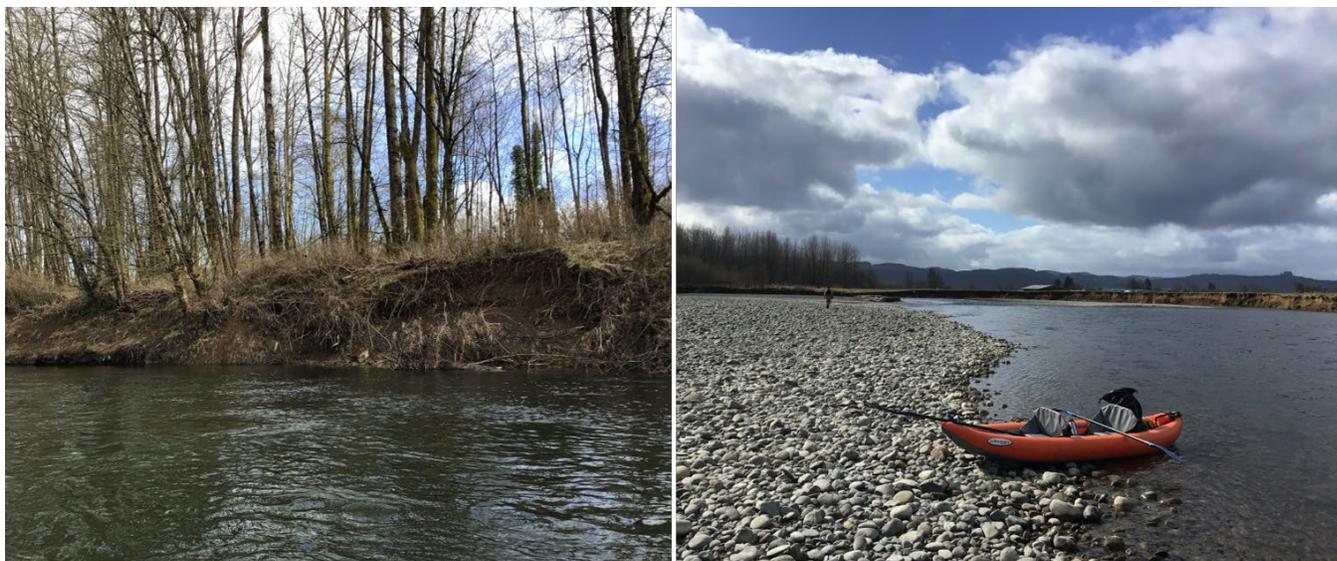
Figure 10. Riparian conditions along the Satsop River near RM 1.7 (NSD, March 2019). Active erosion of outside meander bank with young alder recruitment (left), and view of cultivated area looking downstream (right).

The riparian areas within the Lower Satsop River reach (RM 2.2 – 0.0) contain roughly an equal distribution of farmland and deciduous forest with very few conifers. NSD used field reconnaissance observations to note the species and condition of riparian vegetation in the modern floodplain areas. Tree heights are inferred from the 2017 highest-hit LiDAR dataset. Between RM 2.2-1.7 there is a ~300 ft wide deciduous forest on the right bank, and ~500 ft wide young deciduous forest containing primarily alder on the left bank. From RM 1.6-1.0, the right bank floodplain contains a forest which is dominated by alder and black cottonwood, with tree heights >100 ft and a predominantly salmonberry understory. The left bank from RM 1.6-0.6 is also deciduous forest with large sections of trees >100 ft tall, but very few conifers. The 2018-19 avulsion channel begins at RM 0.6, which flows directly through established deciduous forest. Tree heights in this section are nearly all >50 ft. Along the left bank of the abandoned meander, deciduous forest covers the floodplain area to the confluence with the Chehalis River. Evidence from the field survey, such as flotsam and the presence of fine alluvial material, indicate recent engagement between floodplains and the mainstem channel. There are notably few conifers in the riparian areas. Figure 10 shows typical riparian conditions along the Lower Satsop River reach.

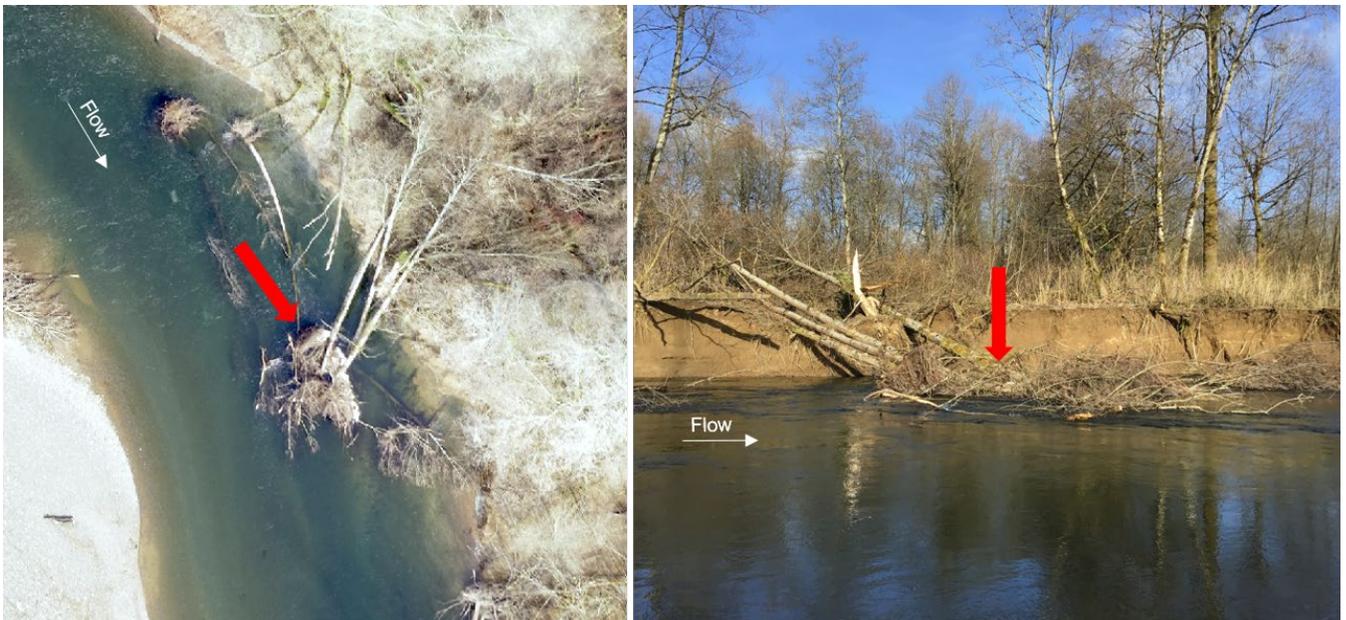
Figure 11. Example of functional, non-stable large woody debris (LWD) on the Satsop River near RM 0.4. 2019 aerial image (left) and ground-based photo (NSD, March 2019). Pictured are bank-recruited alders approximately 60 ft in length and DBH of 14 inches with rootwads 10 ft in diameter.

Functional wood is defined as pieces that exert an influence on bed topography and sediment distributions, but are not necessarily stable during high flows. Examples of functional wood include bank-recruited red alders and black cottonwood that form a scour pool beneath them, but lack the volume and weight to resist mobilizing forces from a bankfull discharge (Figure 11). Measurements of functional wood length and diameter at breast height (DBH) visually estimated in the field for pieces greater than 12 inches DBH. Wood outside of the channel margin was not included in the count.

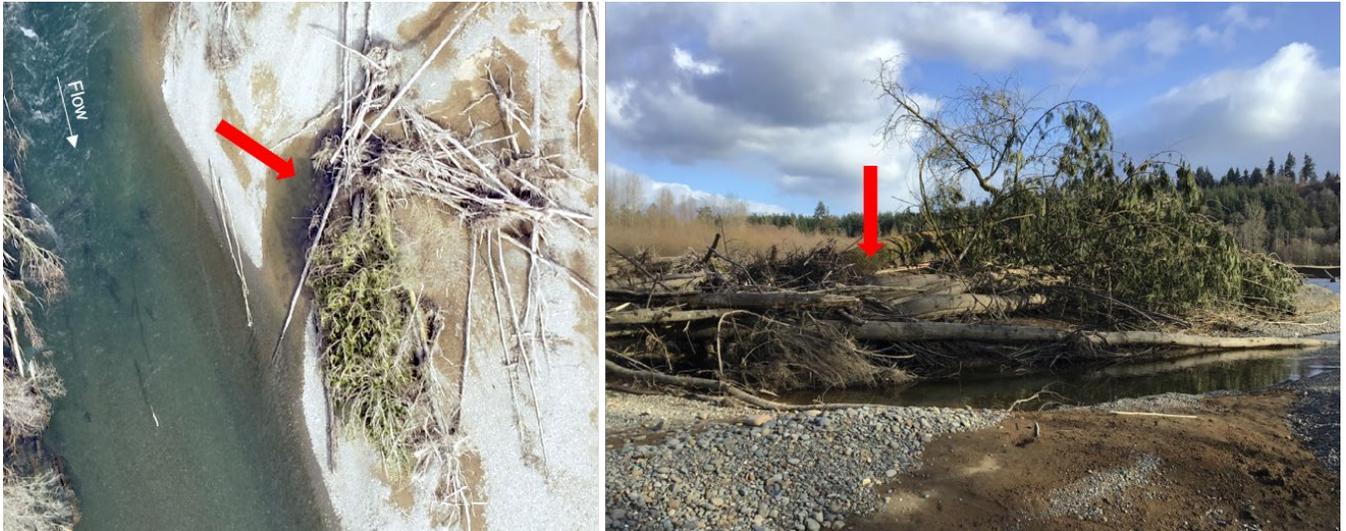
Figure 12. Example of stable key piece on the Satsop River near RM 0.25. 2019 aerial image (left) and ground-based photo looking downstream (NSD, March 2019). The conifer marked in the photo (red arrow) is approximately 60 ft in length and has three separate trunks with DBH of 20 inches.

Key pieces are defined as pieces of wood estimated to be stable during flood events. Key pieces are capable of recruiting additional wood and serve as the forming members of log jams. A general rule for key piece sizing is the length equal to $\frac{1}{2}$ bankfull width and the DBH equal to $\frac{1}{2}$ bankfull depth (Abbe and Montgomery, 2003). Figure 12 is an example of a stable key piece that is accumulating additional debris and sediment. Note that this is the only conifer identified from the field survey.

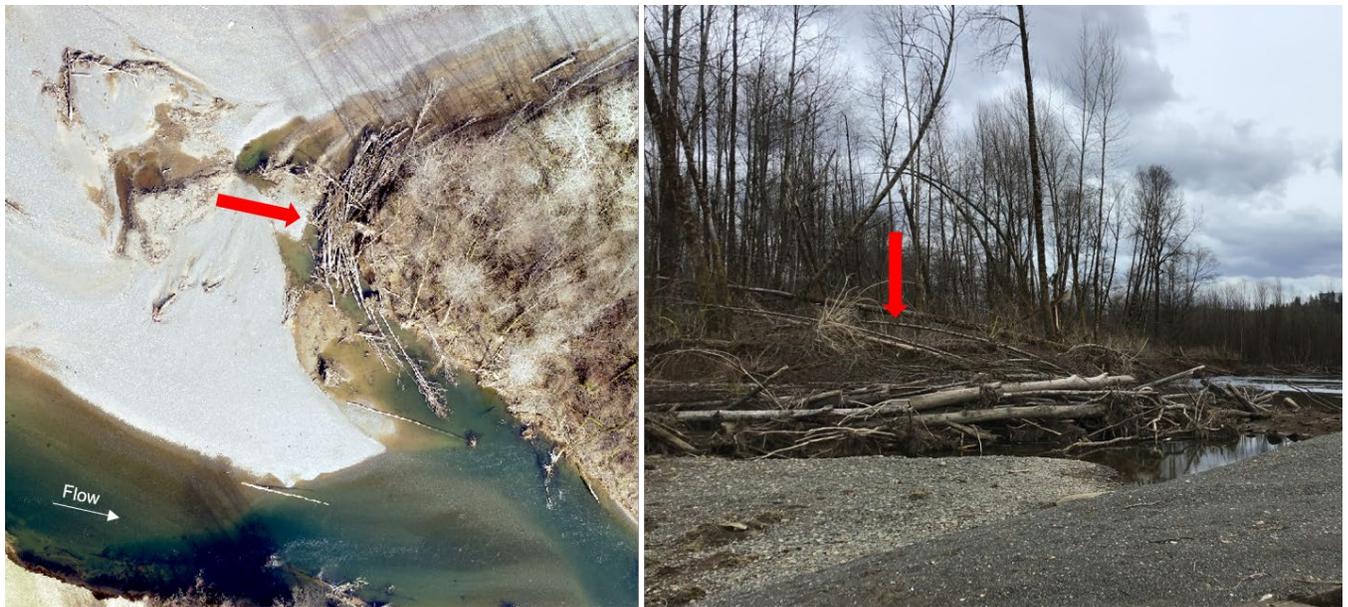
Figure 13. Example of stable log jam on the Satsop River near RM 0.5. 2019 aerial image (left) and ground-based photo (NSD, March 2019). The log jam pictured is located at the apex of the channel split between the avulsion and abandoned meander, near RM 0.5. Aerial imagery shows wood accumulation at this location as early as 2013. The majority of wood accumulation is composed of alder and cottonwood species.

Log jams were defined as wood accumulations that showed evidence of remaining stable under high flow conditions based on review of past aerial photographs. Field evidence included:

- ▶ Presence of multiple piece wood accumulations in the river,
- ▶ Sediment accumulation behind the jam,
- ▶ Vegetation establishment within the jam,
- ▶ A variety of decomposition stages of wood composing the jam (i.e. wood transported from different floods), and;
- ▶ The presence of stabilizing key pieces.
