Memorandum

To: Chehalis River Basin Flood Authority
From: Larry Karpack, WATERSHED Science & Engineering (WSE)
Date: March 8, 2012
Re: **Satsop River Channel and Cross Section Comparisons**

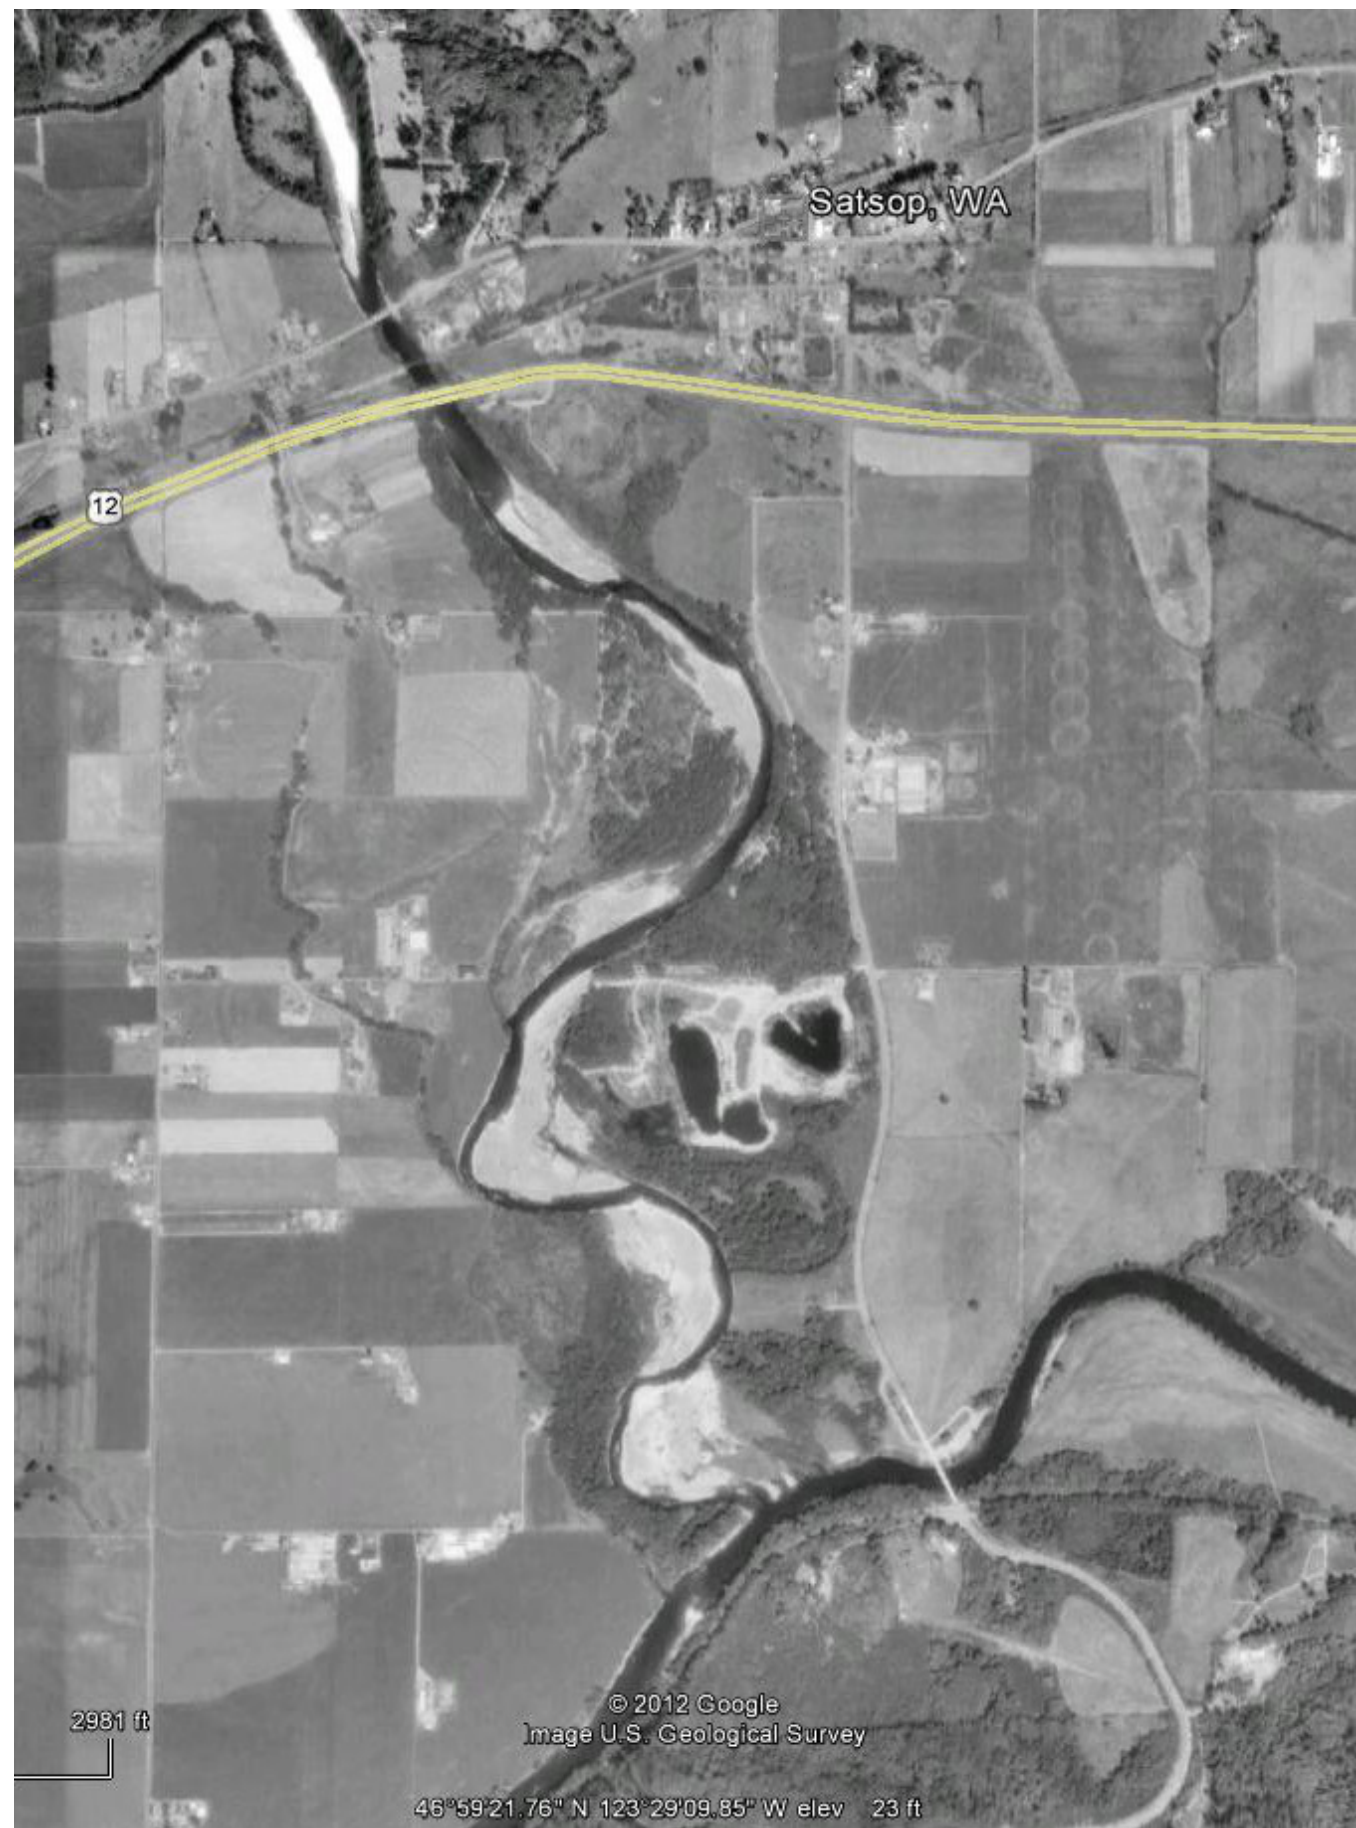
Figure 1: Satsop River near Satsop (SR 12 to Chehalis River) – Photo Date: 1990

Figures 1 through 4 show the Satsop River study reach at four different points in time, 1990, 2005, 2007, and 2009. An aerial photograph for 2001, the time of the previous Corps study, was not available but based on the cross section surveys and the available 2002 LiDAR data it is apparent that at the time of the 2001 survey the channel was in a similar location to the 2005 photo (Figure 2). The 1990 photo (Figure 1) shows a mostly single thread channel with narrower meander bends and several large gravel bars. The 2005 aerial photo (Figure 2) shows significant areas of newly exposed channel bed indicating that the channel probably shifted considerably in the years immediately preceding this photo. The 2007 aerial photo (Figure 3) shows the channel becoming somewhat stabilized at its new location while the 2009 aerial photo (Figure 4) shows some additional lateral movement of the 2007 channel as well as reforestation of portions of the floodplain where the 1990 channel was located.

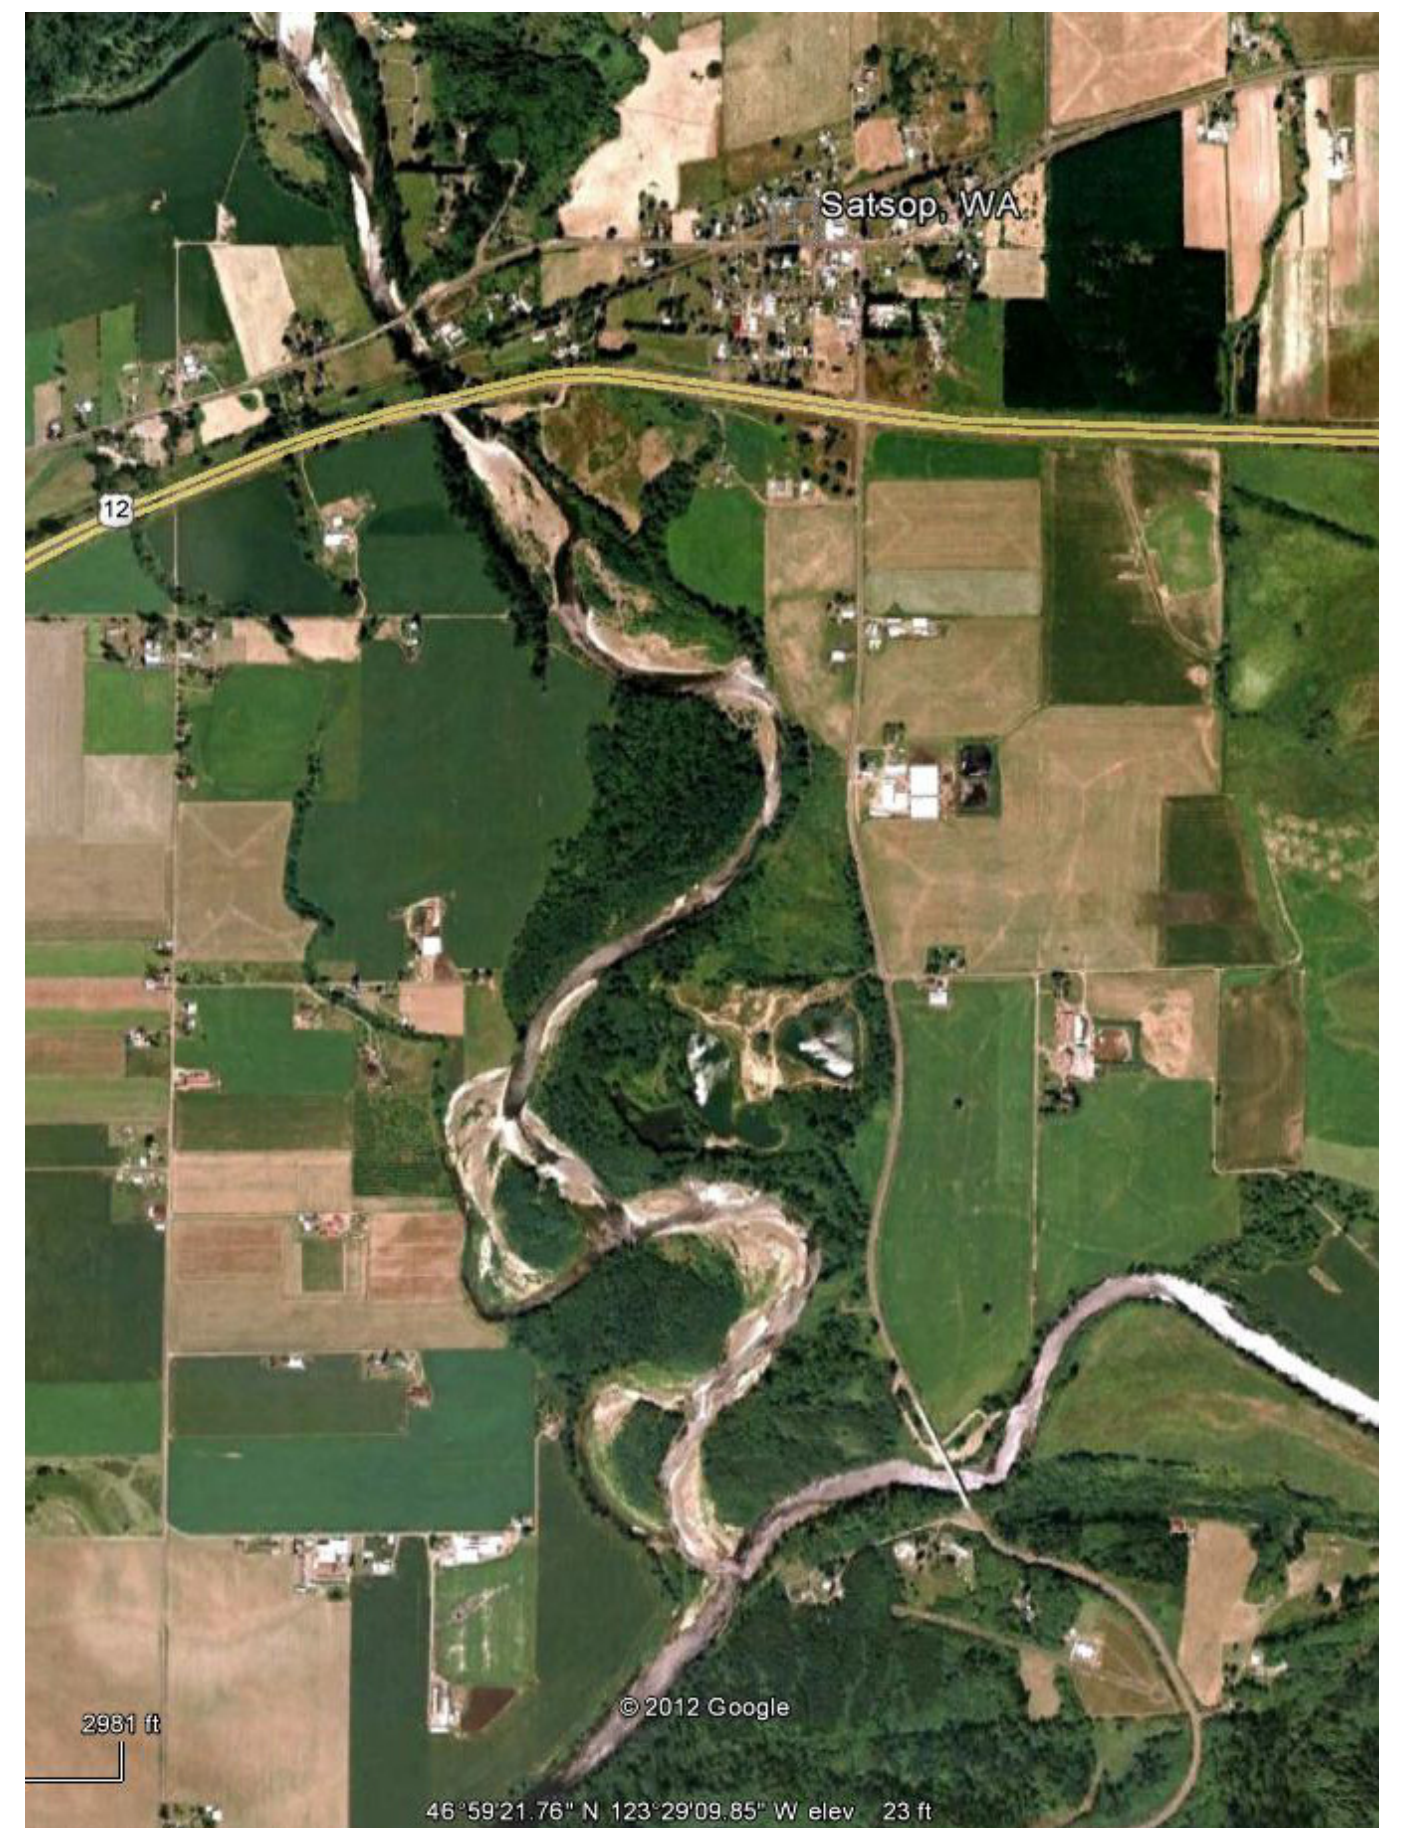
Figure 2: Satsop River near Satsop (SR 12 to Chehalis River) – Photo Date: 2005

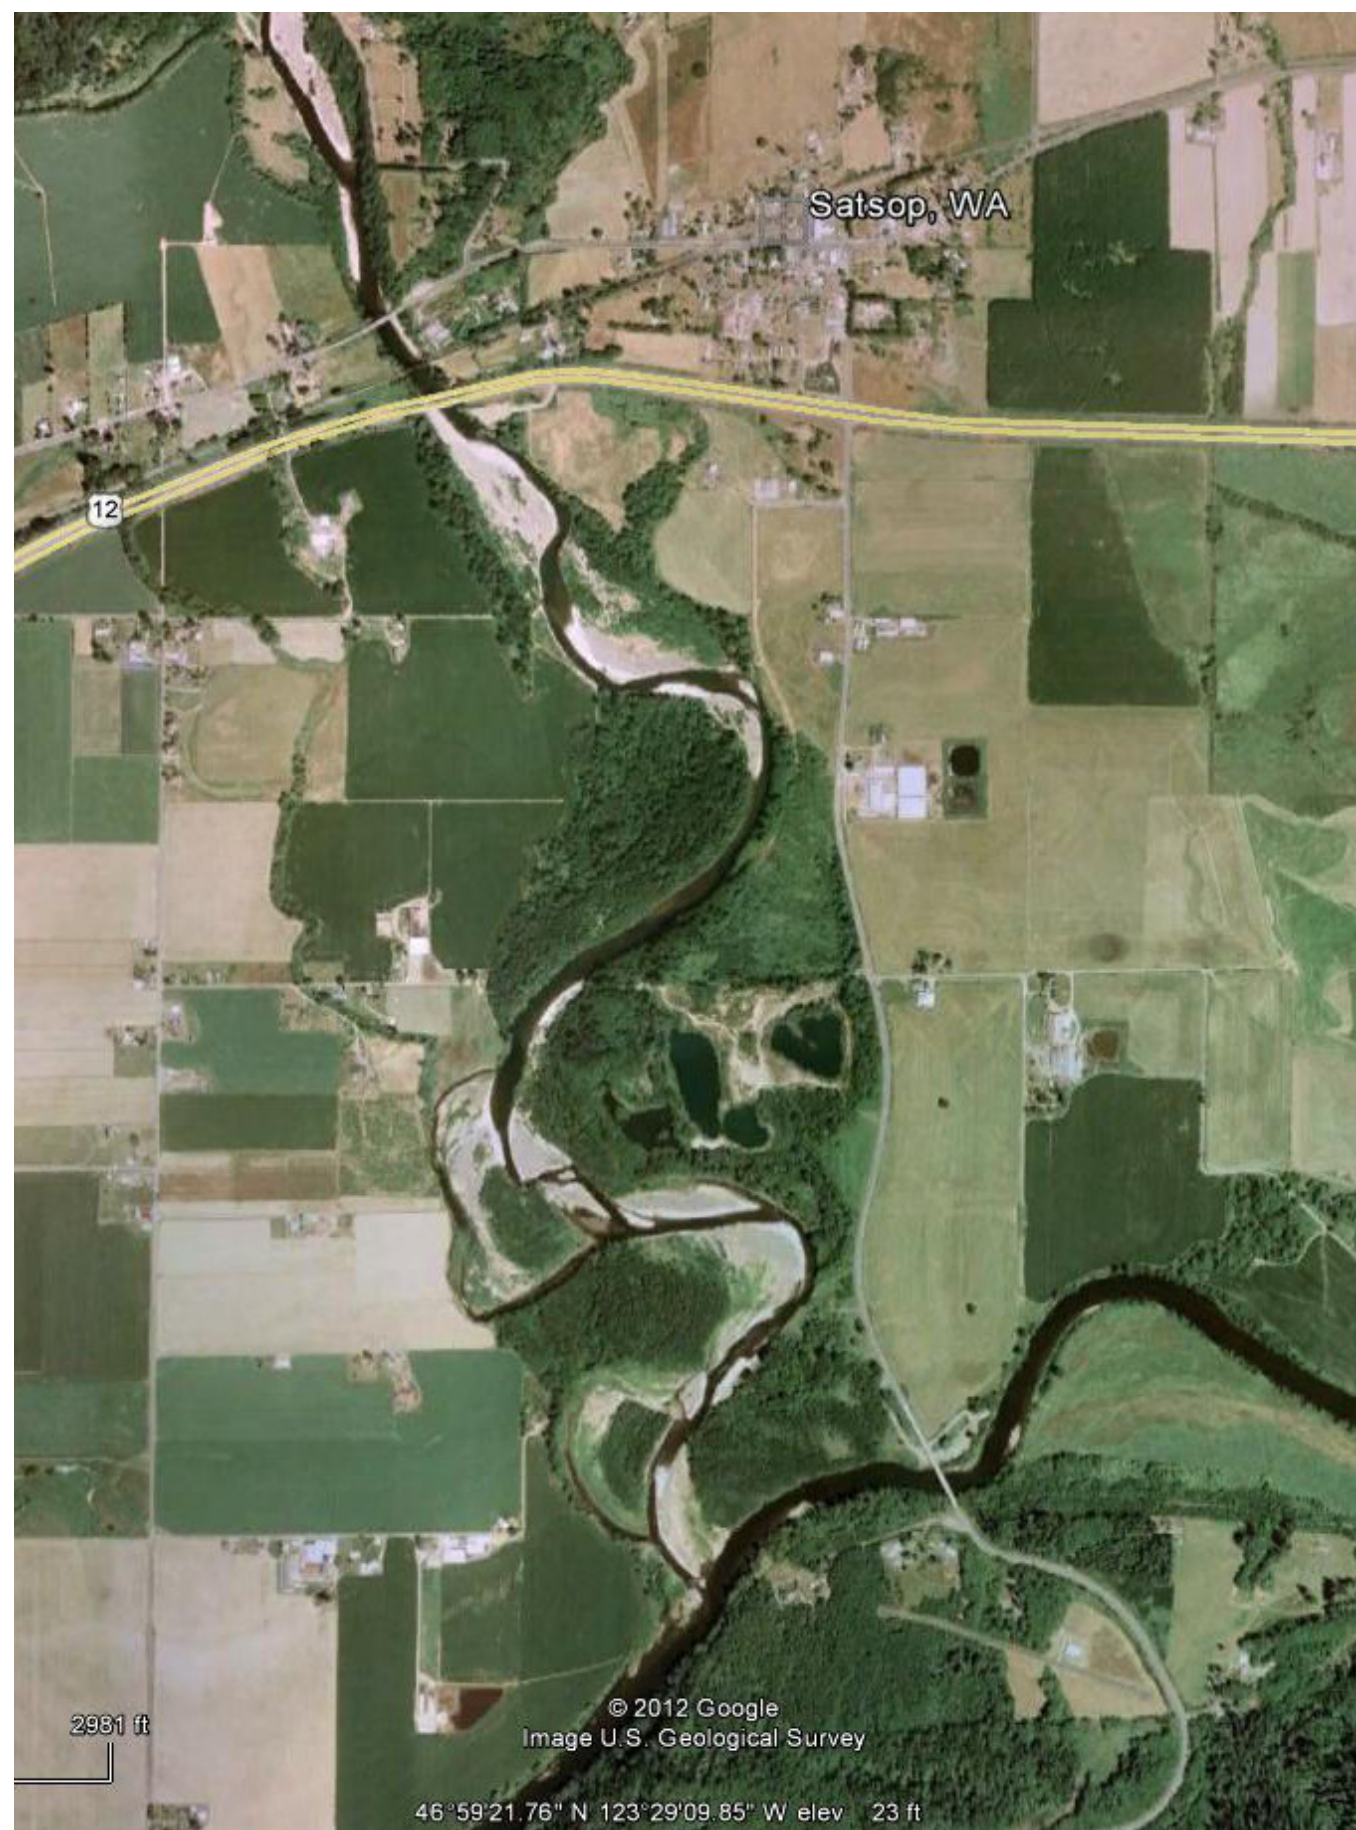
Figure 3: Satsop River near Satsop (SR 12 to Chehalis River) – Photo Date: 2007

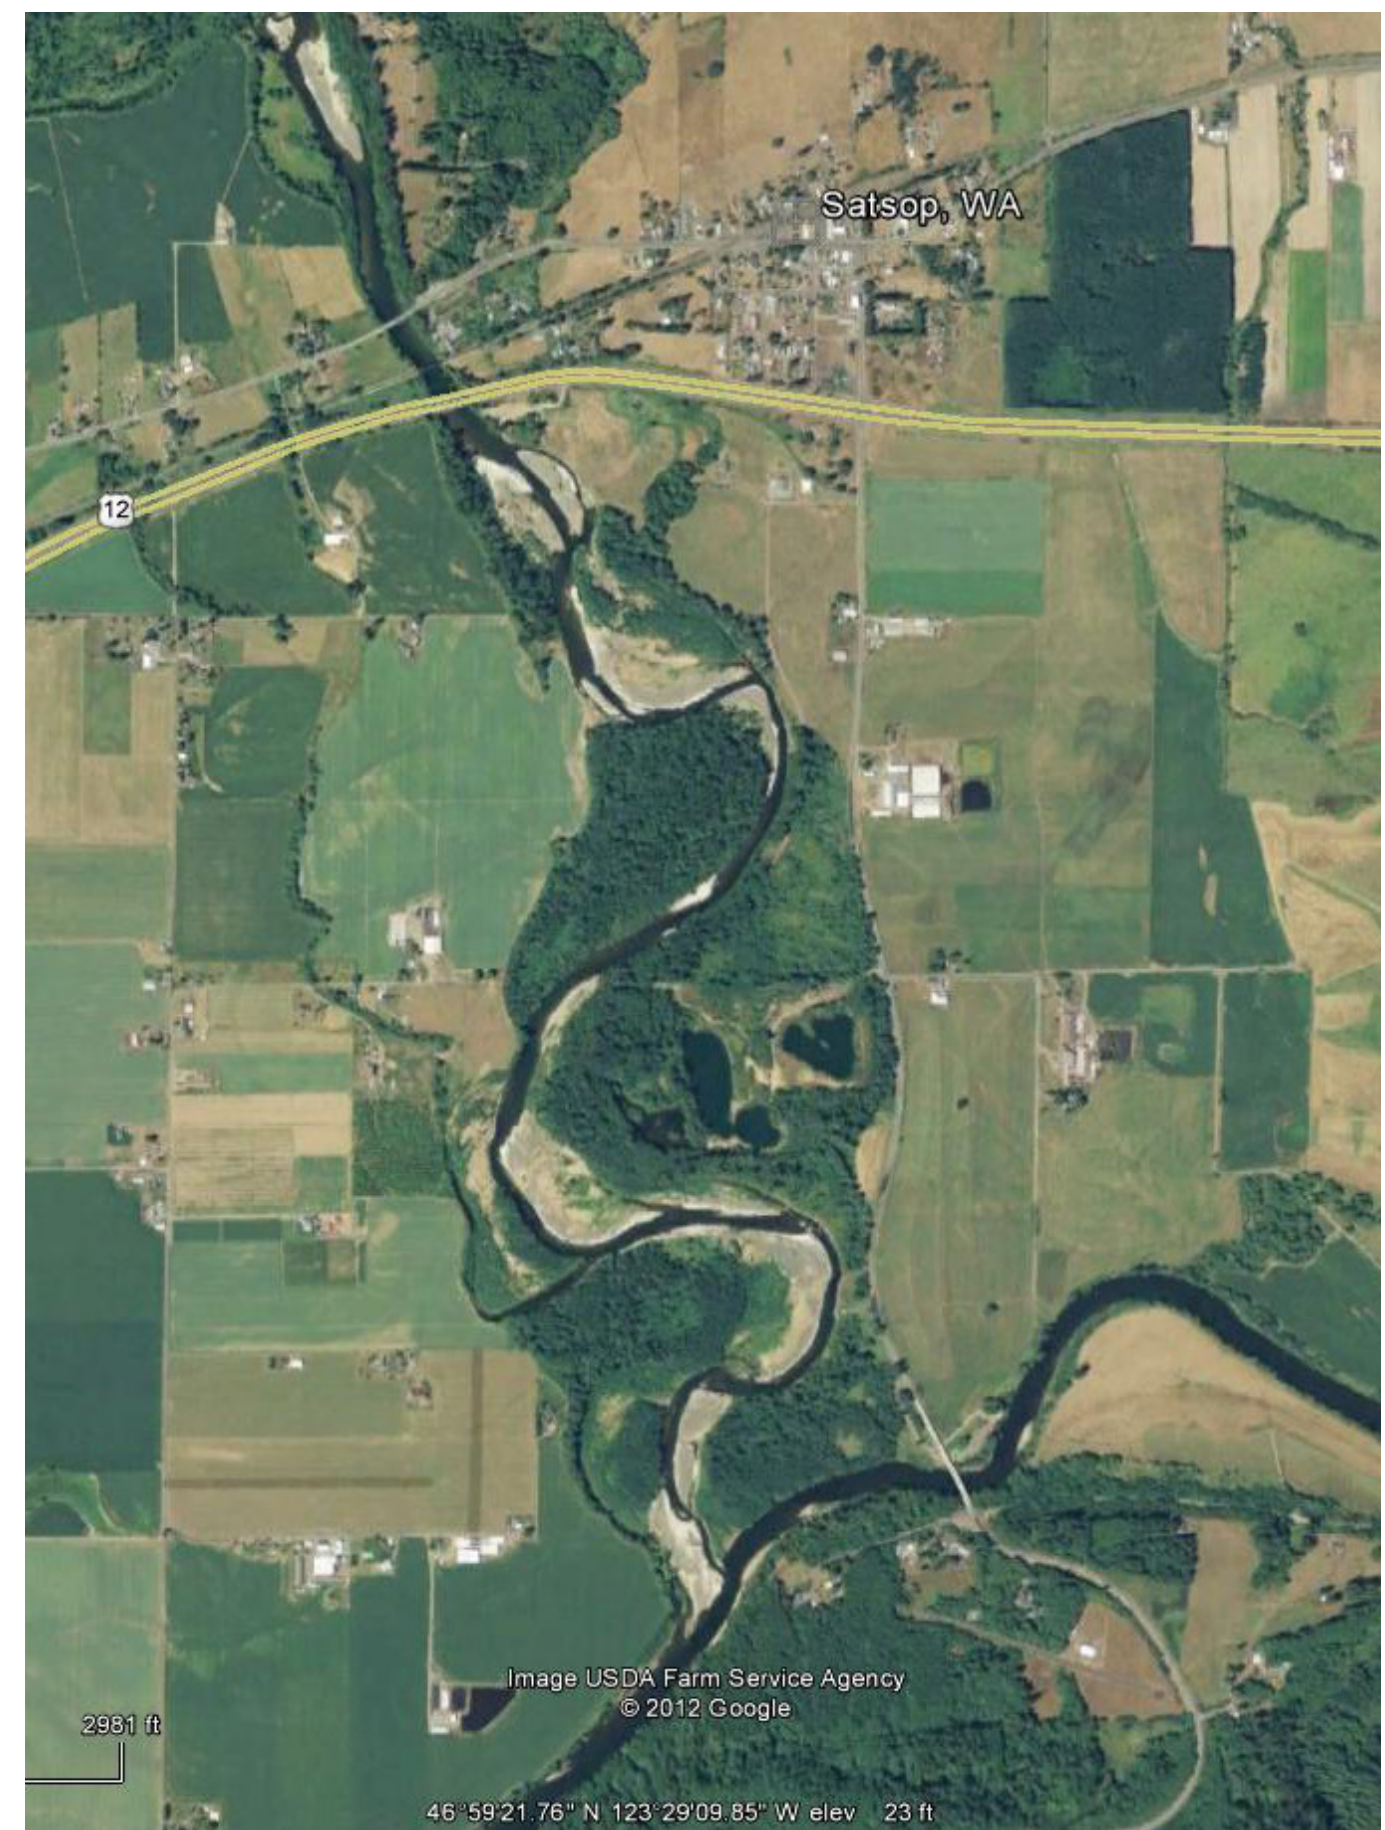
Figure 4: Satsop River near Satsop (SR 12 to Chehalis River) – Photo Date: 2009

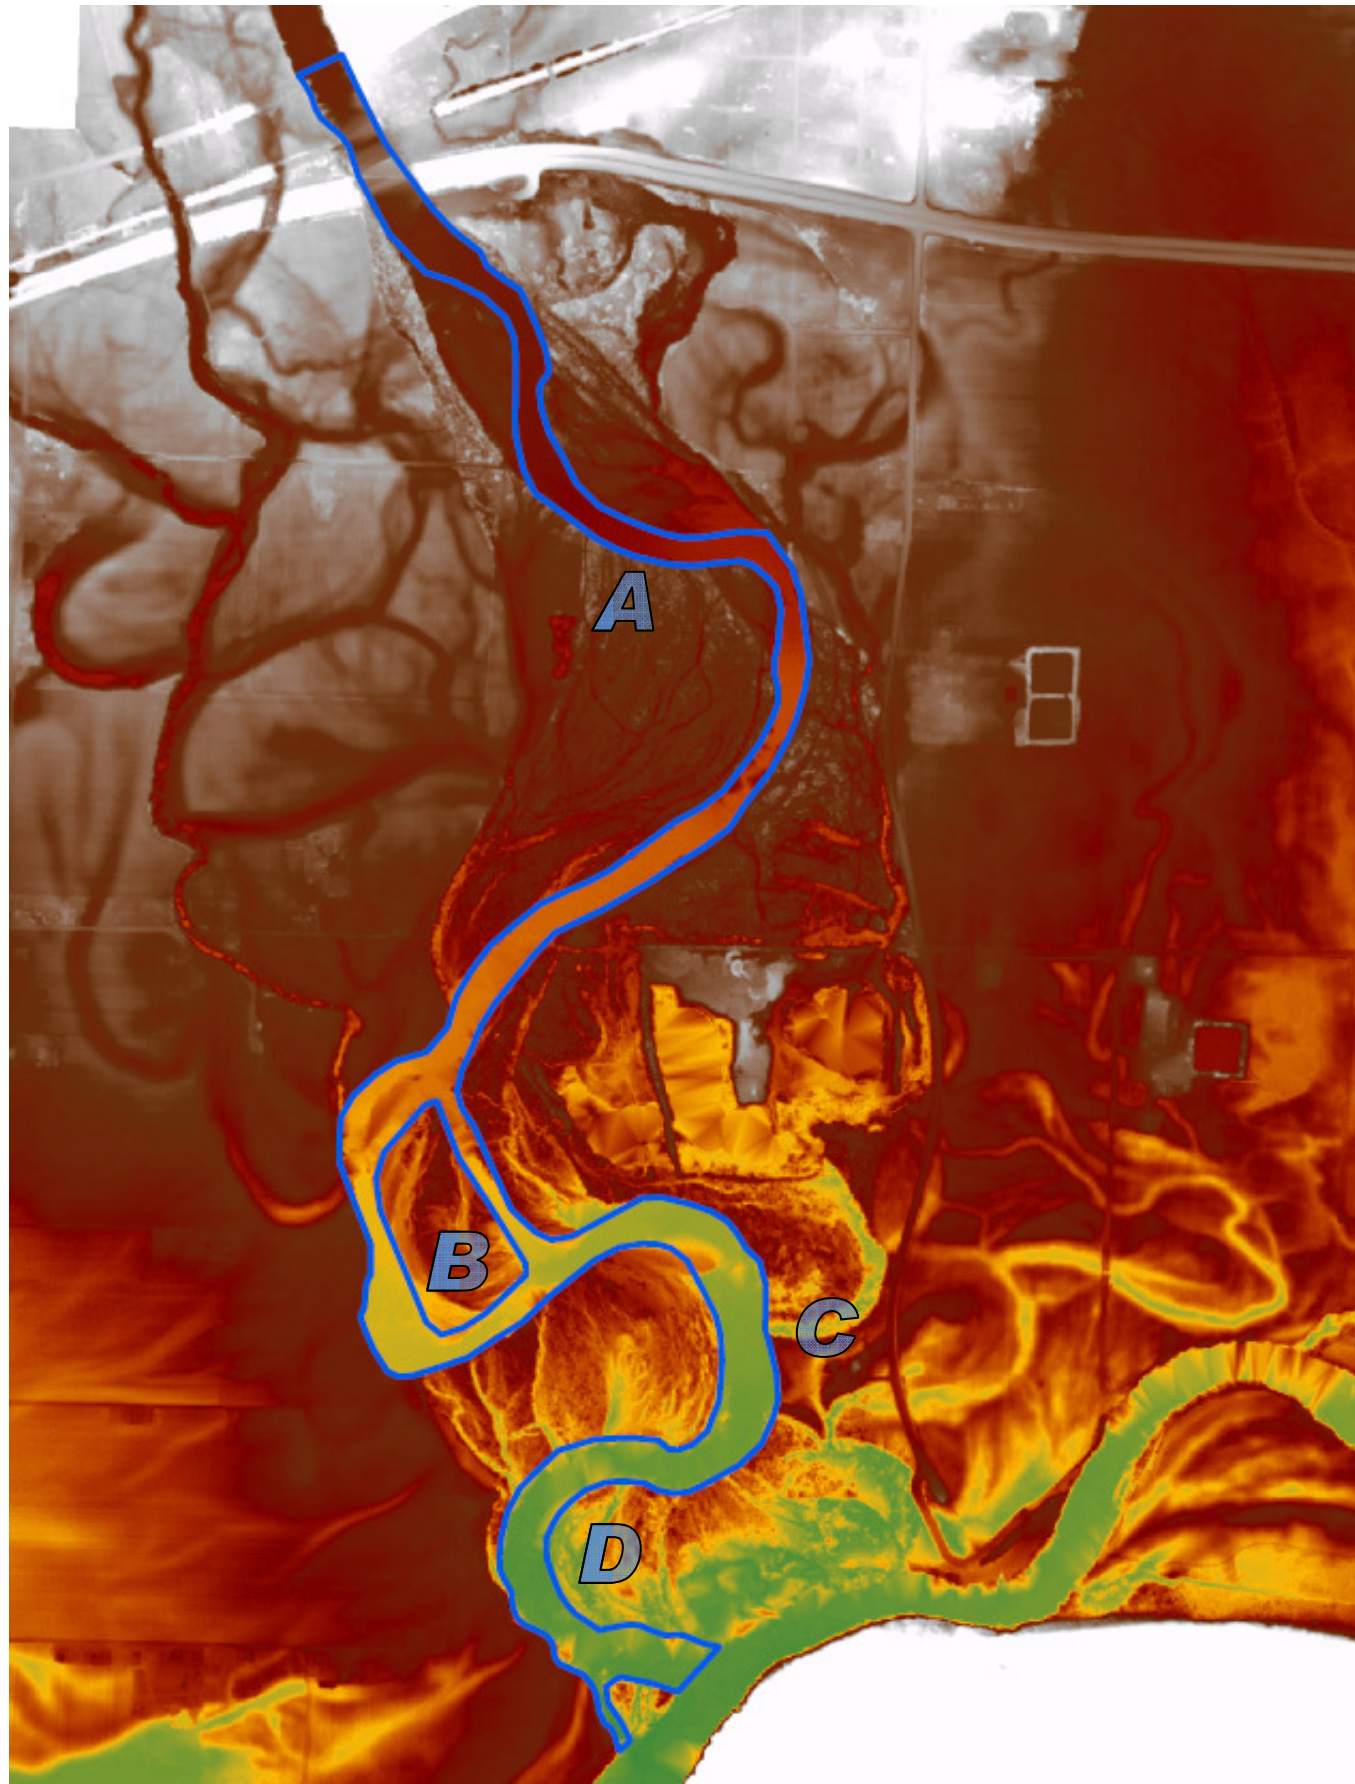
Figure 5: Satsop River near Satsop 2002 LiDAR Data with 2001 Channel Delineation

Figures 5 and 6 compare the channel location at the time of the 2001 survey to the channel location in 2009. Figure 5 shows the 2001 channel location as estimated by WSE based on the 2002 LiDAR data. Figure 6 shows this same channel overlaid on a 2010 aerial photo. As shown in Figure 6 the channel has remained in much the same location at the upstream bridges and in the middle portion of the reach (along a revetted bank) while the section between the bridges and the revetment and the lower half of the study reach has seen significant lateral migration. Of the four major bends in the Satsop study reach two have eroded substantially wider (Bends A and C) while two have retreated considerably (Bends B and D).

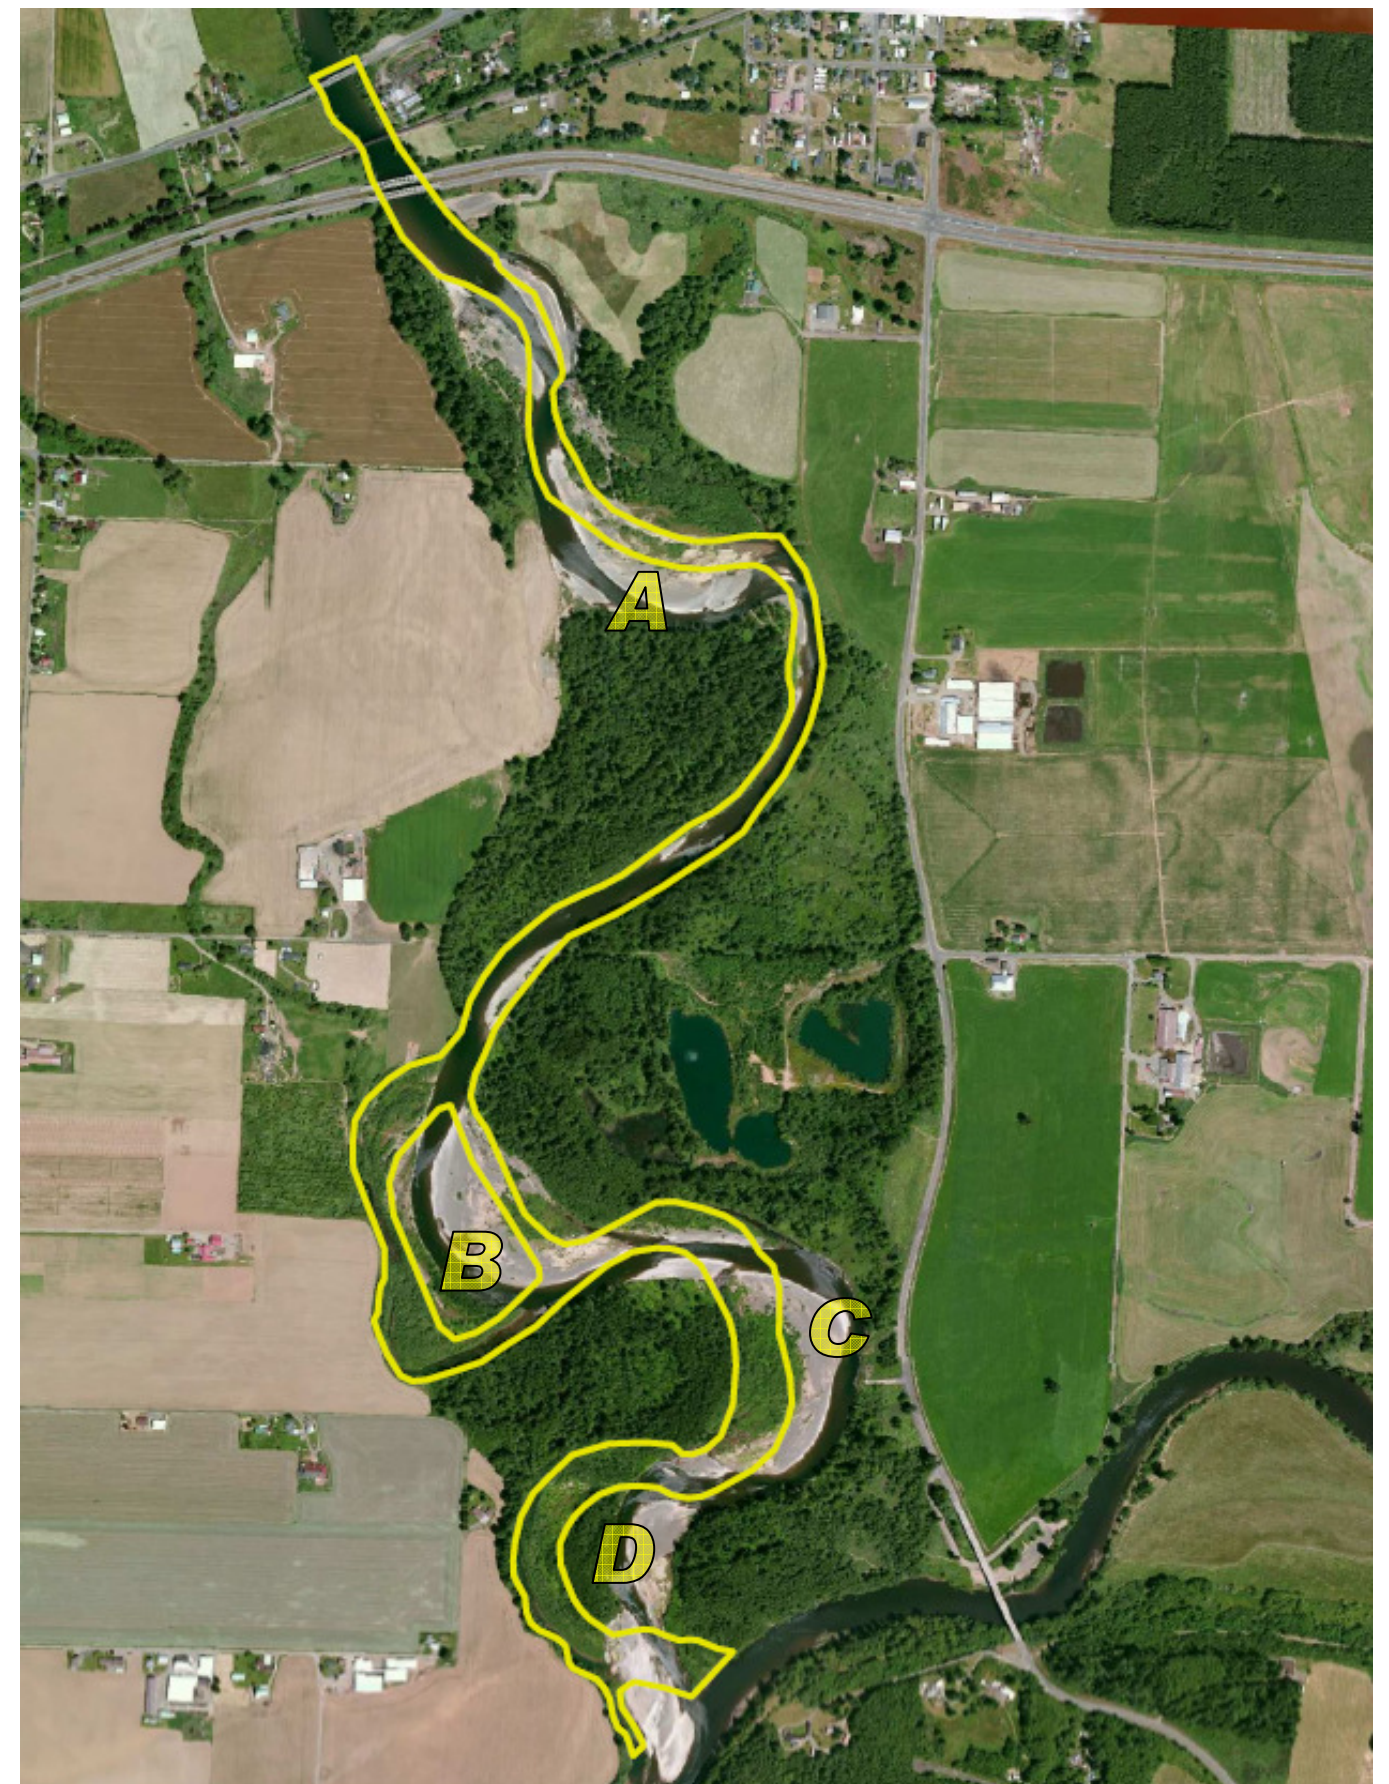
Figure 6: Satsop River near Satsop 2010 Photo with 2001 Channel Delineation
