Memorandum

To: Chehalis River Basin Flood Authority
From: Larry Karpack, WATERSHED Science & Engineering (WSE)
Date: March 8, 2012
Re: **Satsop River Channel and Cross Section Comparisons**

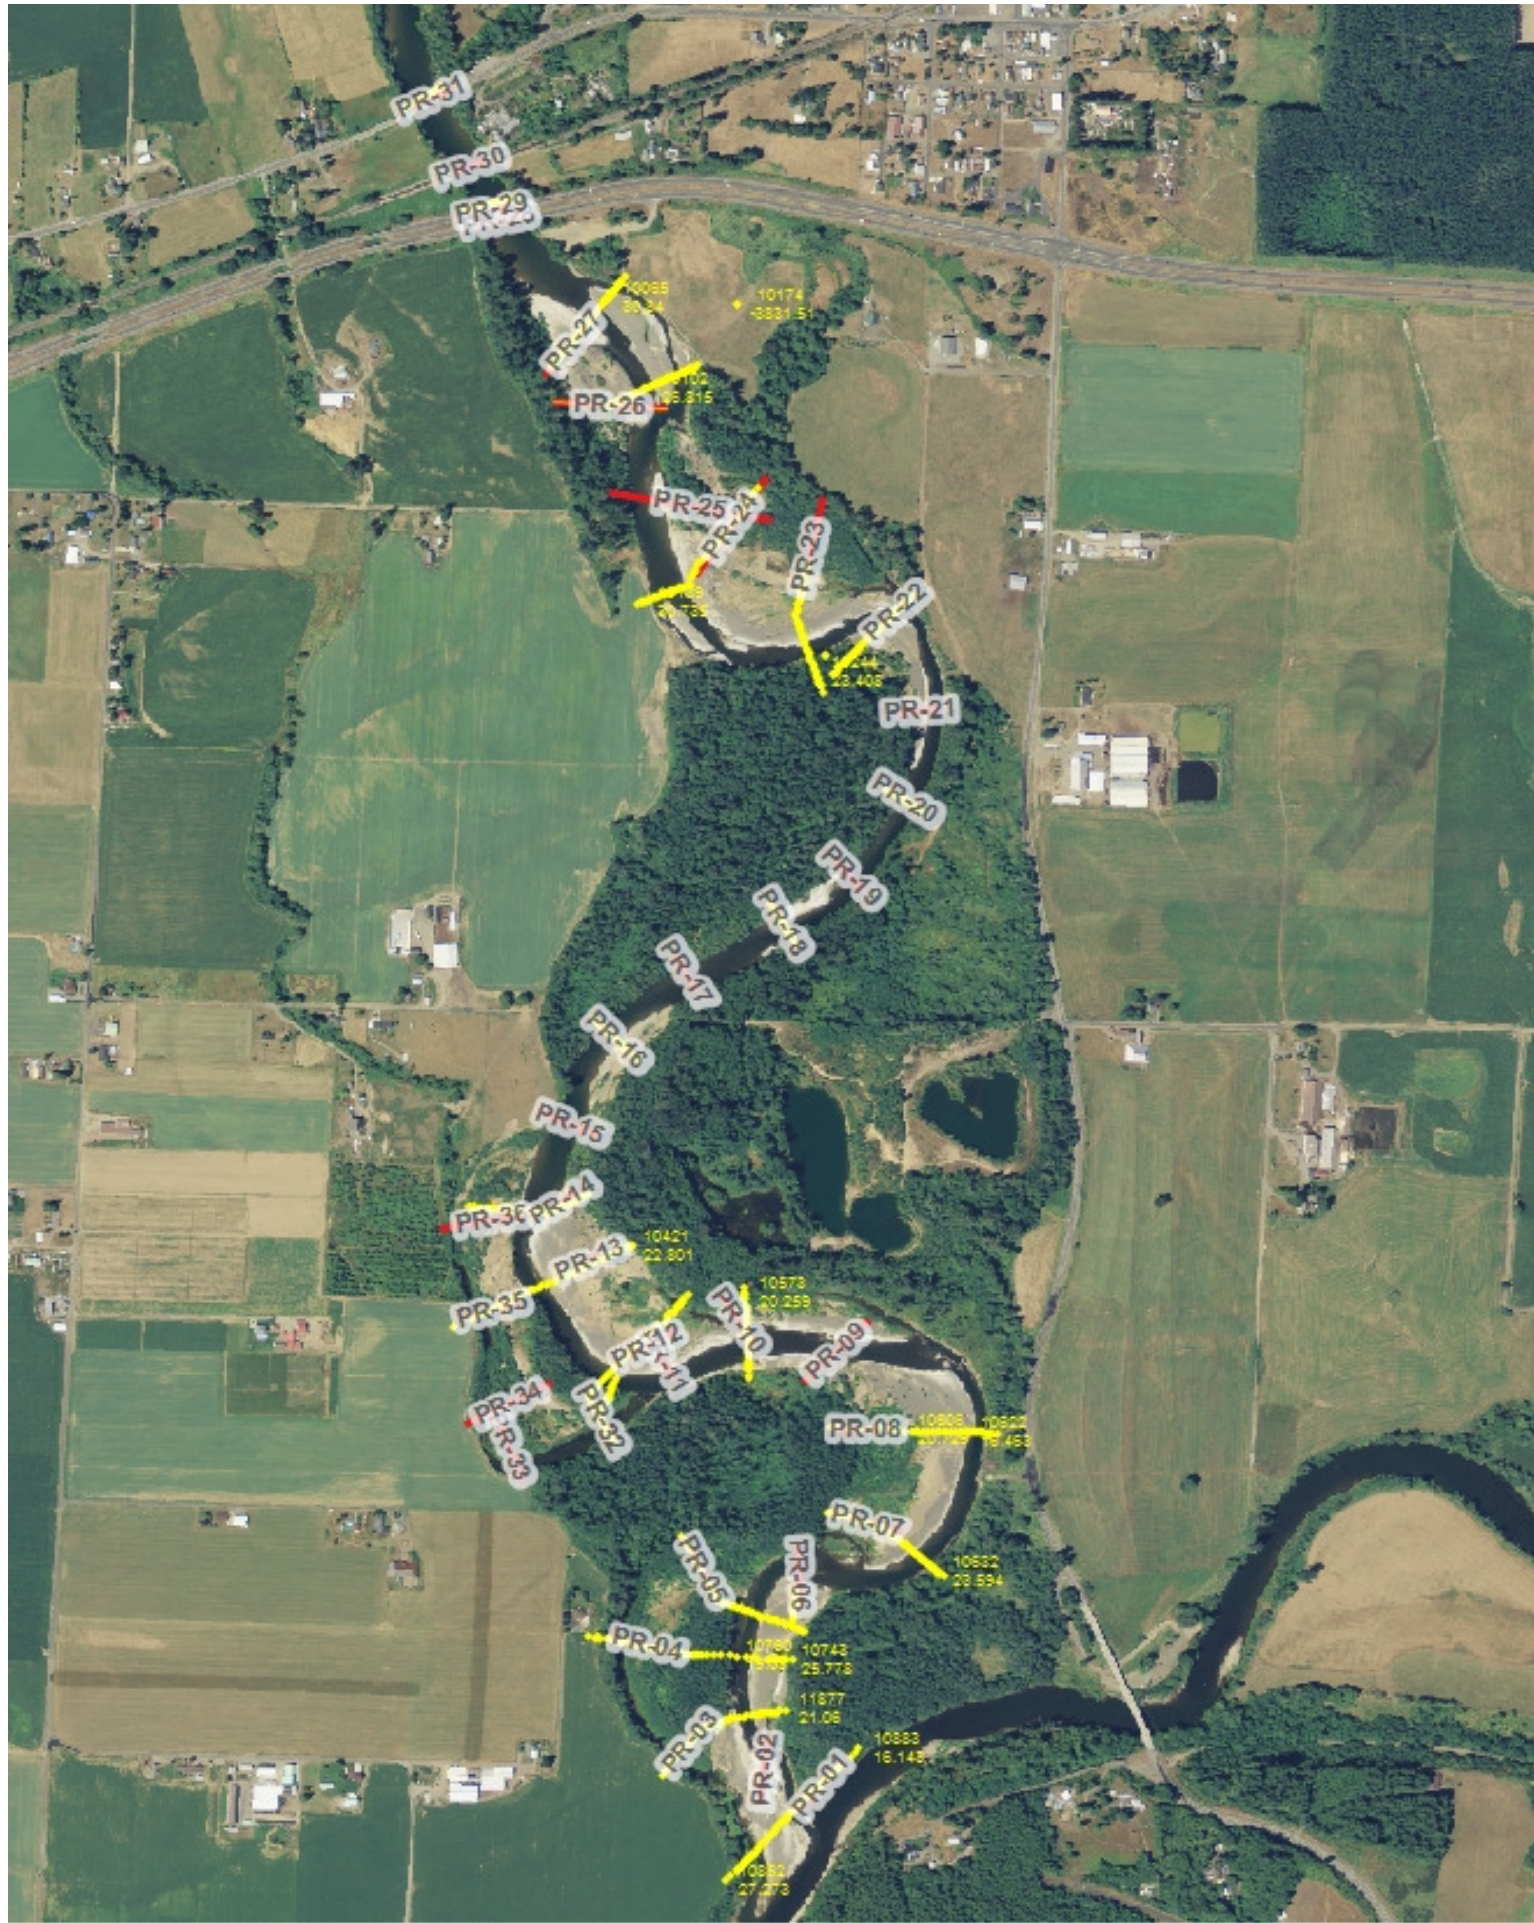
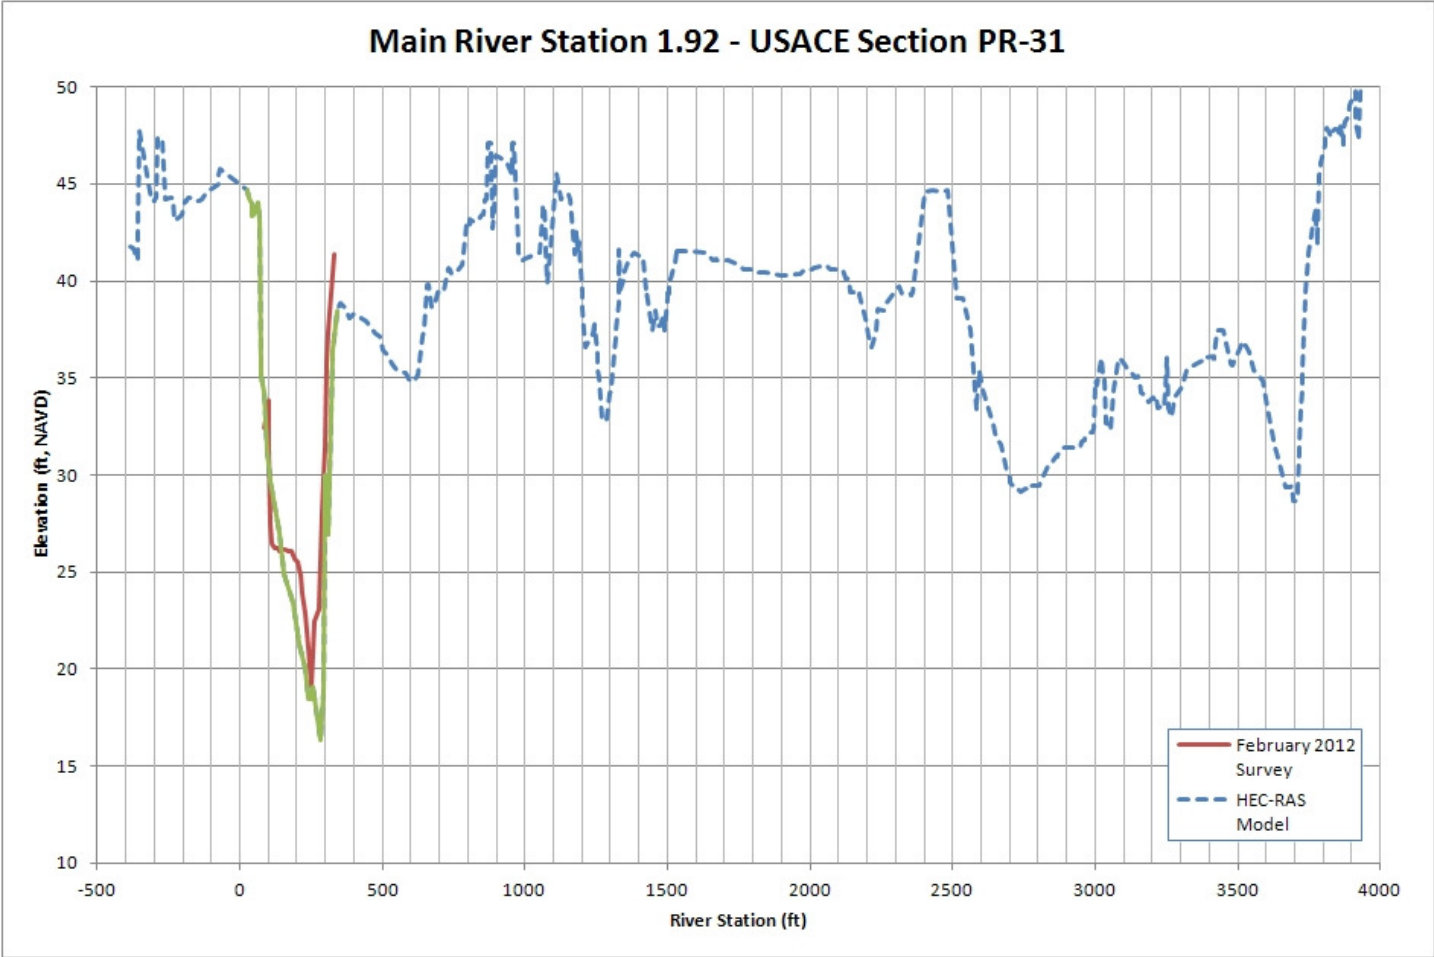
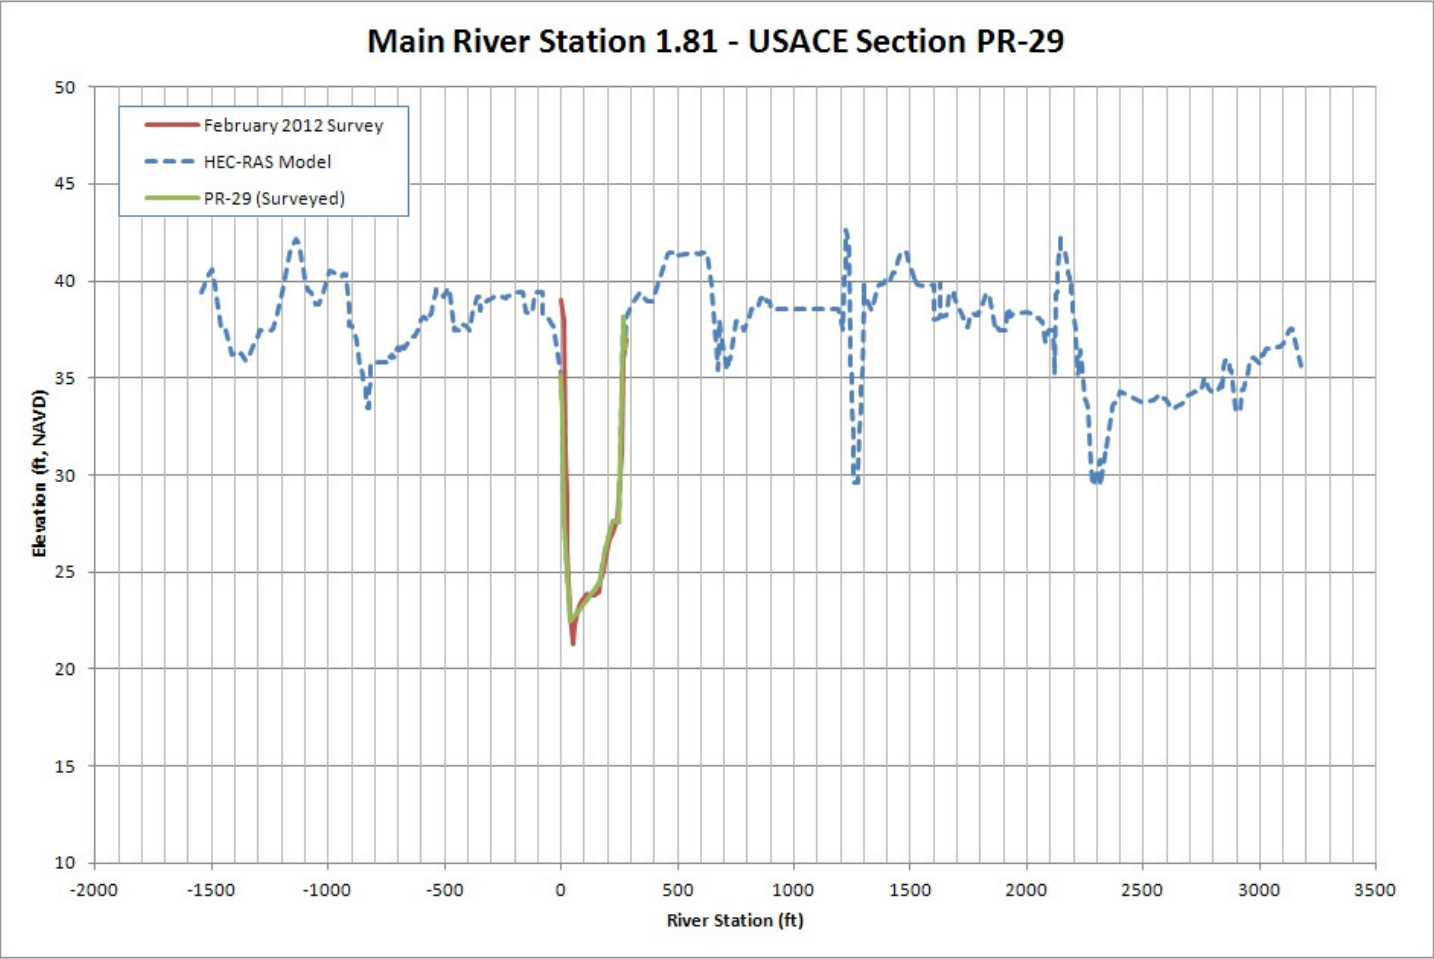
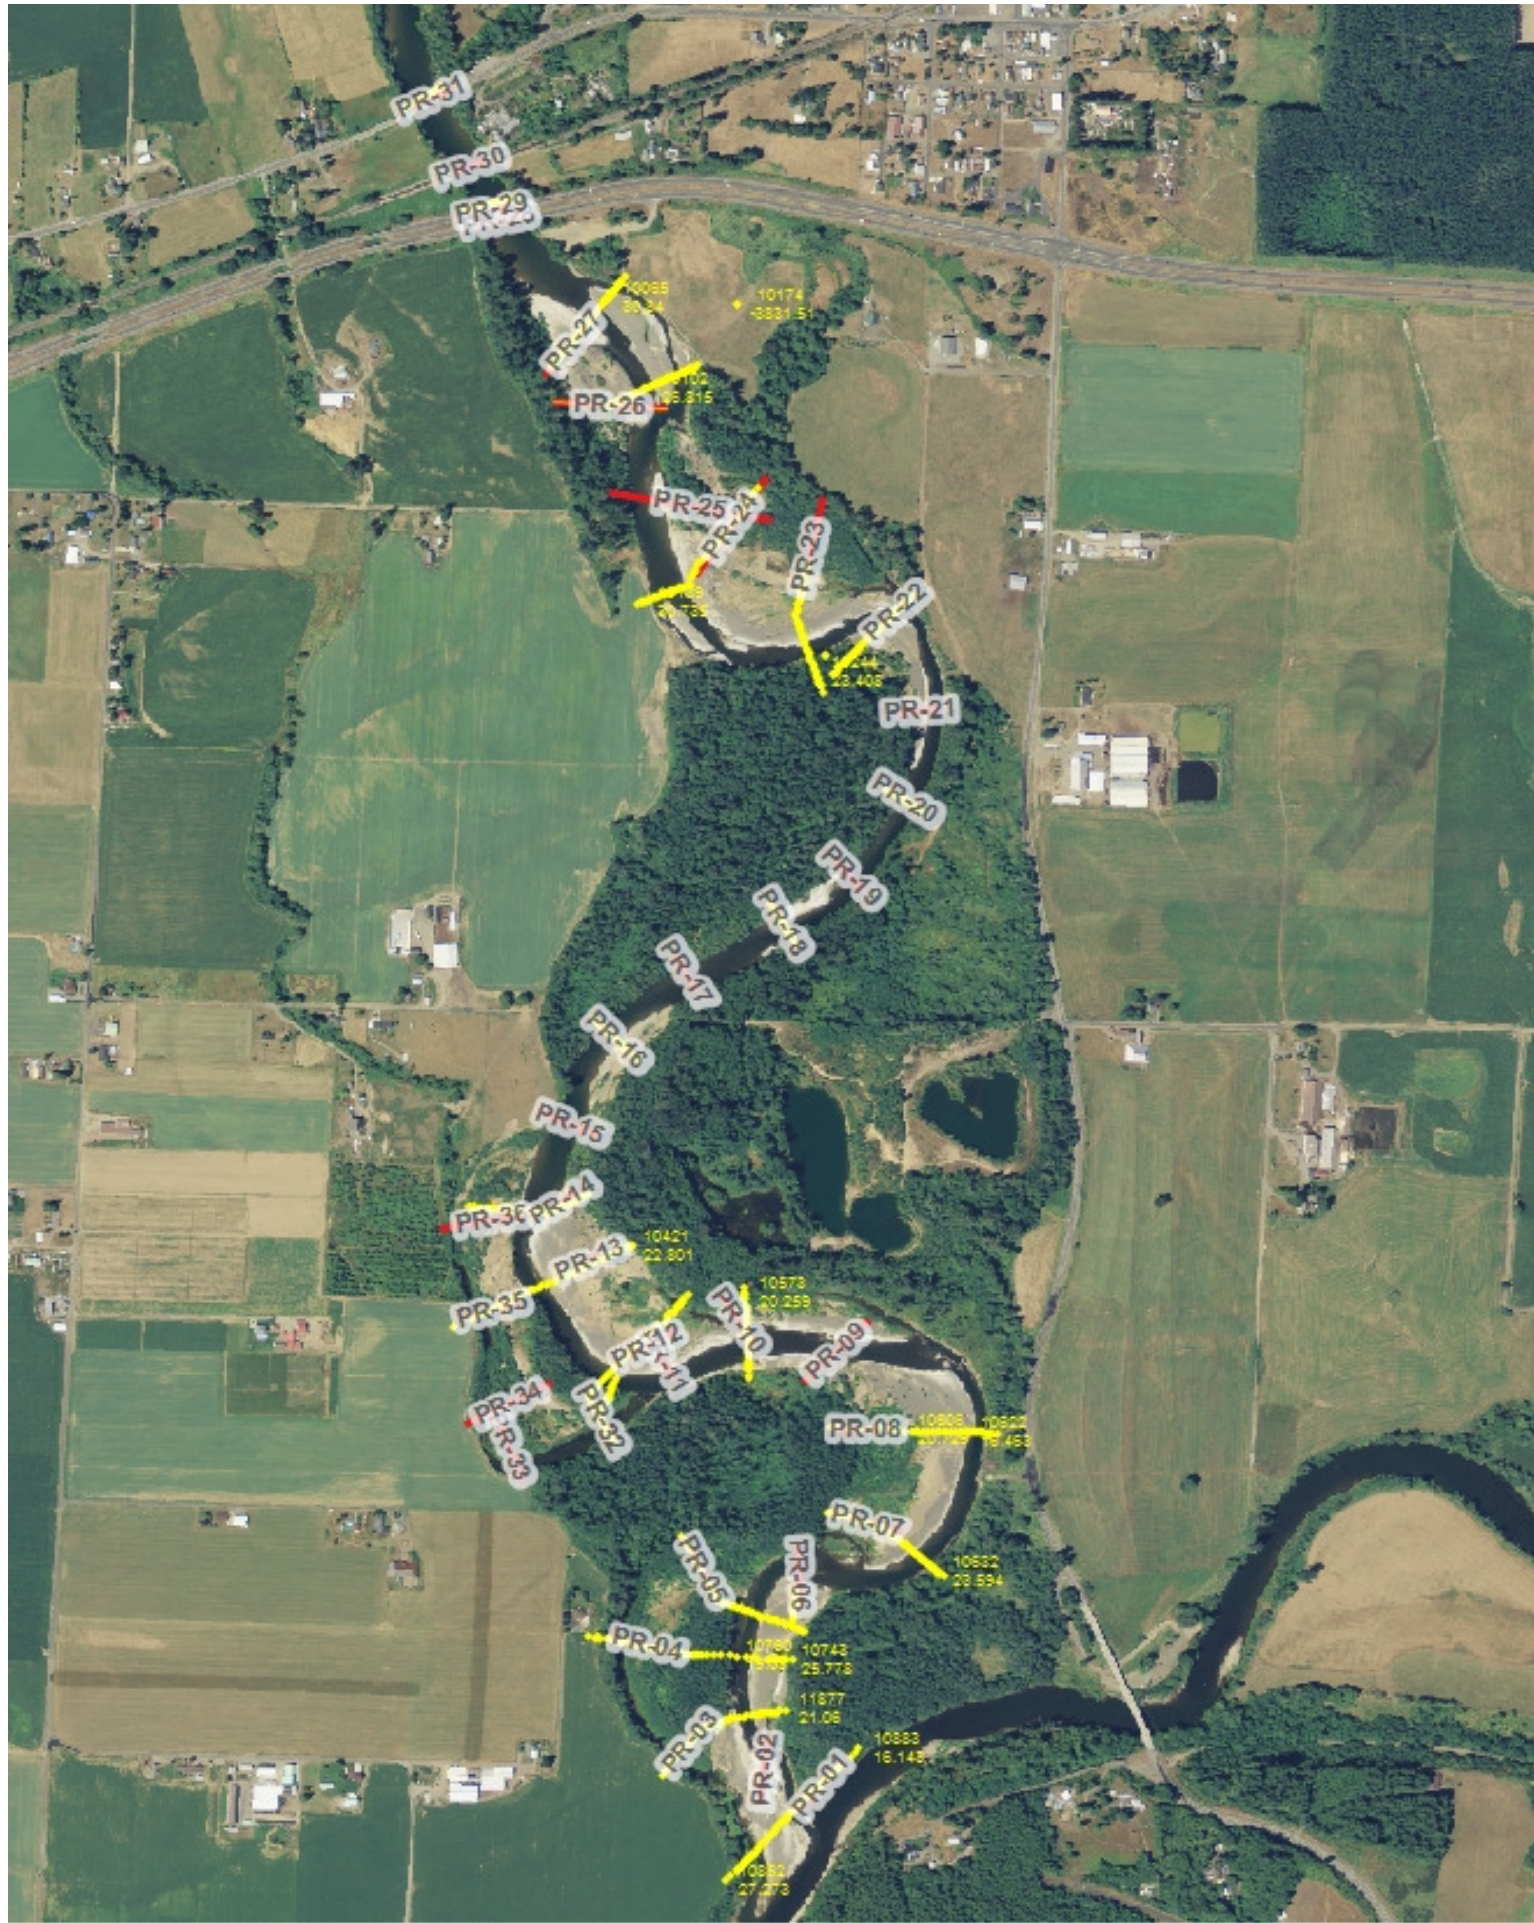
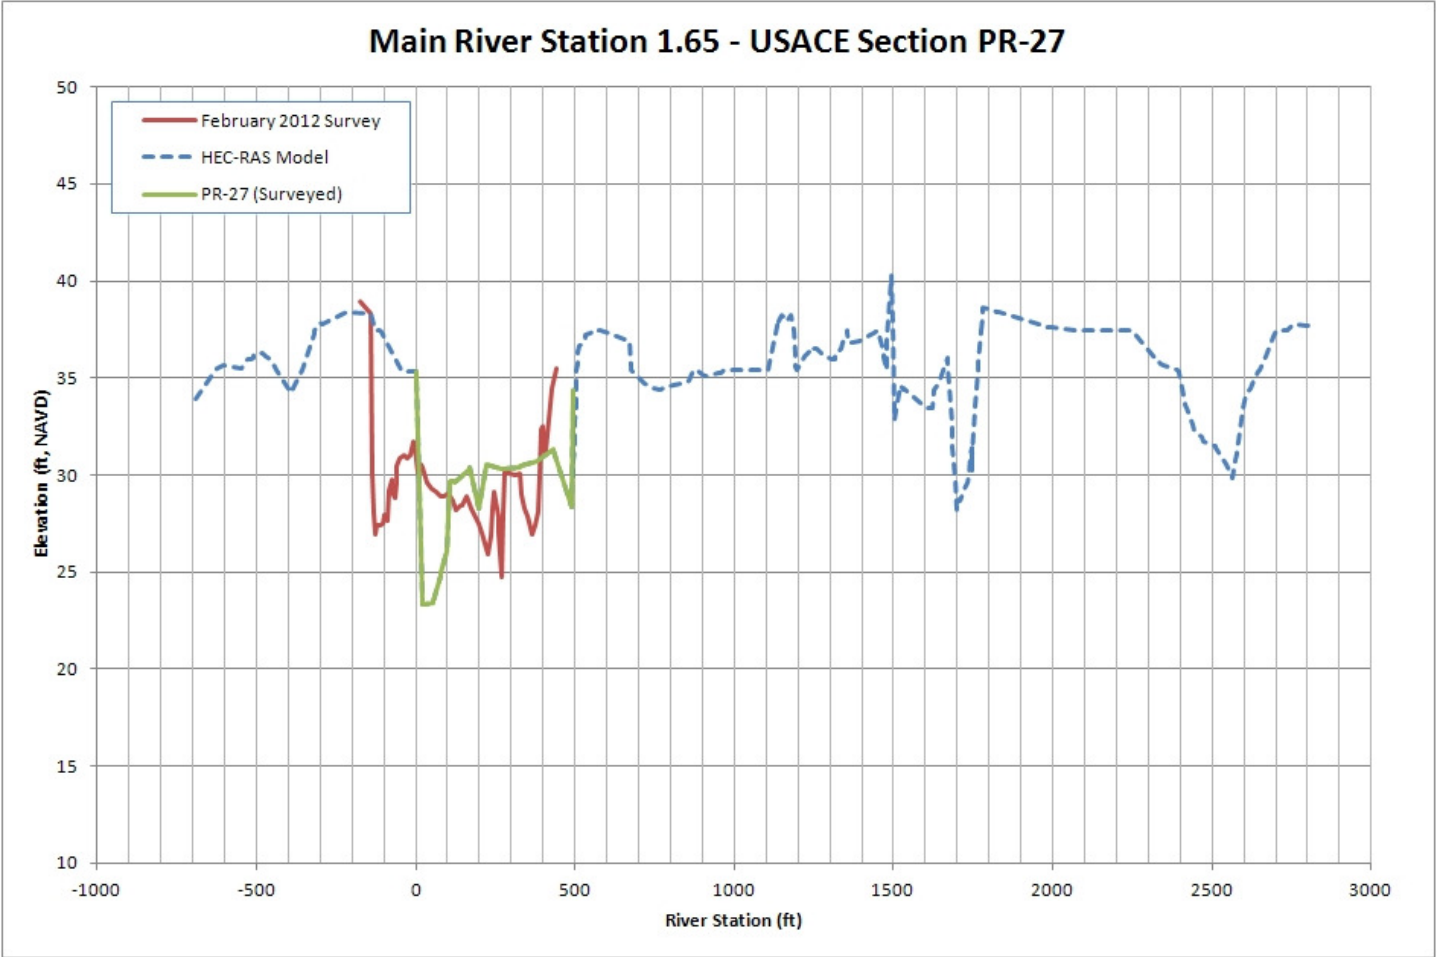
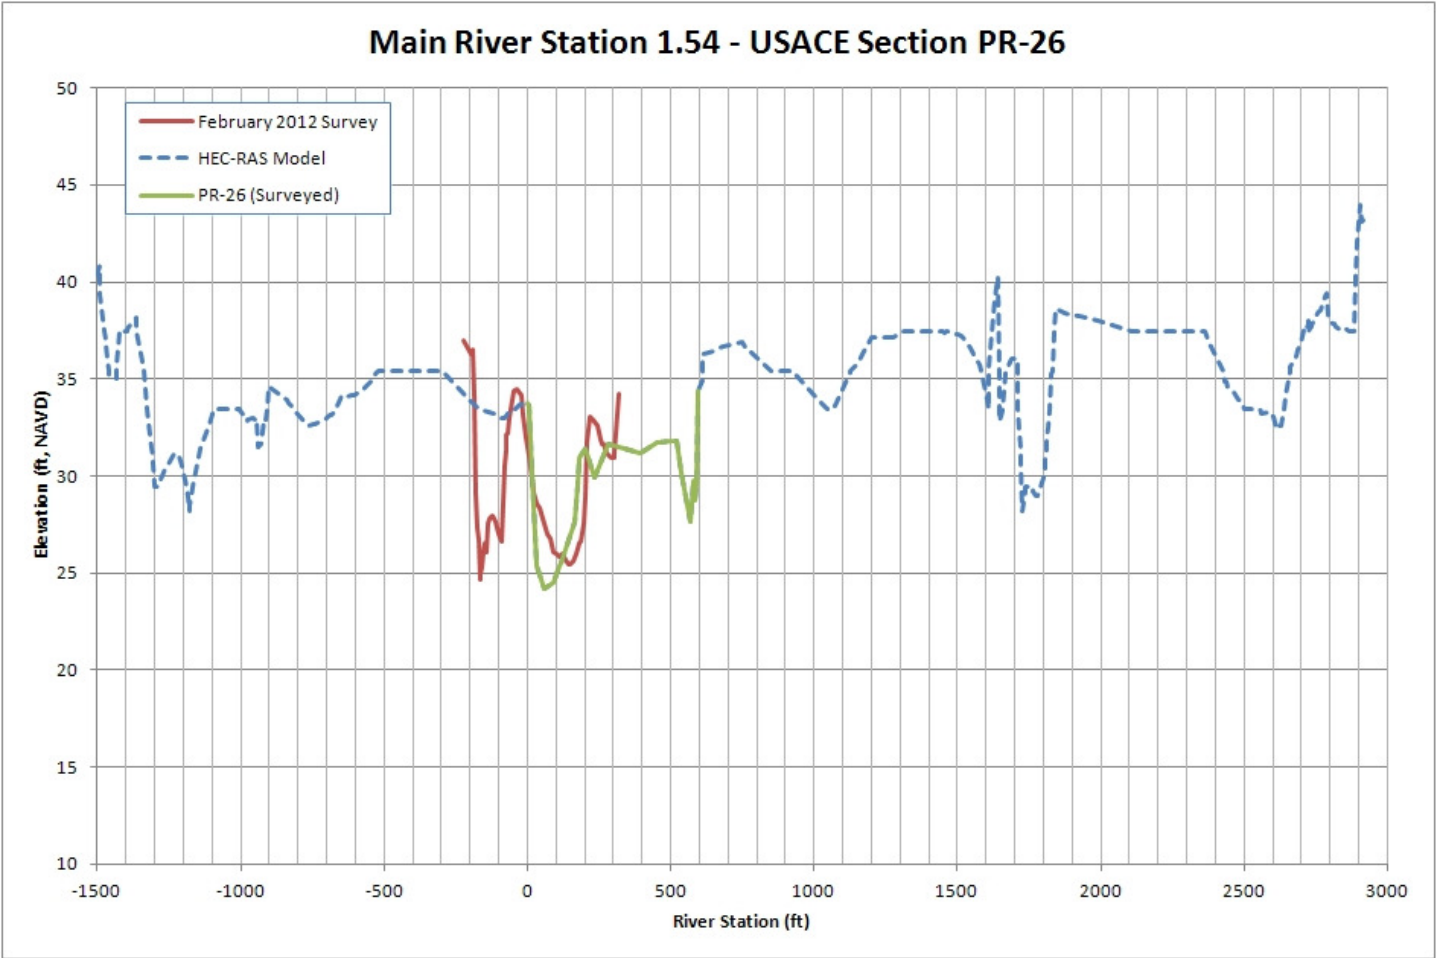
The remaining figures below compare the channel cross sections surveyed in 2001 to those surveyed in February 2012. The layout map on the left of each page shows the 2001 survey layout (red lines and labels PR01 through PR36) as well as the current survey data points (yellow points). The cross section plots on the right of each page compare the old and new survey data. The solid green lines show the field surveyed portions of the 2001 cross sections, the solid red lines show the current field surveyed sections, and the dashed blue lines show the HEC-RAS model cross sections as extended using the 2002 LiDAR data. As can be seen in these figures, with the exception of Sections PR-31, PR-29, and PR-16, which are stable, there has been significant lateral migration of the channel. There has also been channel bed degradation at Sections PR-01, PR-08, and PR-13 and aggradation at Sections PR-14 and PR-24.
