TO:	Karen Witherspoon, Lewis County					
FROM:	Scott Boettcher, Staff Chehalis River Basin Flood Authority					
SUBJECT:	2016-17 Flood Hazard Reduction Activities in the Chehalis Basin					
Local Flood Hazard Reduction Projects		 Major focus is to implement local flood hazard reduction projects throughout the Basin that will benefit local communities on a near-term time-scale. <u>In 2016-17:</u> Funded implementation of 33 local flood hazard reduction projects and studies throughout the Basin at a total cost of \$18M and an average cost of \$250K to \$2M. Local projects: Take ~2-3 years to design, permit, construct; Protect people, property, infrastructure; and Improve readiness, response, resiliency. Examples include: Drinking Water (Boistfort, Bucoda). Wastewater (Montesano, Pe Ell). Emergency Response (Grays Harbor County, Chehalis-Centralia Airport). Regional Economic Infrastructure (Montesano). Community Protection (Adna, Bucoda, Chehalis Tribe, Oakville). Flood Warning Infrastructure (Basin wide). See Attachment A, as well Local Projects Information Center at https://www.ezview.wa.gov/site/alias_1492/34489/local_projects.aspx.

Re: Annual Flood Warning System Update

The foll

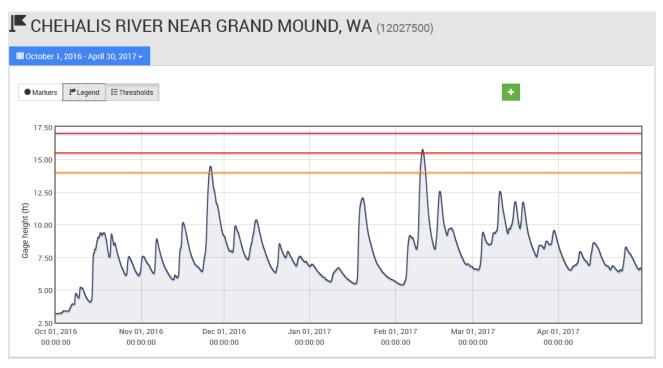
Figure 3: River Stages at the Chehalis River Near Grand Mound, WA

Several highwater events occurred during the 2016-17 wet season largely due to the extraordinary number of atmospheric river events that made landfall along the west coast of the US during the season as shown in Figure 2. Figure 3 shows the graph of river stages on the Chehalis River near Grand Mound. The many river rises and falls during the winter were in response to the large number of atmospheric river events. Flood stage was exceeded in late November 2016 and moderate flood stages were reached in early February 2017. Fortunately, most of the atmospheric river events moved through fairly quickly and the region avoided a major flood event.

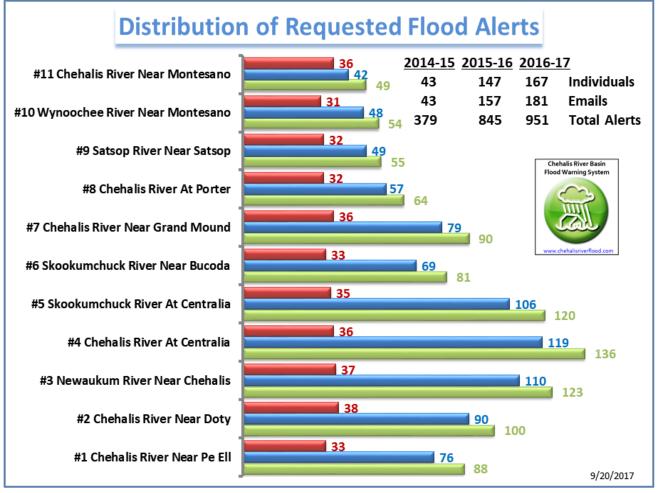
Figure 4: Chehalis River Flood Warning System High Water Alerts

The Flood Authority's Contrail website has the ability to automatically send alarms and alerts via text or email triggered by observed data. Since the website's inception, high water alerts have been available as a test to approximately 40 individuals closely associated with the Authority. At the beginning of the 2015-16 wet season, the opportunity to receive high water alerts for selected river elevations was opened to the general public. The program has been very well received. Figure 4 shows the distribution of the current 951 highwater alert requests from 167 different individuals. (Some individuals requested alerts to home and work email addresses and many individuals requested alerts from multiple sites.)

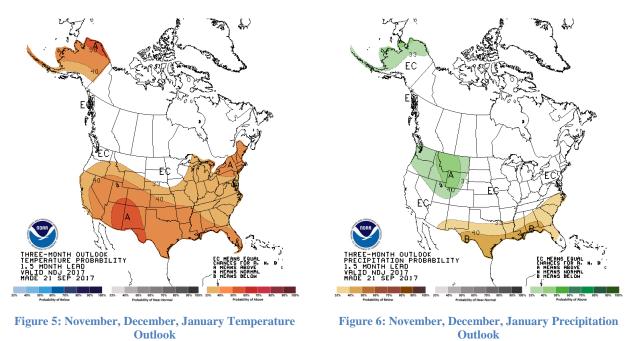
Figure 5 and Figure 6 show the latest November-January temperature and precipitation outlooks from the NWS Climate Prediction Center. Current projections suggest a strong chance of above normal precipitation and with about normal temperature through the period.
