State of Washington Department of Ecology  
**Cruise Ship Memorandum of Understanding, Cruise Operations in Washington State Inspection Report**

Inspection Date June 19, 2018	Permit Number NA	County King	Receiving Waters Marine Waters	Ecology Inspector Amy Jankowiak
Entry Time 10:11 am	Photos Taken <input checked="" type="checkbox"/> Yes <input type="checkbox"/> No	Samples Taken <input type="checkbox"/> Yes <input checked="" type="checkbox"/> No	Inspection Announced <input checked="" type="checkbox"/> Yes <input type="checkbox"/> No	Discharges to: <input checked="" type="checkbox"/> Surface Water <input type="checkbox"/> Ground Water <input type="checkbox"/> Dewater <input type="checkbox"/> POTW
Exit Time 12:21 pm				
Name and Location of Site Inspected: CARNIVAL LEGEND, Carnival Cruise Line Pier 91, Seattle, Washington				Additional Participants/Inspectors: Gretchen Onstad, Ecology
On-Site Representative(s): <i>Name/Title/Phone/e-mail</i> Evangelos Voutsis, Environmental Officer e: <a href="mailto:LEENVOFF@carnival.com">LEENVOFF@carnival.com</a>

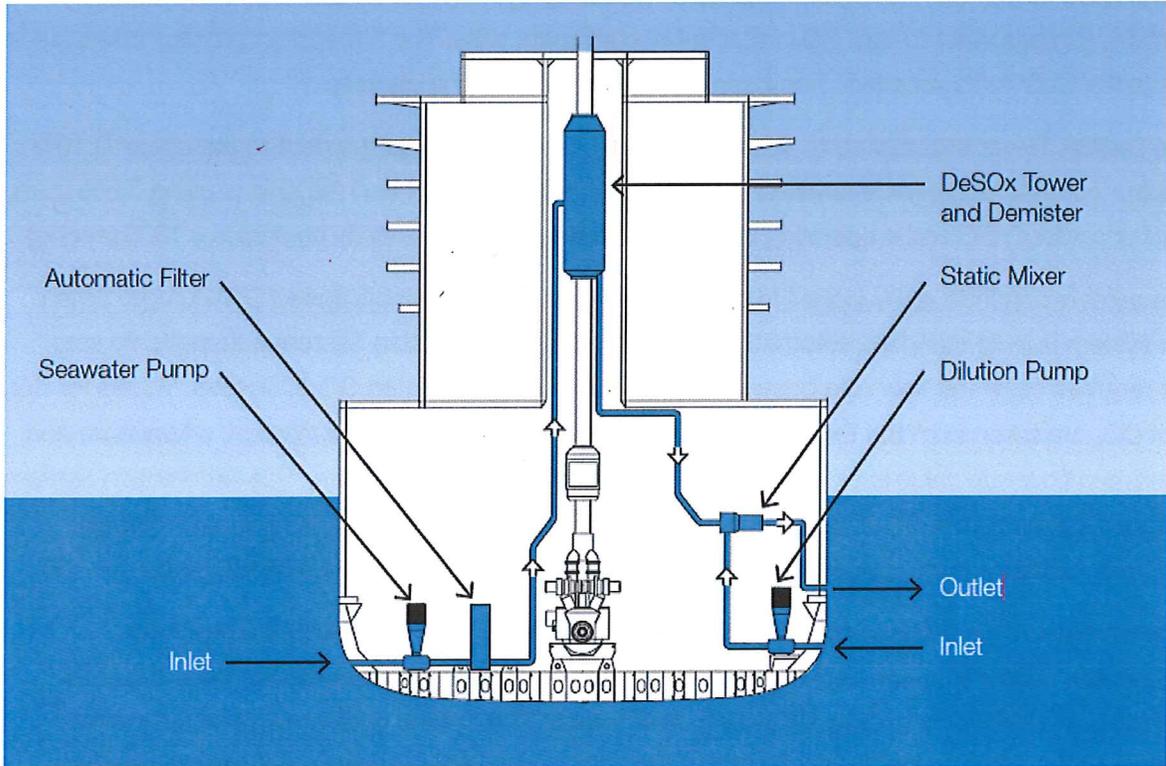
**Figure 1.** Components of Exhaust Gas Cleaning System

A diagram of the system is shown below.

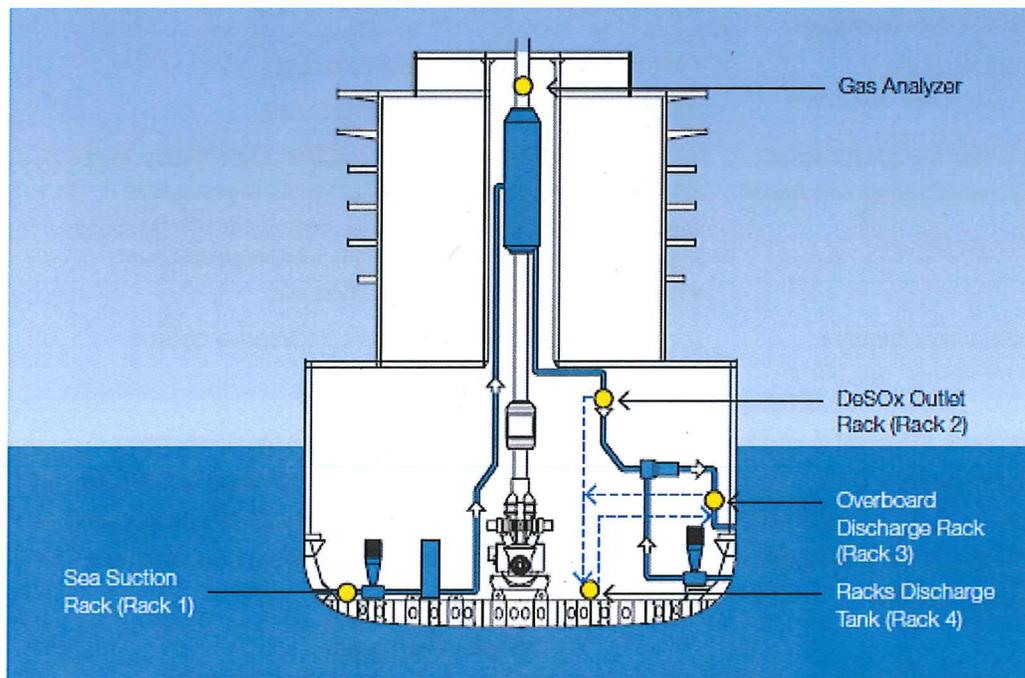
**Figure 3.** Wash-water Racks and Gas Analyzer

A diagram showing the location of the monitoring equipment is shown below.
