DRAFT
REDMOND PAIRED WATERSHED STUDY
EXPERIMENTAL DESIGN SUMMARY REPORT

Prepared by
Herrera Environmental Consultants, Inc.

EXPERIMENTAL DESIGN SUMMARY REPORT

July 14, 2015 DRAFT

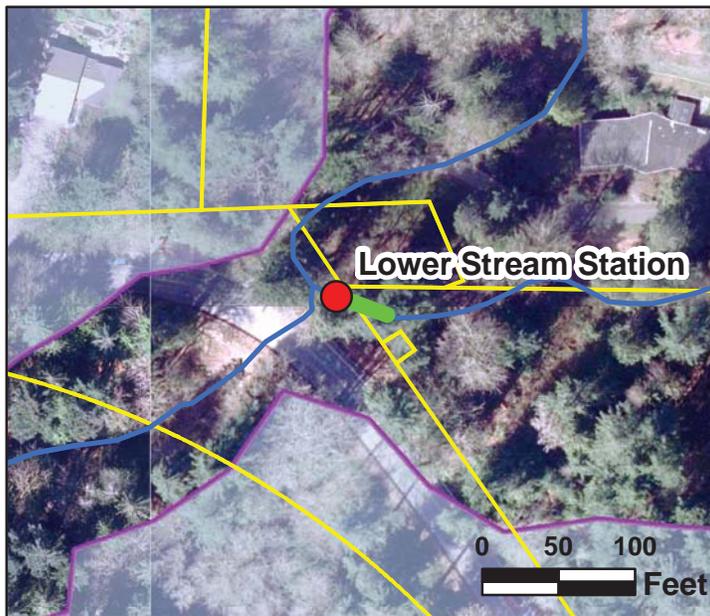
Figure 2 - Evans Trib. 108 Paired Basin Study Monitoring Locations.

- Flow, WQ, Sediment Monitoring
- Habitat and Biological Monitoring
- ~ Streams and Rivers
- King County Parcels
- Basin Boundary

Evans Creek Tributary 108 is located in the Northeast Quarter, Sections 4, 5, 8, and 9, Township 25, Range 6 East WM, in King County (Figures 1 and 2). Evans Creek Tributary 108 is within the Bear-Evans Creek watershed. The watershed is approximately 397 acres with dominantly Alderwood and Everett soils; land cover in the watershed is approximately 37 percent forest and 16 percent impervious area. The Evans Creek Tributary 108 watershed has experienced a significant amount of residential development that occurred before adequate stormwater controls were required on new development, which has degraded the tributary's water quality/health and contributed to documented degradation of Evans Creek. Currently, average median benthic index of biotic integrity (B-IBI) scores for three stations in the watershed range from 28 to 31, which indicates the stream's health is on the low side of "fair".
