# Groundwater Flow Direction Evaluations in the Spokane River, Mission Reach

Prepared for:  
Spokane River Regional Toxics Task  
Force

21 June 2023  
PRELIMINARY DRAFT

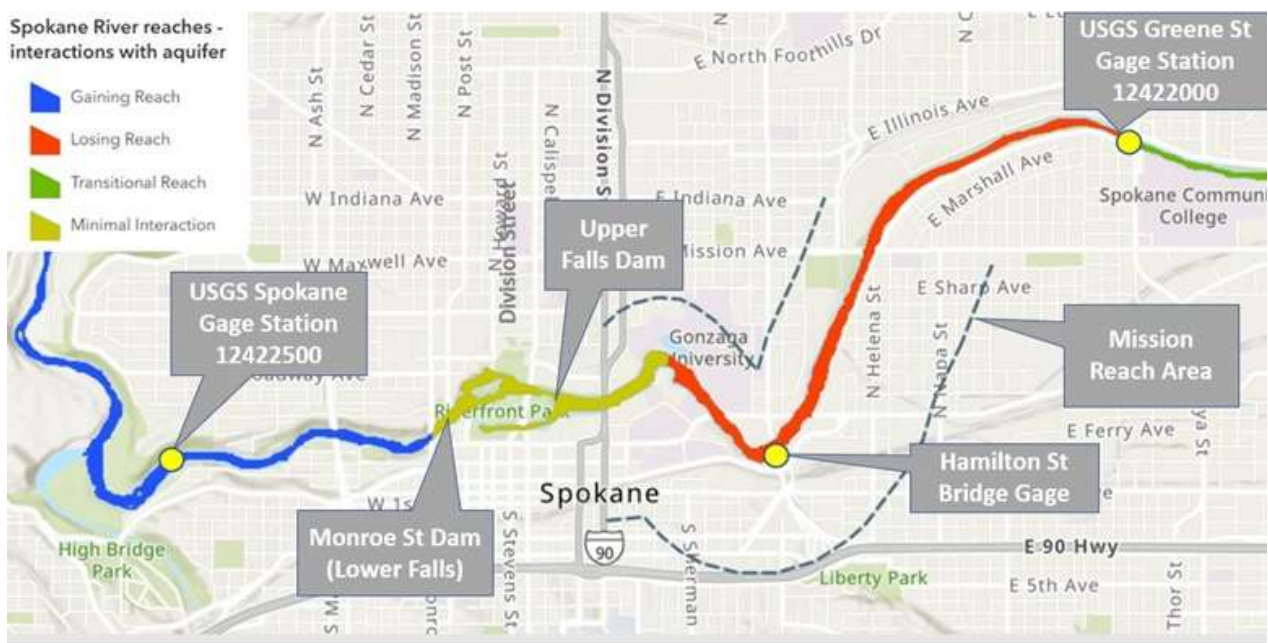
Figure 4. Map of Spokane River gage stations 12422000 (Green St) and 12422500 (Spokane)

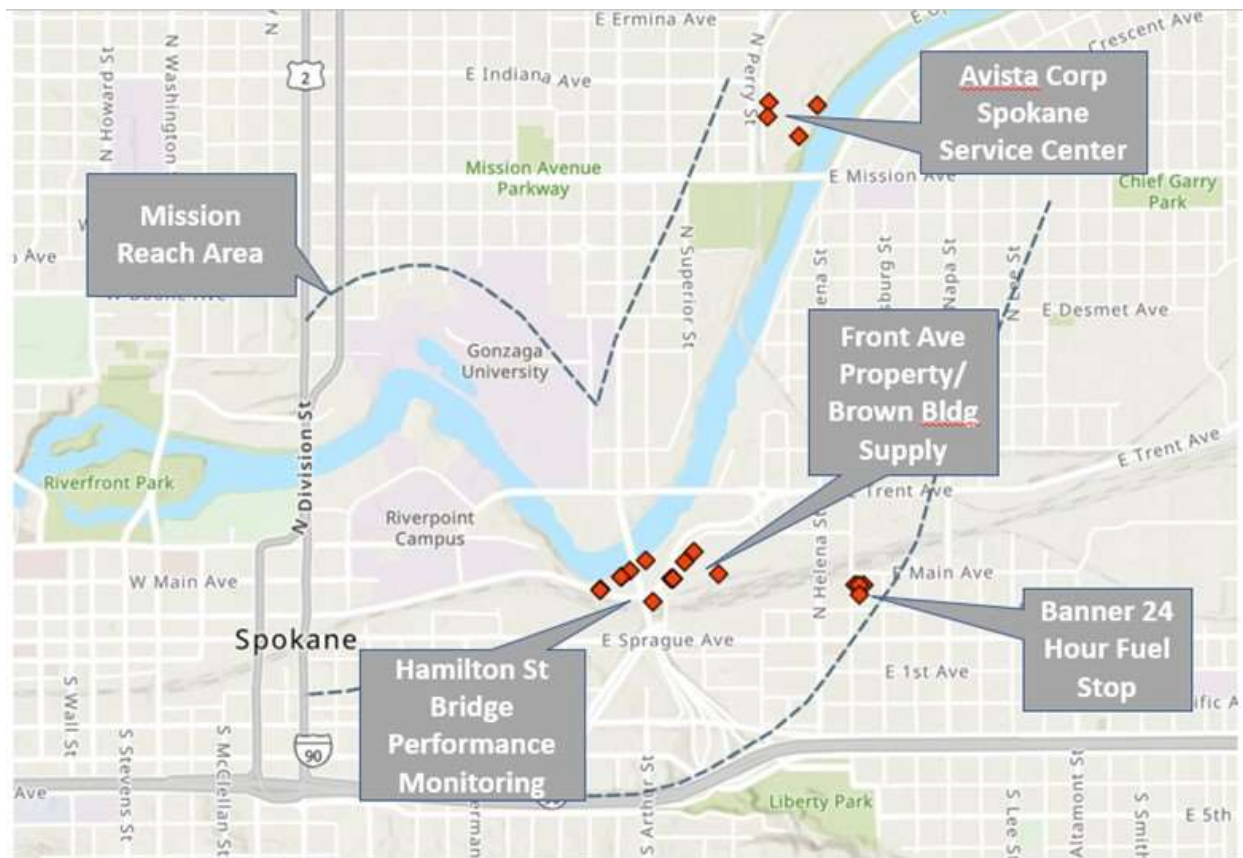
Figure 6. Map of EIM sites in Mission Reach area with groundwater monitoring data.

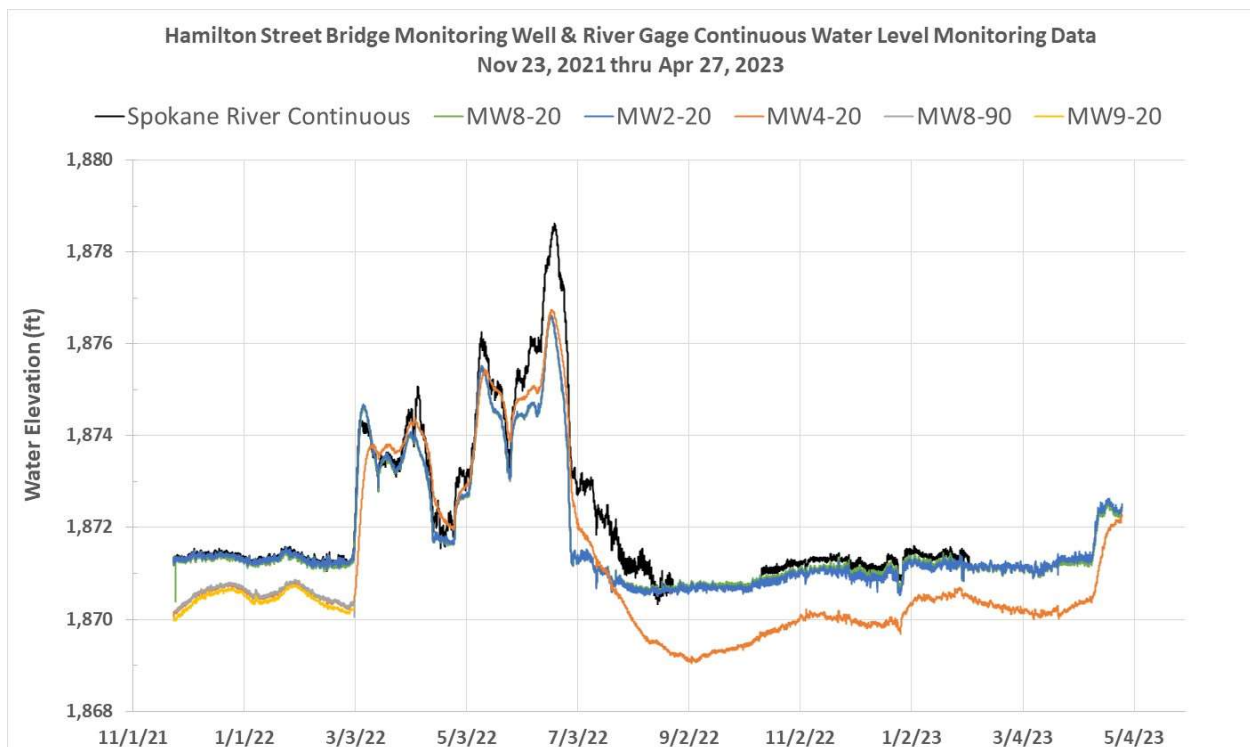
ft, respectively, during “gaining” events. The most extreme losing event was recorded in June 2022 at all three locations, and the most extreme gaining event was recorded in March 2022 at MW2-20 and MW8-20 and in April at MW4-20. During March 2022, groundwater levels were observed to be above surface water levels for approximately 46%, 56% and 37% of the month at the MW2-20, MW2-40 and MW8-20 locations, respectively. During April 2022, groundwater levels were observed to be above surface water levels for approximately 49% of the month at the MW2-40 location. This suggests that during more pronounced gaining periods (March and April), there is approximately a 50% chance or less of observing a flow reversal/gaining event when relying on monthly or quarterly depth to groundwater data that are collected manually rather than continuously. There were no readings where the river level was below the groundwater elevation in shallow monitoring well MW9-20 for the period November 23, 2021 through March 2, 2022. The maximum water level differences between the Hamilton Street Bridge gage and shallow groundwater in MW9-20 ranged from 0.064 ft to 1.508 ft during this “losing” period. MW9-20 is located further from the river than the other three shallow wells.

Figure 8. Continuous surface water and groundwater level monitoring data for the Hamilton Street Bridge study area.

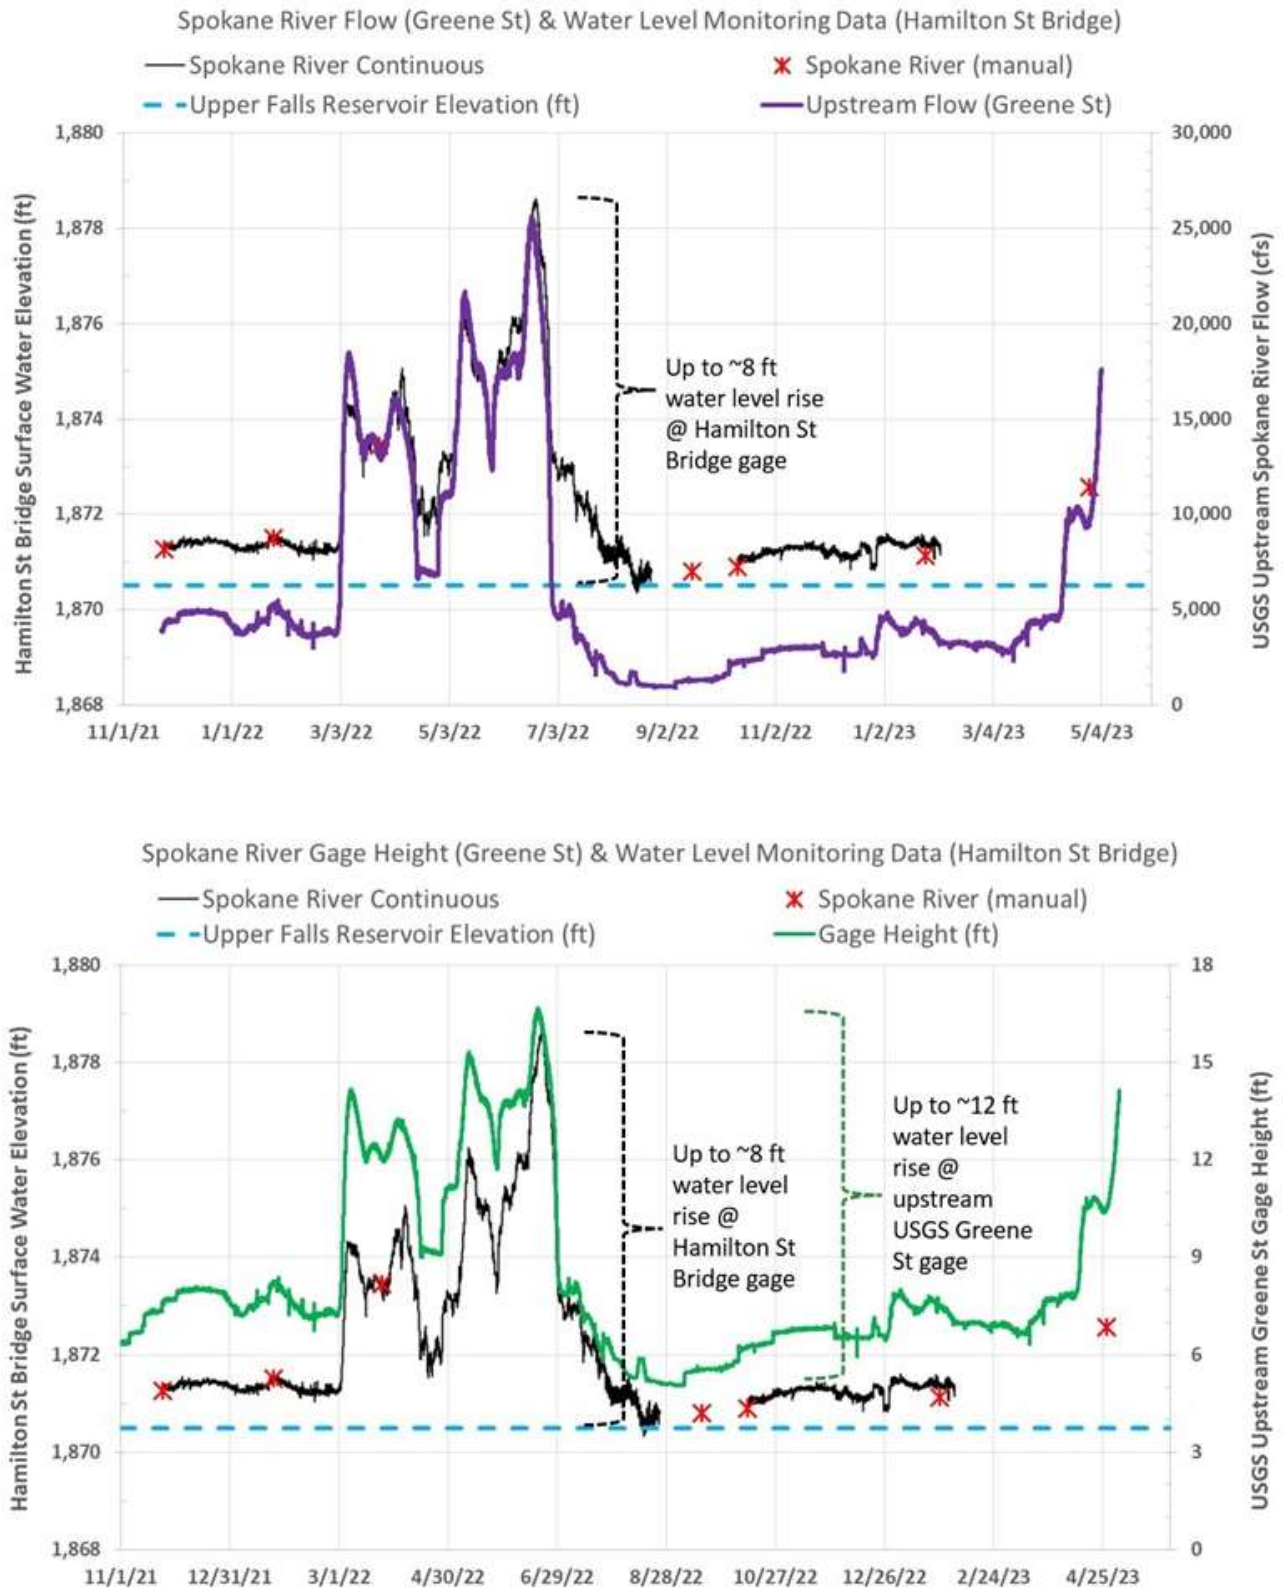
The Spokane River continuous elevation data also compare very well with the USGS flow and gage data obtained from the upriver Green Street gage ([Figure 9](#)) and the downriver Spokane gage ([Figure 10](#)). Historical manual river elevation data are included in these figures for reference, as is the pool elevation for the Upper Falls Reservoir (1870.5 ft), which has remained relatively stable since November 2021. These figures show that river levels and flows rose and fell very rapidly upstream and downstream of the Upper Falls and Monroe Street dam systems during the period from early March through early July. During the low flow interval, surface water levels at the Hamilton Street Bridge location were generally 1 foot or less above the downstream Upper Falls Reservoir pool elevation. However, during the 2022 high flow period, the Hamilton Street Bridge water level increased by approximately 7 to 8 ft. This is a significant increase above the Upper Falls controlled pool elevation, but the 2023 SVRP Aquifer Atlas indicates that the river elevation trends shown in the late 2021 through early 2023 Hamilton Street Bridge continuous monitoring data are consistent with historical Spokane River monitoring information (refer to [Figure 11](#)). The rapid surface water and groundwater level increases in spring coincide with snow melts, and the SVRP Aquifer can manage large recharge volumes because groundwater flow velocities are very rapid in the SVRP Aquifer (up to 50 ft/day) because of the very permeable nature of the aquifer.

Figure 9. Continuous and manual surface water level monitoring data for the Hamilton Street Bridge study area and USGS Green Street flow and gage data.

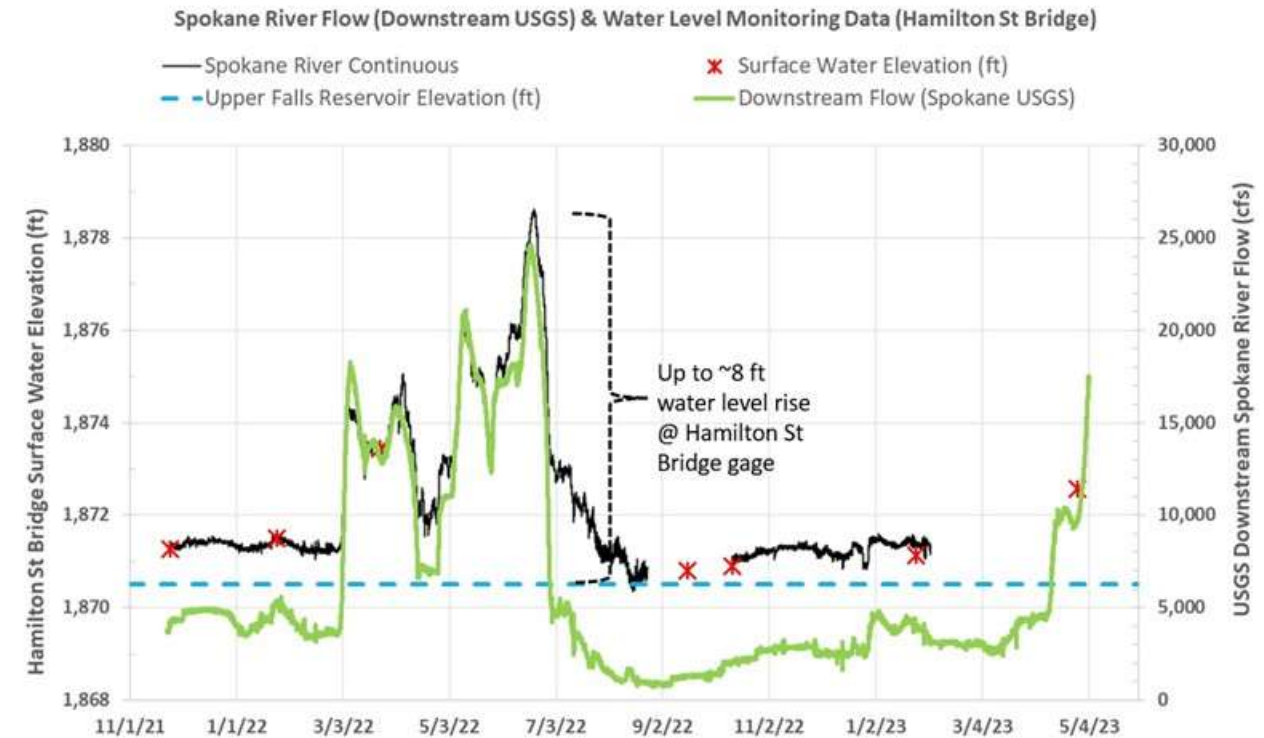
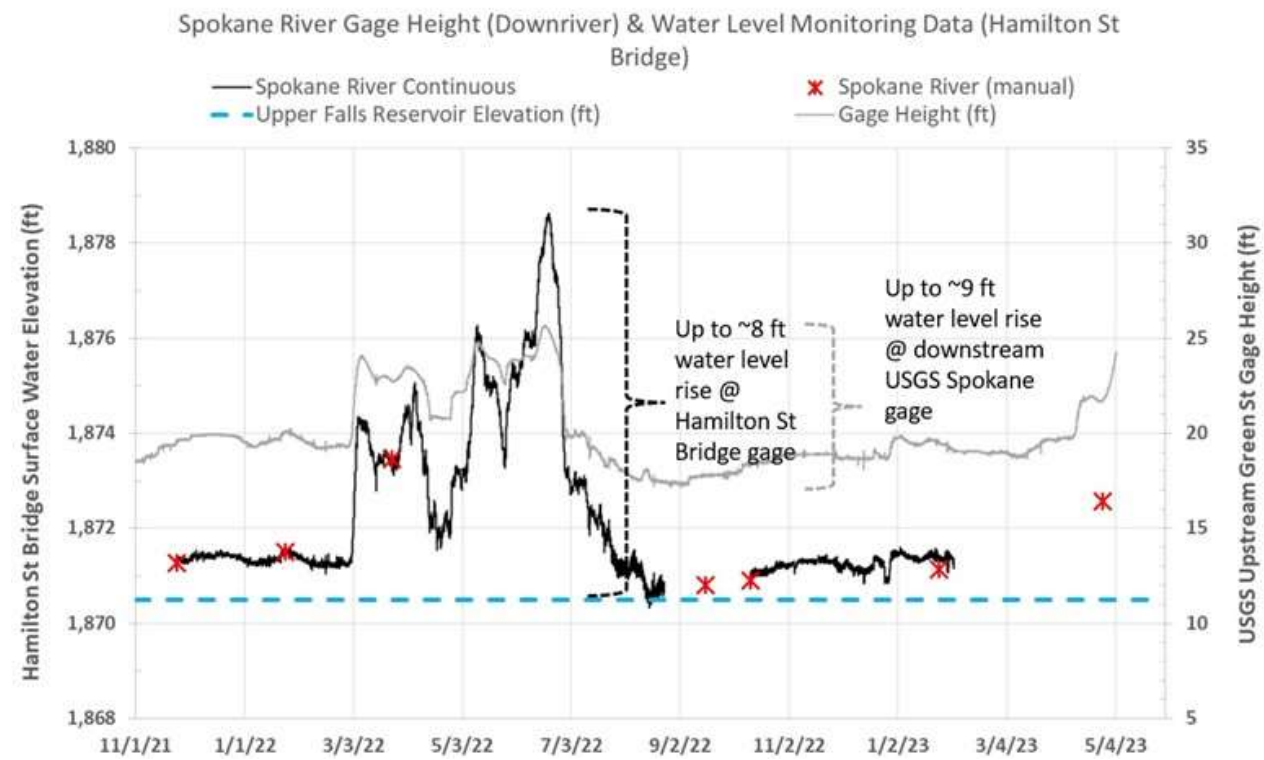
Figure 10. Continuous and manual surface water level monitoring data for the Hamilton Street Bridge study area and USGS Spokane flow and gage data.

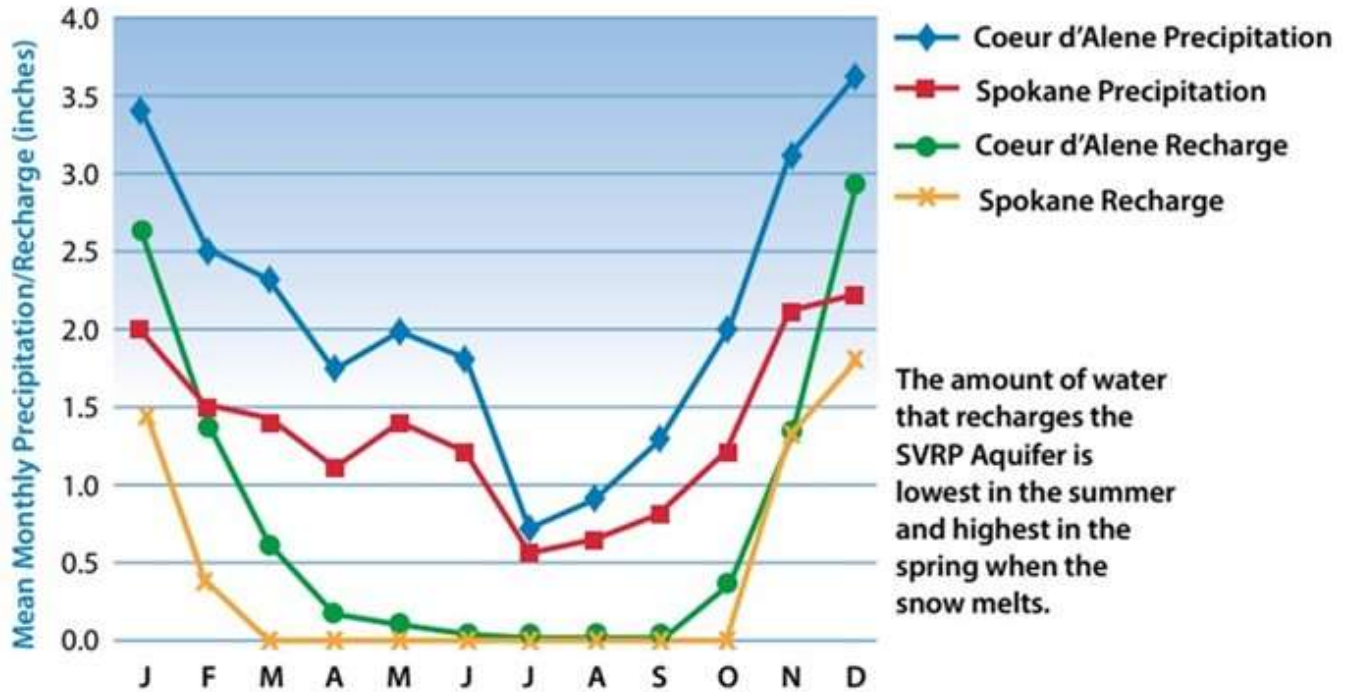
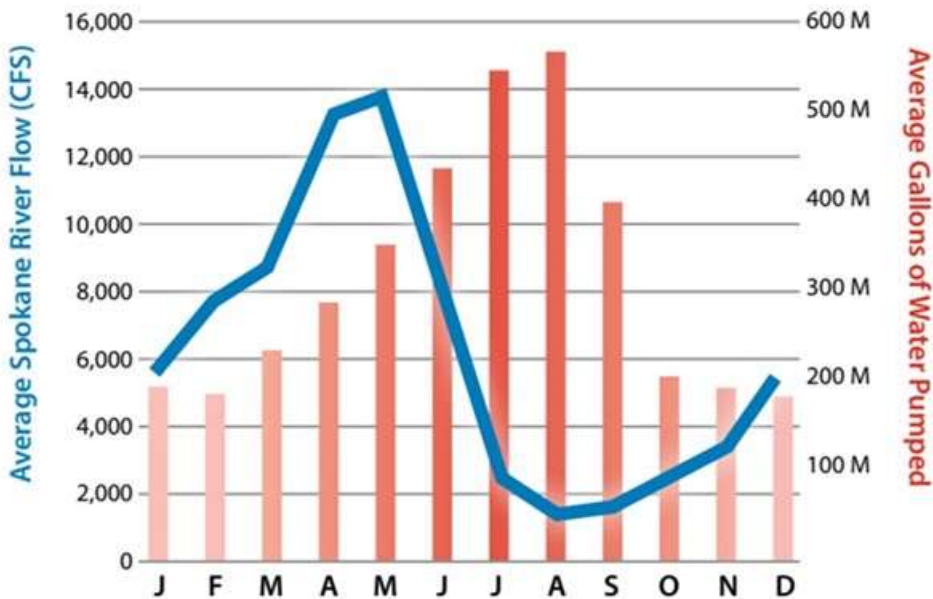
Figure 11. Recharge to the Spokane Valley Rathdrum Prairie Aquifer and average monthly Spokane River flows relative to groundwater withdrawals (Source: 2023 SVRP Aquifer Atlas).

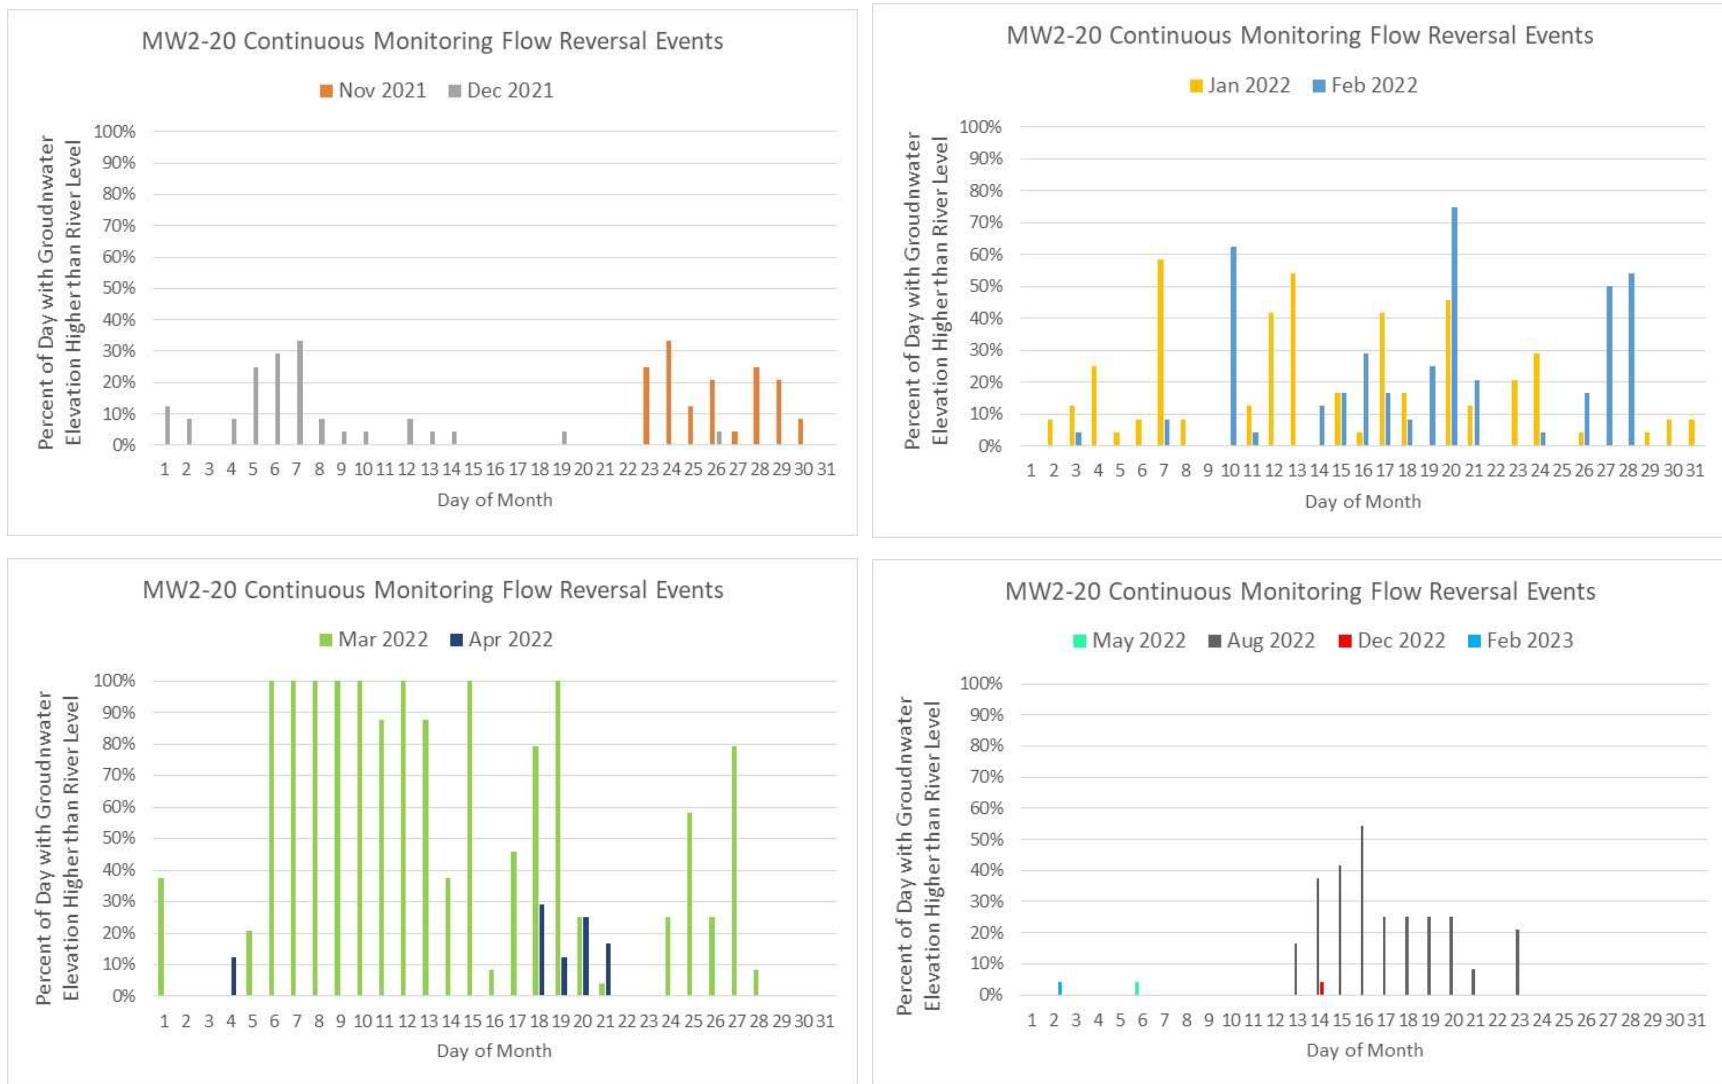
Figure 12. Graphs of daily frequency and duration of events for months where MW2-20 hourly groundwater elevations were above Hamilton Street Bridge river gage elevations.

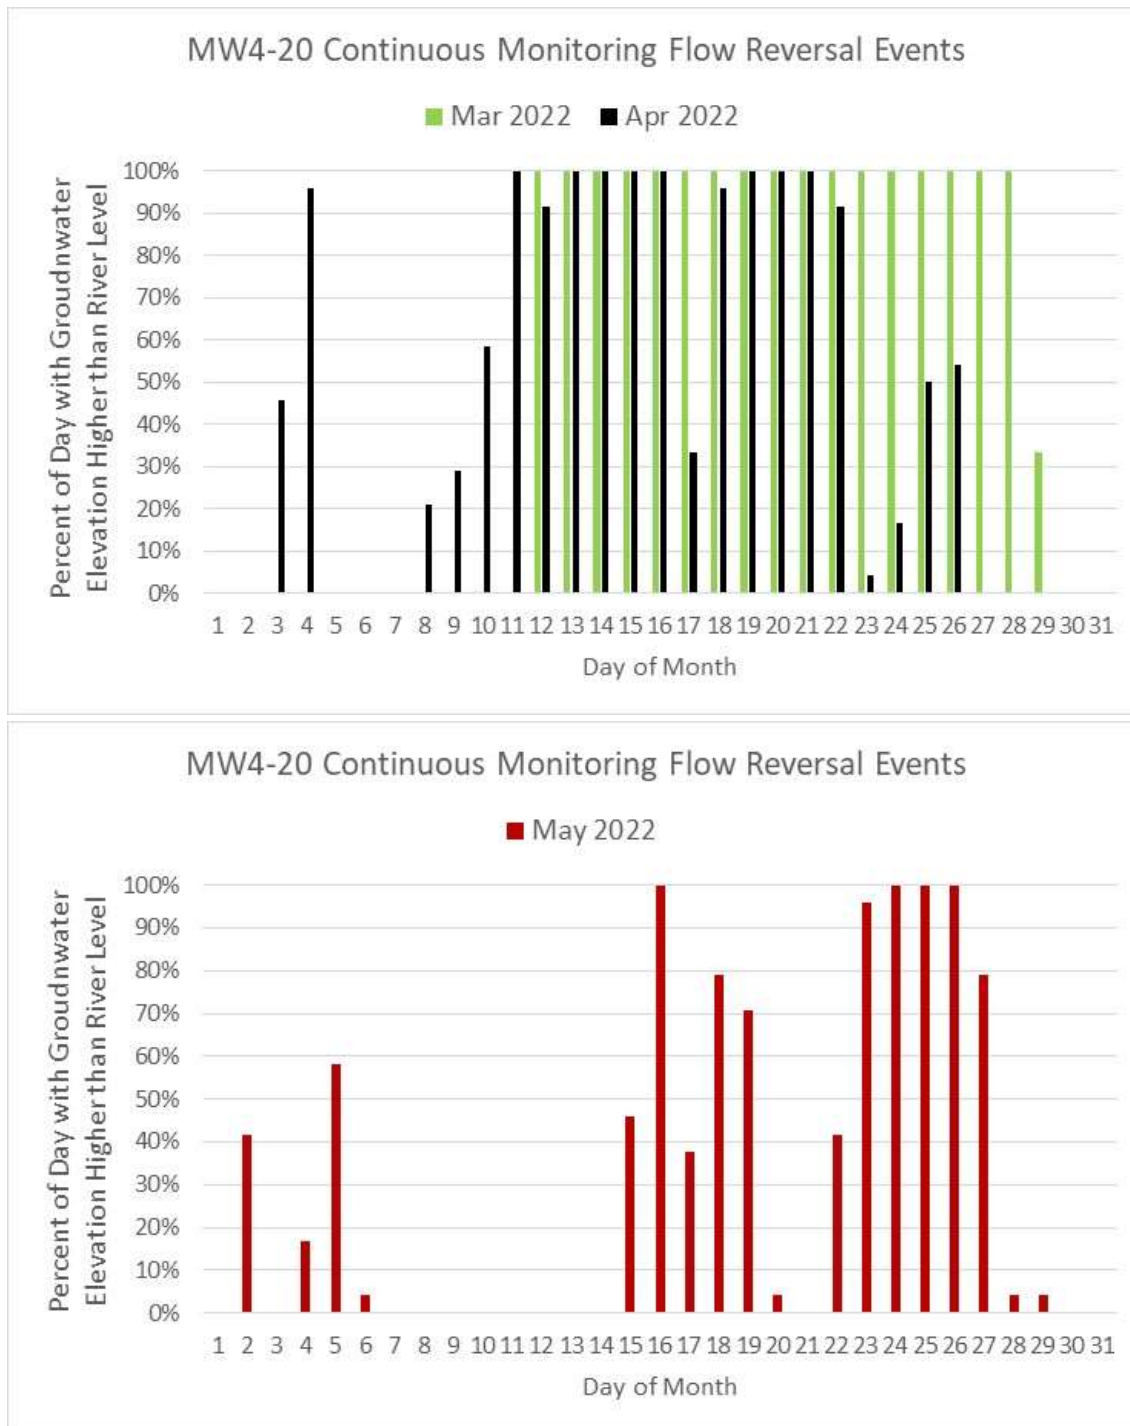
Figure 13. Graphs of daily frequency and duration of events for months where MW4-20 hourly groundwater elevations were above Hamilton Street Bridge river gage elevations.

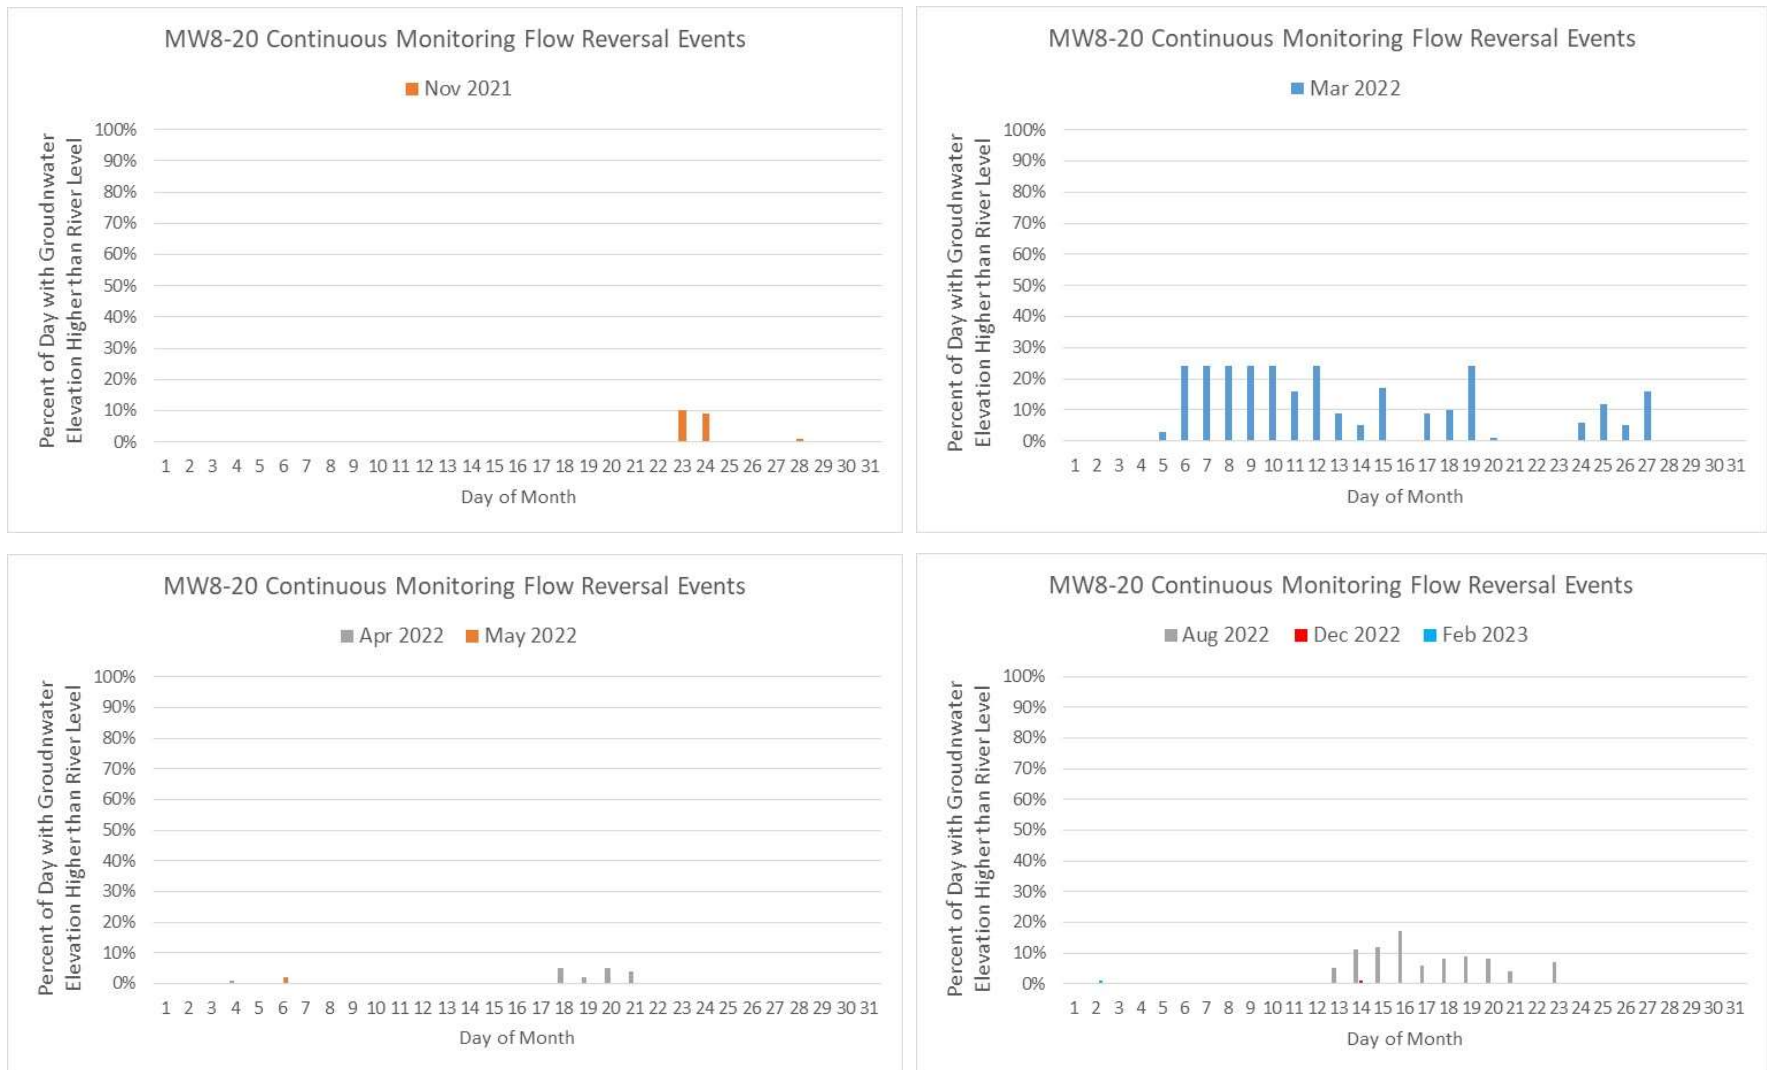
Figure 14. Graphs of daily frequency and duration of events for months where MW8-20 hourly groundwater elevations were above Hamilton Street Bridge river gage elevations.

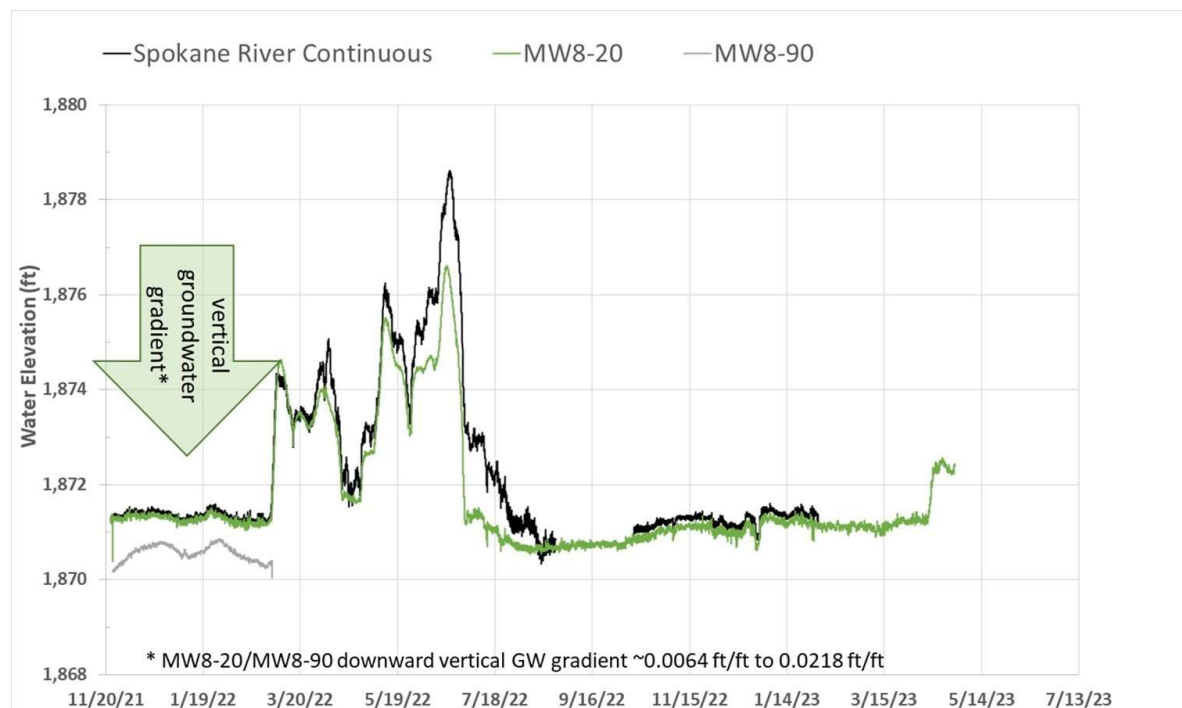
Continuously monitored vertical groundwater gradients data are available for clustered monitoring wells MW8-20/MW8-90 for the period 10:00 am on November 24, 2021 through 2:00 pm on March 2, 2022. The results are depicted in **Figure 15**, which shows that groundwater elevations at the shallower MW8-20 well location consistently were above groundwater elevations at the deeper MW8-90 well location (i.e., a consistent downward vertical gradient), which indicates that the river generally was losing to the aquifer for this period. The groundwater level difference between the two wells ranged from 0.45 ft to 1.53 ft, with an average difference of 0.71 ft. Downward vertical gradients were calculated relative to the differences between the screen center elevations for the two clustered wells (approximately 70 ft), and ranged from 0.0064 ft/ft to 0.0218 ft/ft, with an average downward gradient of 0.0102 ft/ft.

**Figure 15. Graph of continuous groundwater level monitoring data for clustered wells MW8-20 and MW8-90, showing a consistent downward vertical gradient for the period late November 2021 through March 2, 2022.**

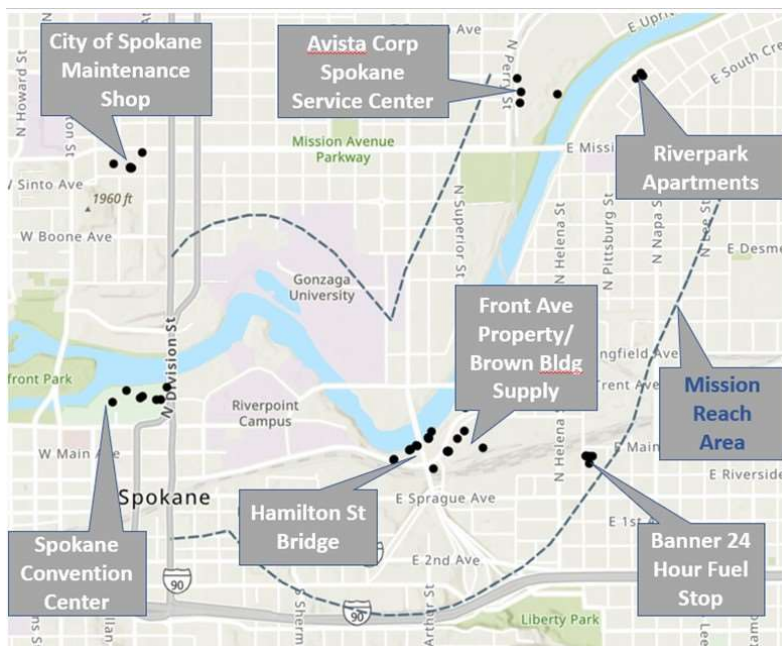
Of the twenty-two sites located within and near Mission Reach with known or suspected groundwater impacts, only seven sites had historical depth to groundwater data (refer to [Figure 17](#)):

**Figure 17. Sites within and near Mission Reach with historical depth to groundwater data.**

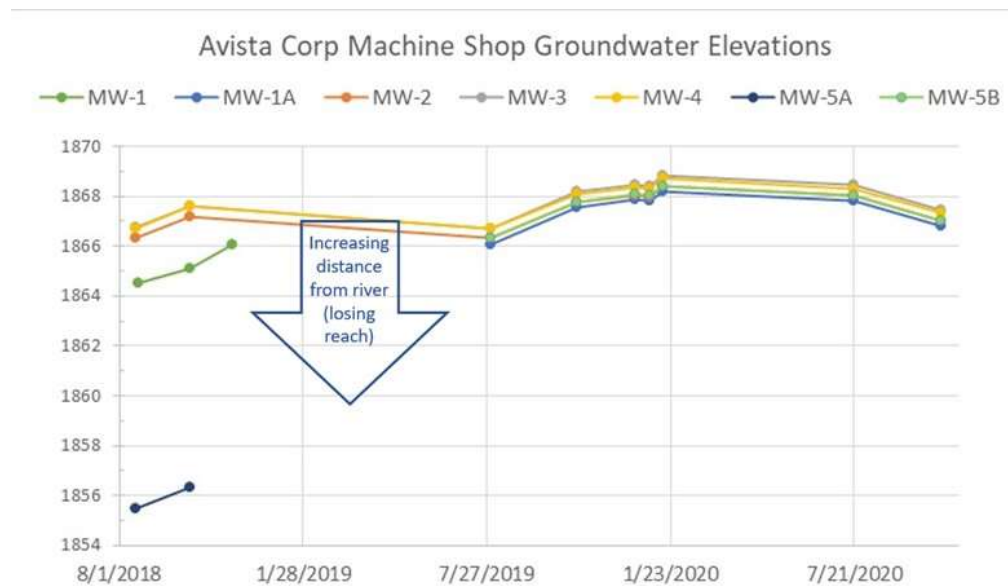
Figure 18. Historical groundwater elevation data for Avista Corp Machine Shop site, August 2018 through October 2020.

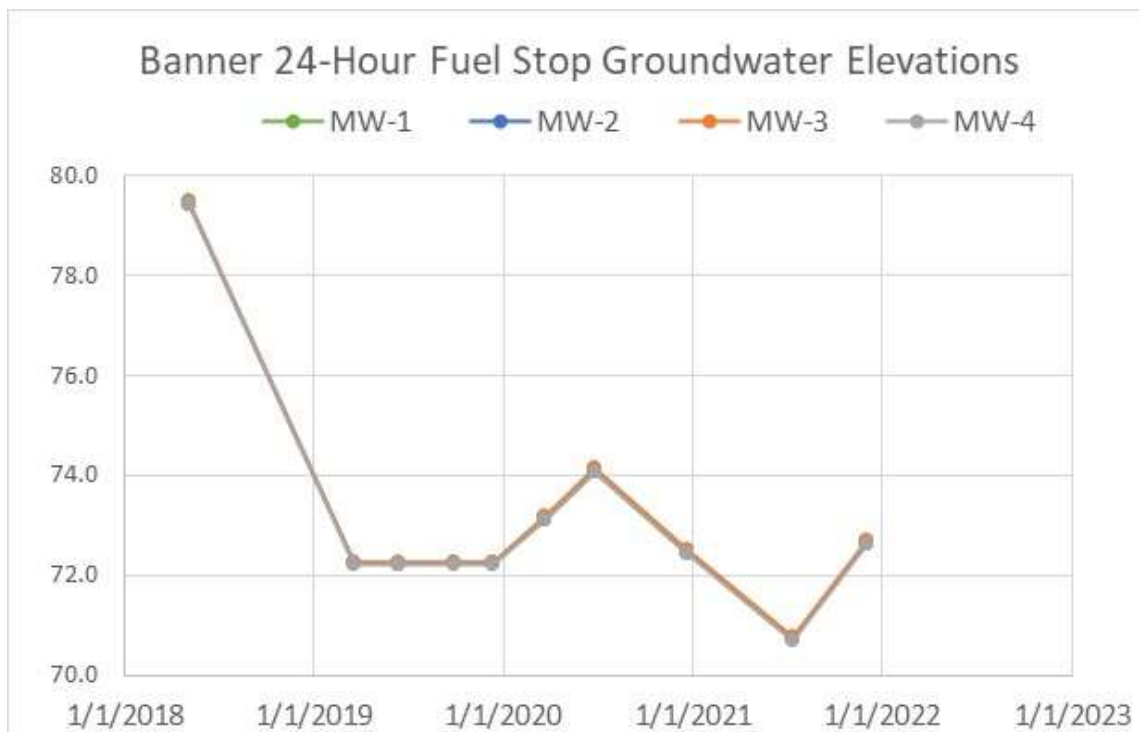
Figure 19. Historical groundwater elevation data for Banner 24 Hour Fuel Stop site, May 2018 through December 2021.

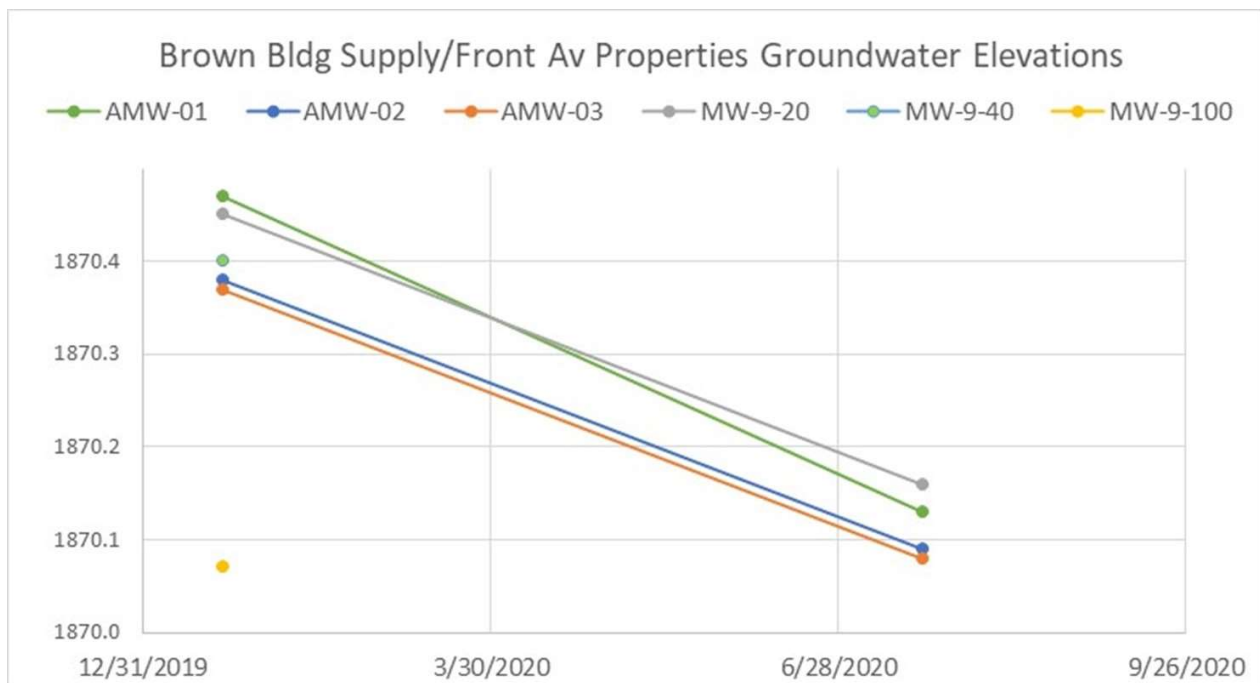
- Groundwater flow was generally towards the river for both monitoring events; however, the horizontal groundwater gradients are very low (approximately 0.00011 ft/ft to 0.00023 ft/ft).
- The January 2020 data for the MW9 clustered wells shows a downward vertical groundwater gradient.

Figure 20. Historical groundwater elevation data for Brown Building Supply/Front Street Property site, January and July 2020

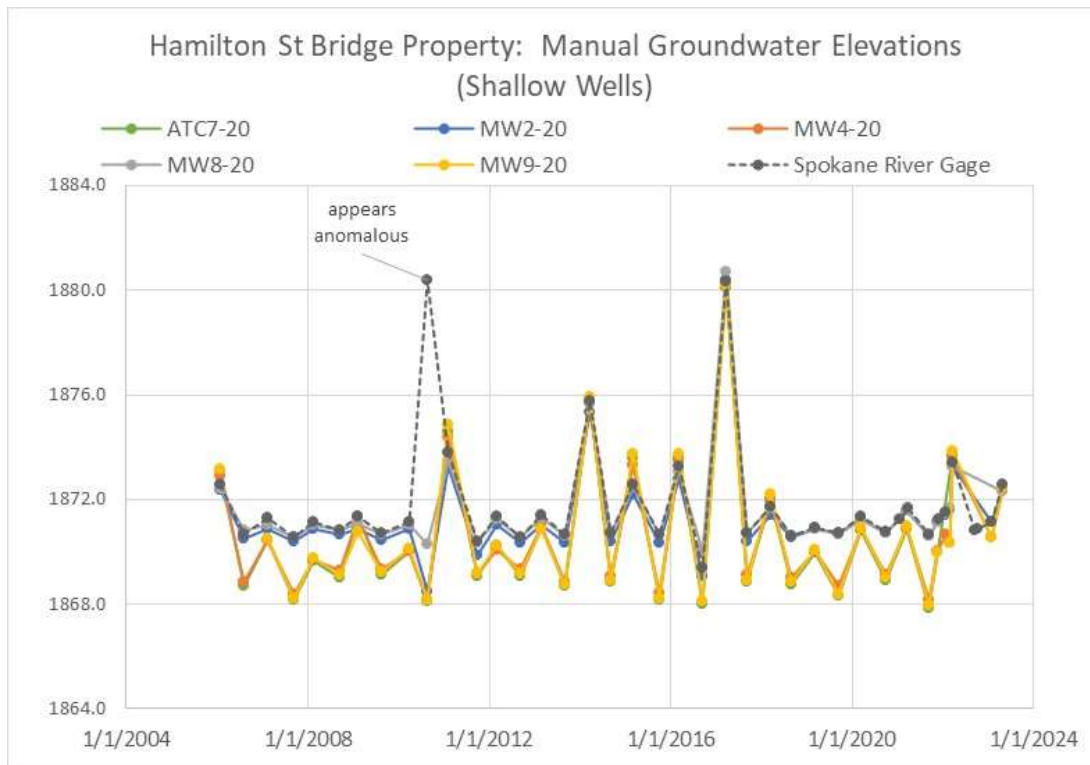
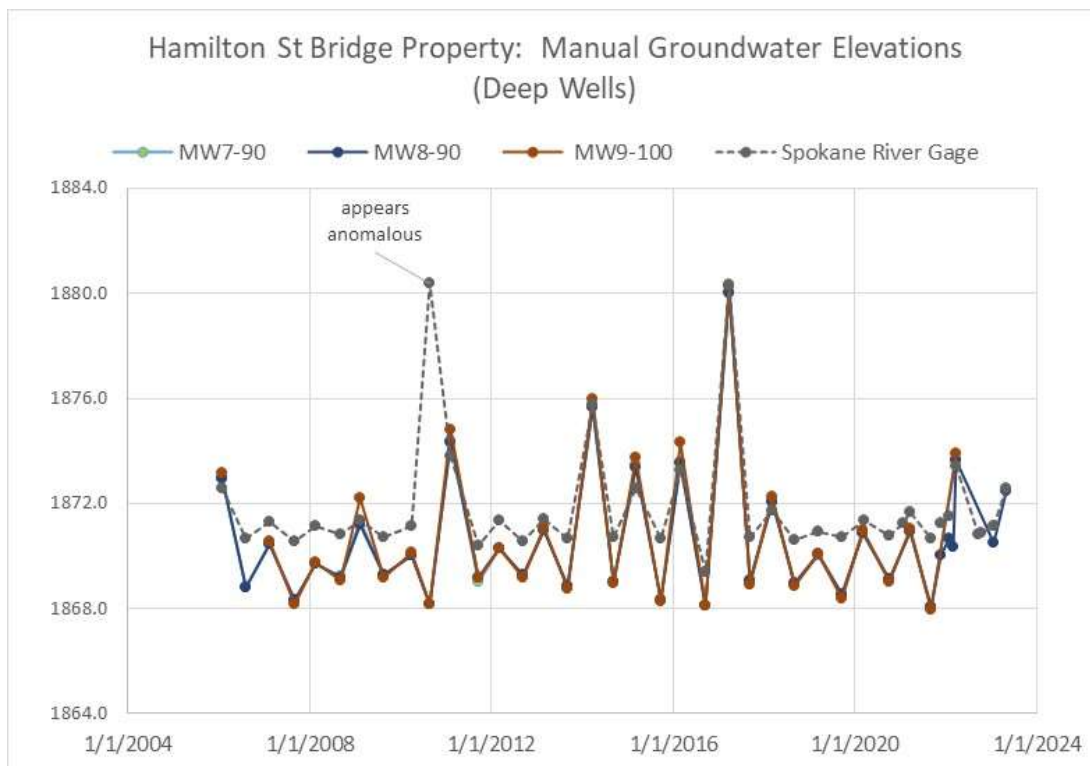
- There are 31 to 35 paired readings between the river gage and the three shallow monitoring wells located closest to the river (MW2-20, MW4-20 and MW8-20). For the majority of these observations, surface water levels are above groundwater levels, indicating that the reach is generally “losing”. But as noted in Section 3.1 above, there is approximately a 50% chance or less of observing a flow reversal/gaining event when relying on monthly or quarterly depth to groundwater data that are collected manually rather than continuously.

Figure 21. Historical manual groundwater elevation data for Hamilton Street Bridge site shallow and deep monitoring wells, January 2006 through March 2022.

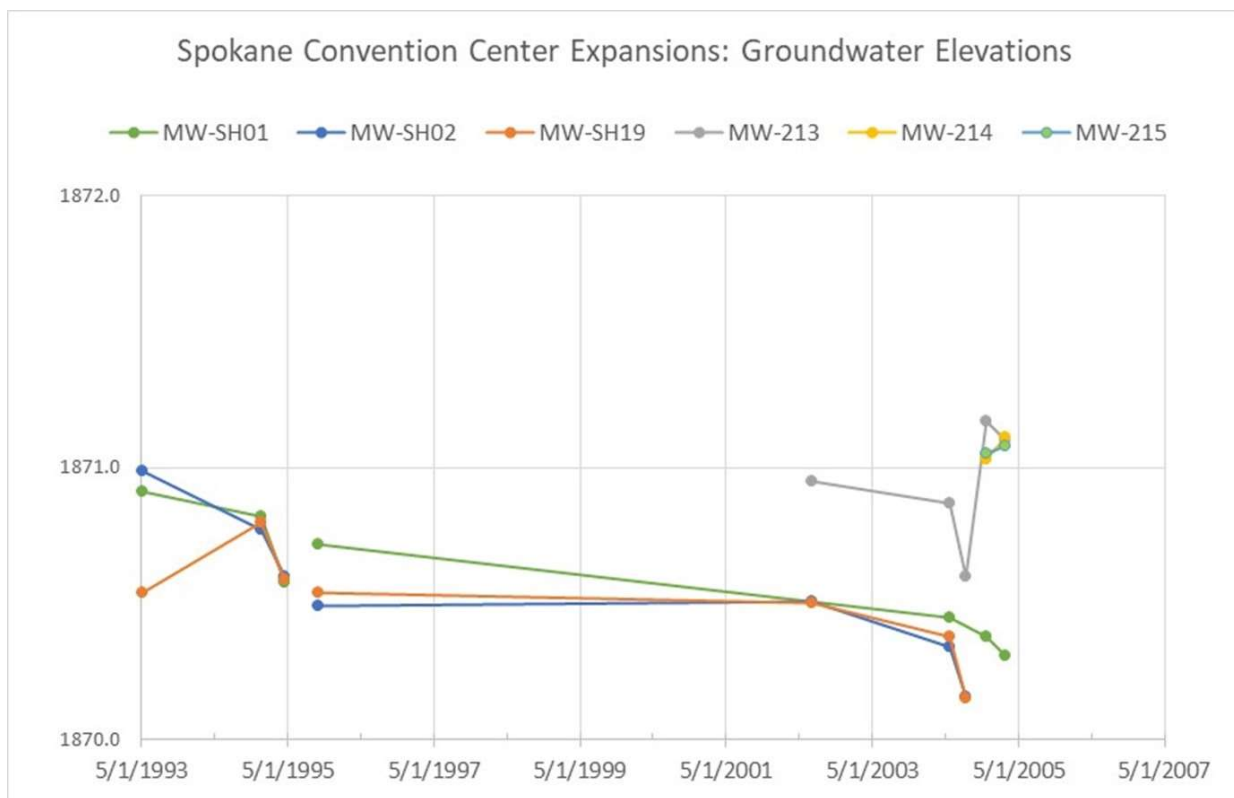
- This site is situated on a shallow basalt ridge.
- Monitoring wells appears to be installed in a shallow weathered basalt interval.
- Although shallow groundwater flow appears to be primarily away from the river (losing reach), groundwater likely is perched within the weather basalt zone; consequently, groundwater may be stagnant.

**Figure 22. Historical manual groundwater elevation data for Spokane Convention Expansion site, May 1993 through February 2005.**
