# Groundwater Flow Direction Evaluations in the Spokane River, Mission Reach

Prepared for:  
Spokane River Regional Toxics Task  
Force

21 June 2023  
PRELIMINARY DRAFT

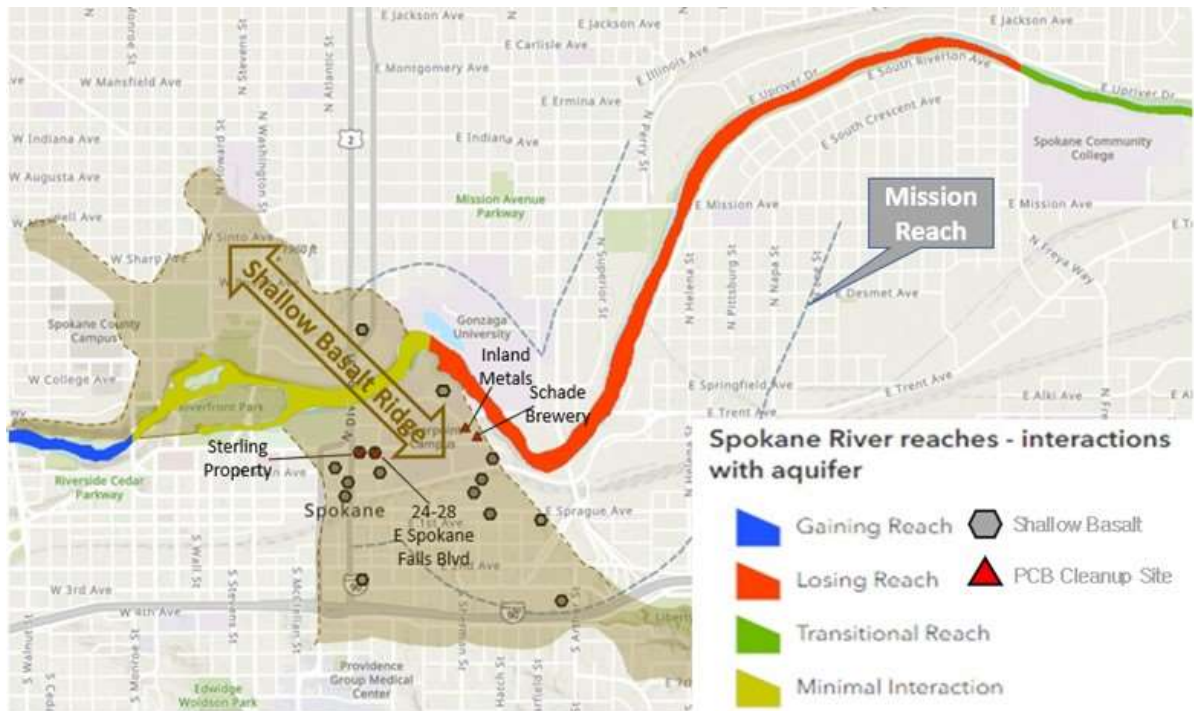
- **City of Spokane sewer infrastructure.** A west-to-east trending 60-inch diameter sanitary sewer line runs through the Hamilton Street Bridge property, south of the artesian point source, and near PCB cleanup sites Schade Brewery and Inland Metals (refer to [Figure 25](#)). The bedding material surrounding sewer infrastructure can function as a preferential pathway for subsurface flow, especially if embedded within a relatively finer-grained material such as a basalt or weathered basalt. The artesian point source may have a connection to the sewer line bedding if the point source serves as an area drainage feature for sections of the line that are carved within the basalt ridge. However, the depth of the sewer line may rule out a possible connection with the artesian point source and should be investigated further.

- **Trent Tunnel.** This structure is located due west of the artesian point source and is constructed within the basalt ridge. Drainage management for the tunnel currently is unknown, but the tunnel's proximity to the artesian point source/well suggests that there could be a connection that warrants additional investigation.

Figure 23. Location of artesian point source/well relative to shallow basalt ridge, former river bank (vintage 1910)/fill zone, 60-inch sanitary sewer line and Trent Tunnel (lower figure is modified from State of Washington Department of Ecology, July 2004).
