MACKNER SCALES CLEANUP

ELLENSBURG WASHINGTON

CLEANUP CHALLENGES

REMEDY SOLUTION

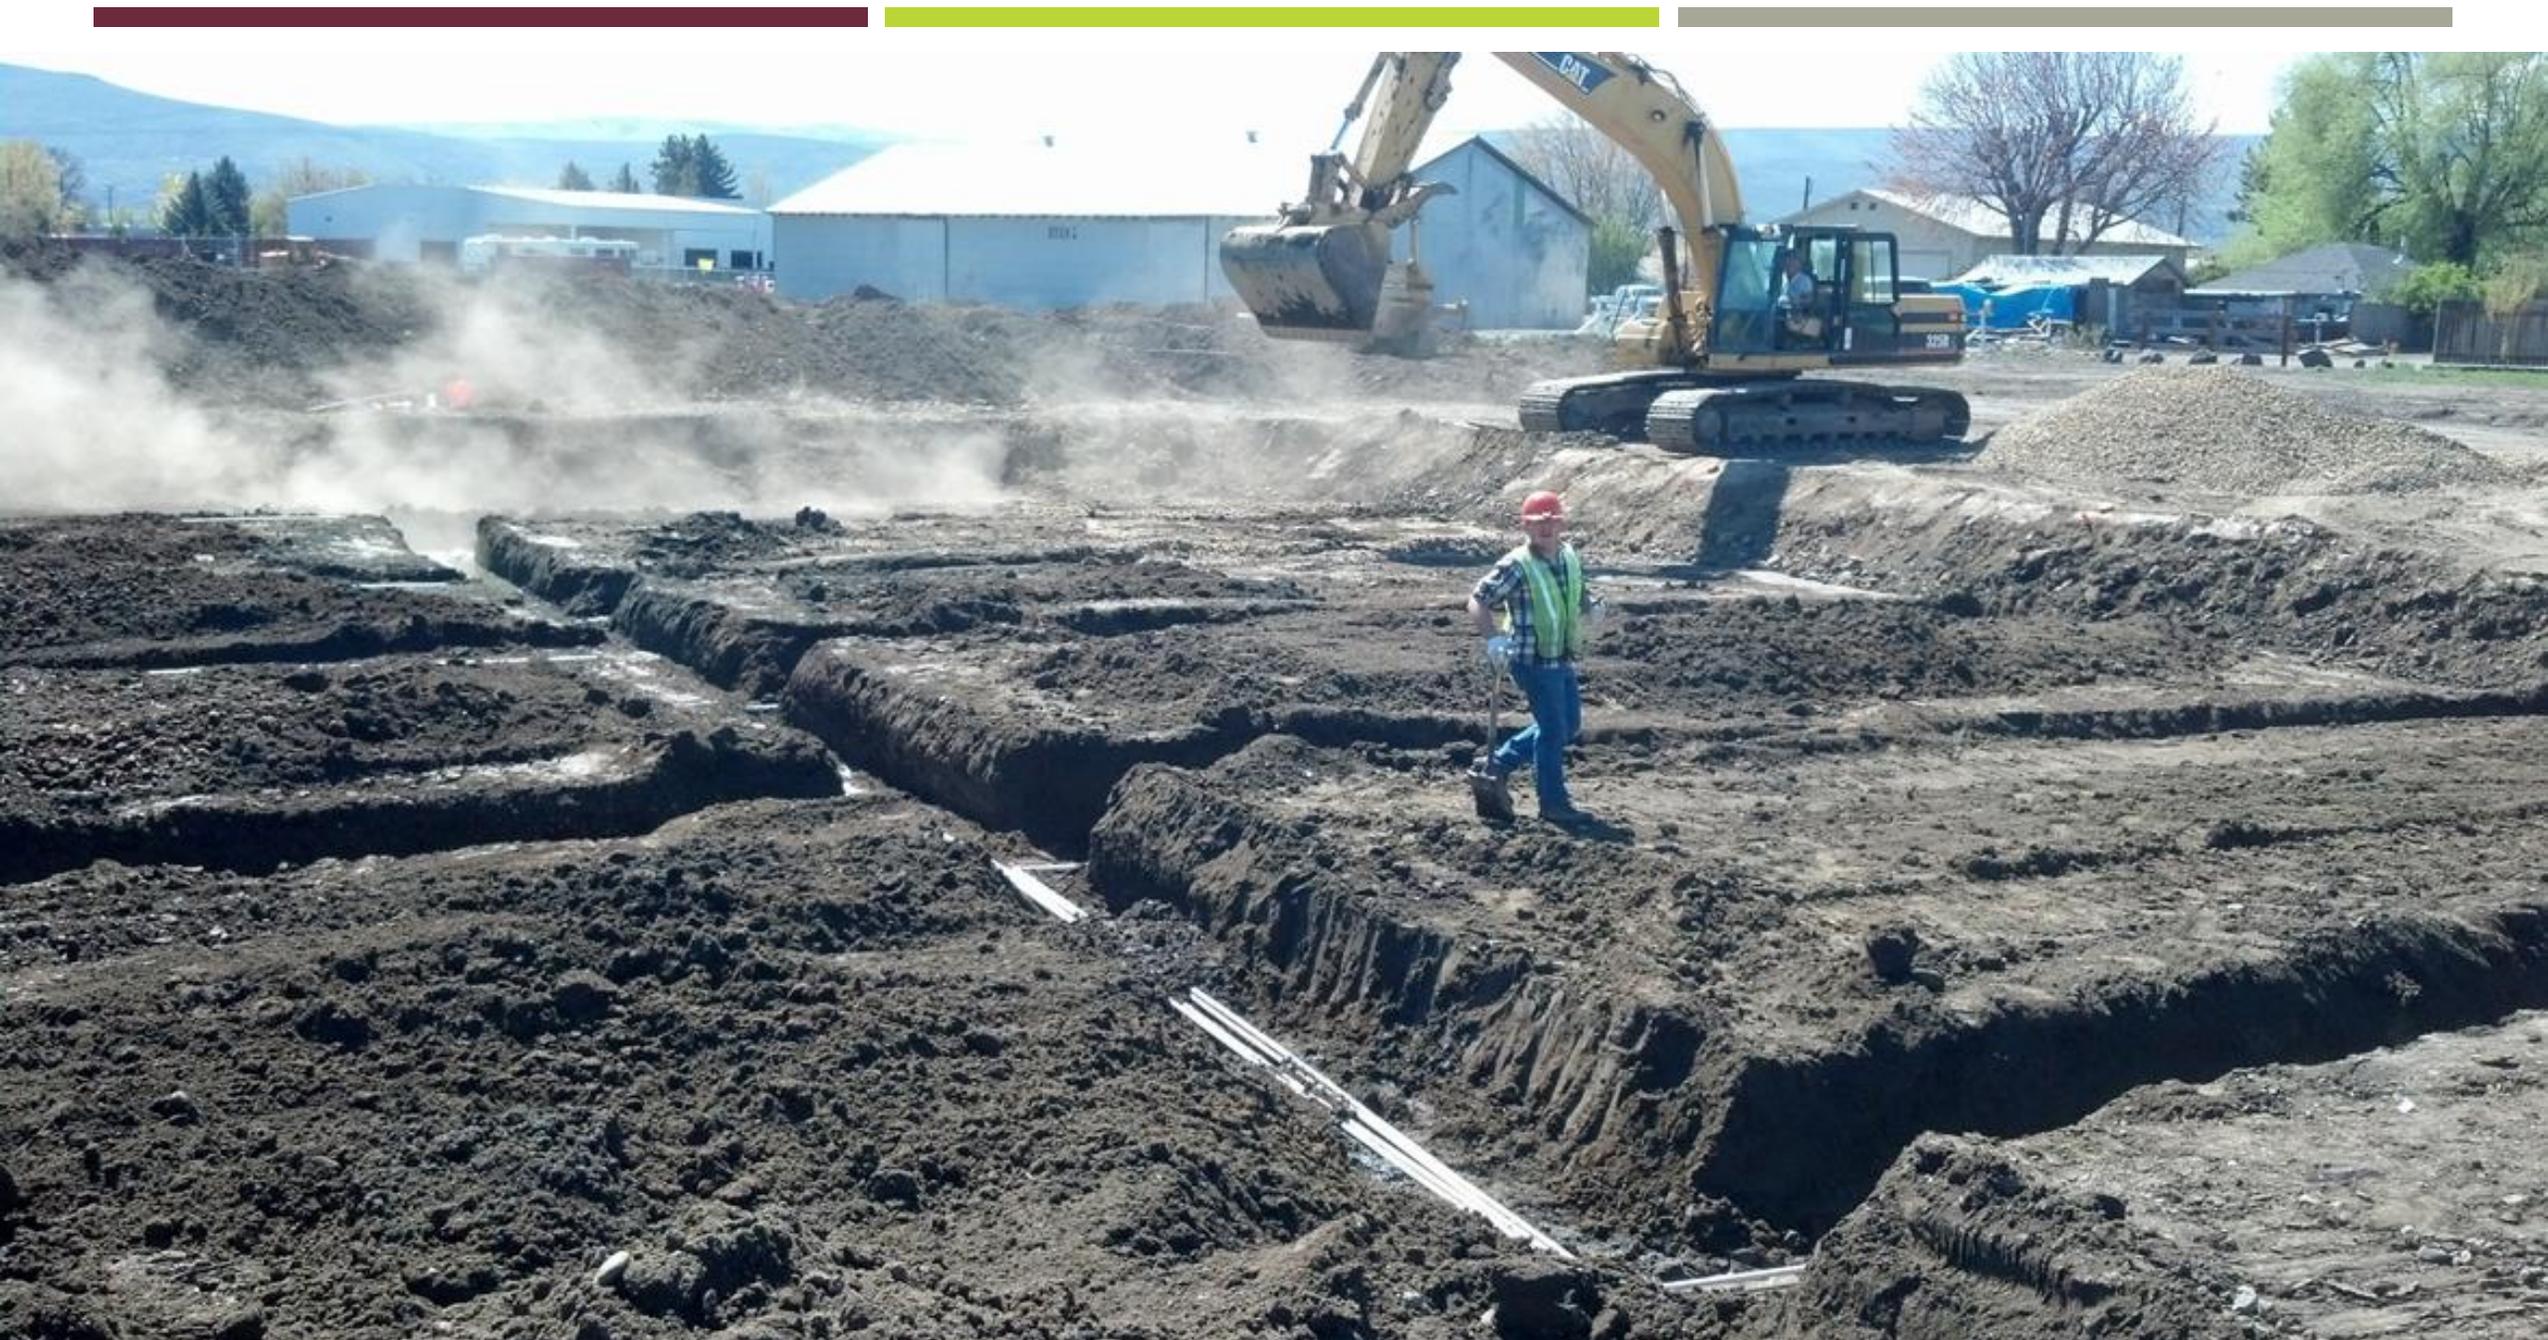
- Use the building design as a protective cap.
- Non-contaminated overburden soil removed and stocked piled
- Hot spot removal under the building
- Lance injection of chemical oxidants
- Infiltration pipe gallery for subsequent slug injection
- Compliance Monitoring
