Lacamas Creek Watershed

Source Assessment Study Goals

2021 Source Assessment Bacteria Monitoring

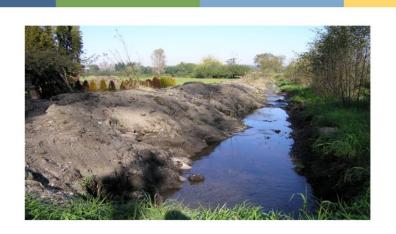
What's the Problem? Erosion on stream bank increases sediment in the waterway.
