# Salmon Habitat Protection and Restoration Strategy WRIA 12

NOVEMBER 13, 2019

# What is the Strategy?

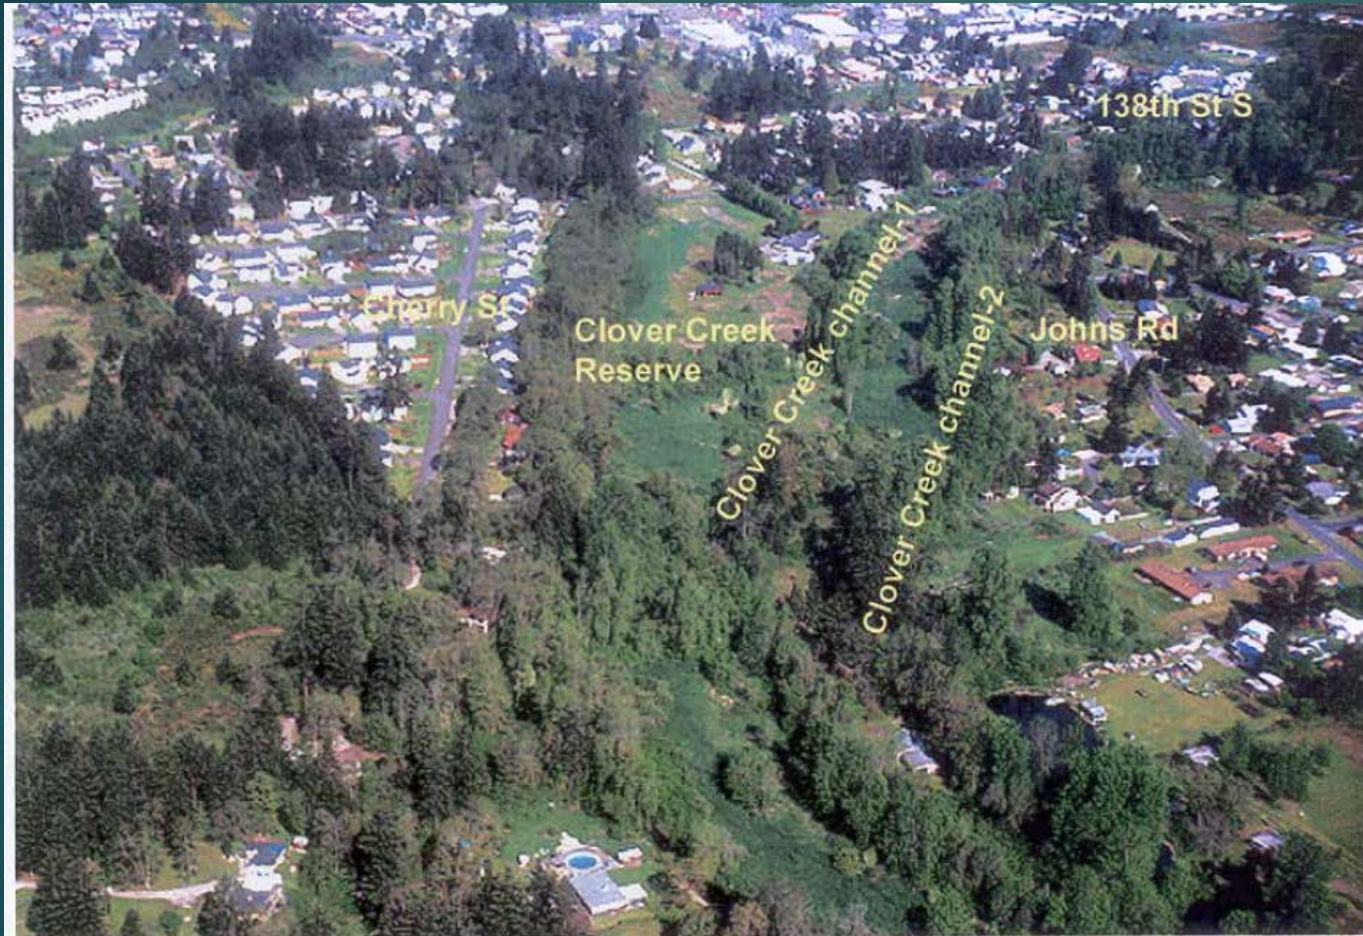
1895- one mile of Clover Creek between Golden Given and 138<sup>th</sup> street was rechanneled into 2 large irrigation canals to provide water for an extensive hop farming operation

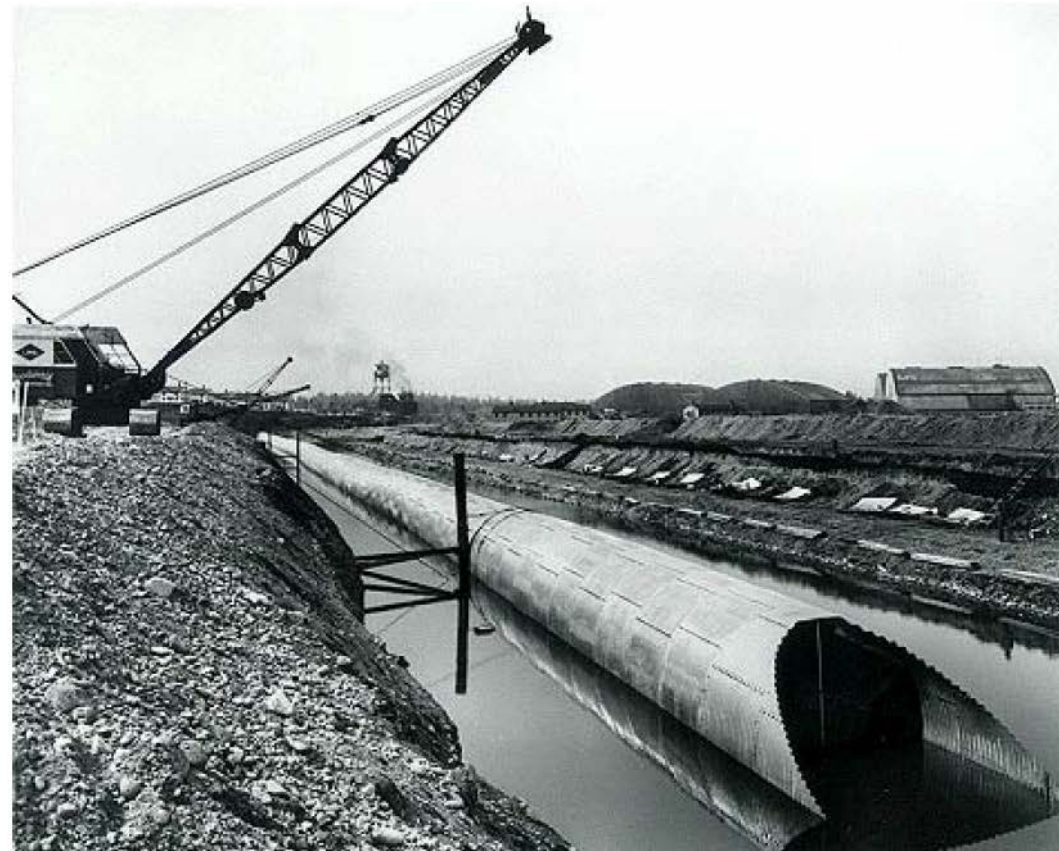
Figure 14. The McChord Airbase channel dredged in 1938 with one of the **two 12-ft diameter culvert pipes, 1400 ft long, rolled into place, courtesy of the Tacoma public Library**

- ▶ 1940's McChord air force base officially dedicated by federal government- sections of clover creek were extensively dredged, channelized and diked
- ▶ 1938-1940- McChord Airfield- sections of clover creek on the base were relocated to allow for construction of runways and other facilities. Rechanneled creek now flows through two 12' diameter culverts under runway for 0.6 miles

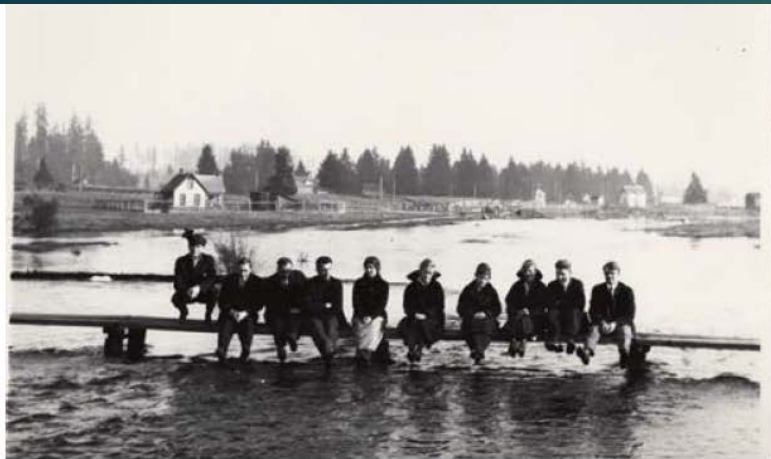
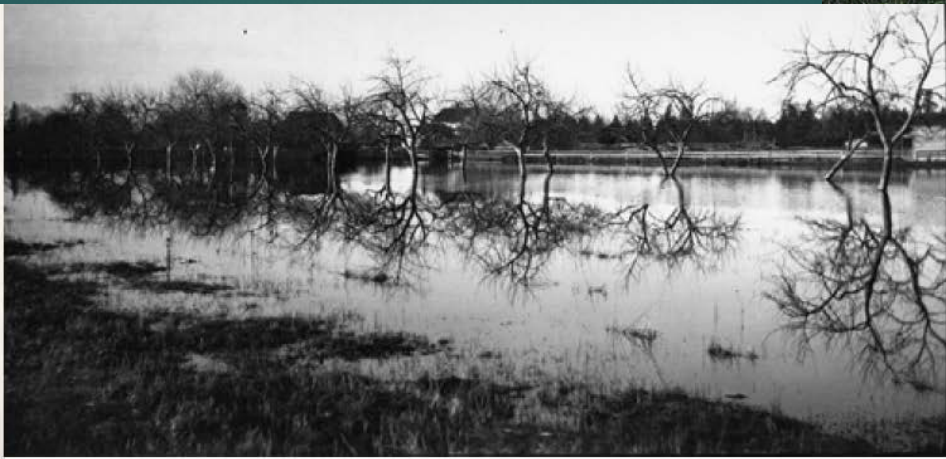
Figure 1 and Figure 2. Flooding pictures taken near Pacific Lutheran University during the 1930's. Clover creek at that time flowed through a riparian line of apple trees planted around 1892. Courtesy of PLU Archives.

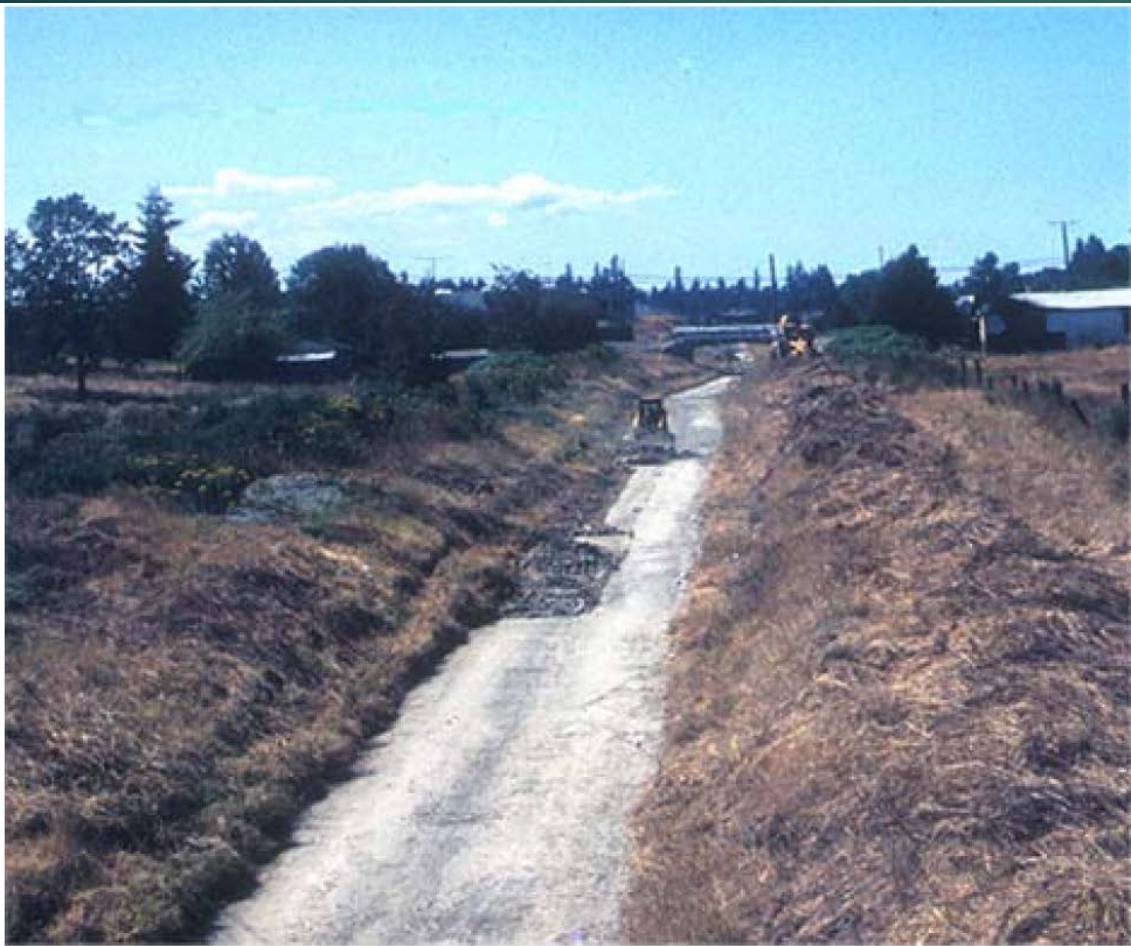
West view along Clover Creek in Parkland, WA near C St S during a Pierce County cleanup, late summer 1973 (photograph by Fred L Tobiason).

1969- Pierce County increased the width and depth of the Clover Creek Channel and asphalted the streambed from Pacific Ave S to B St. S

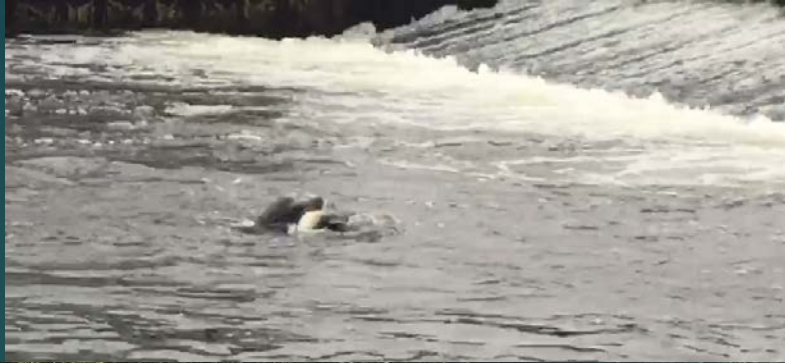
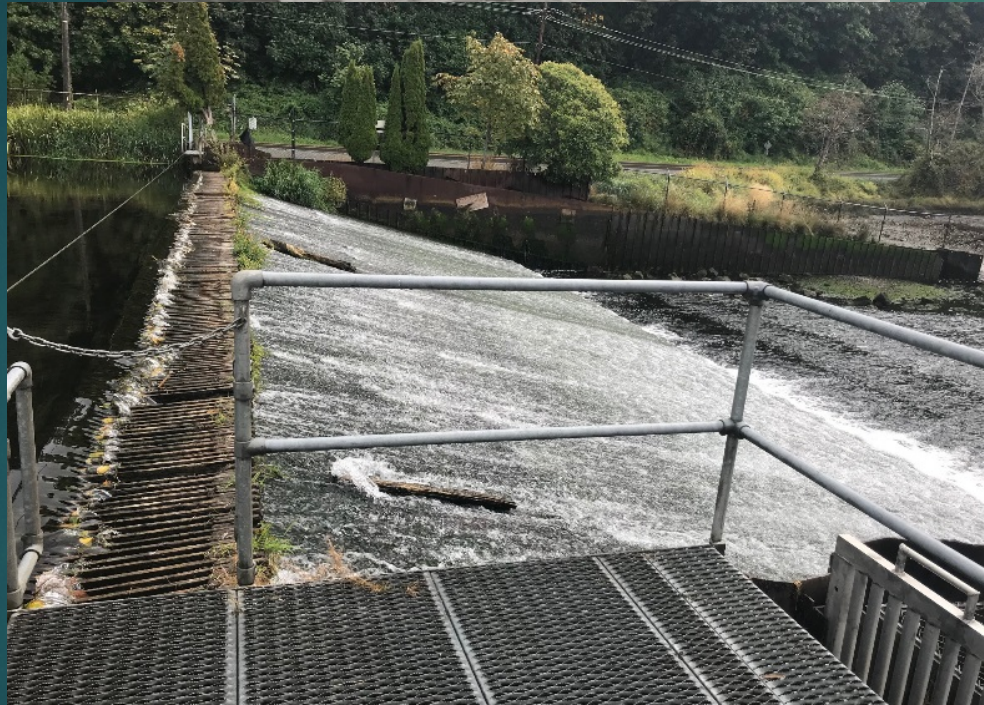
# Chambers Dam: Fish Passage

Delayed upstream adult fish migration,  
increased predation, poor juvenile downstream  
passage and reduced survival

Fish ladder not functioning properly

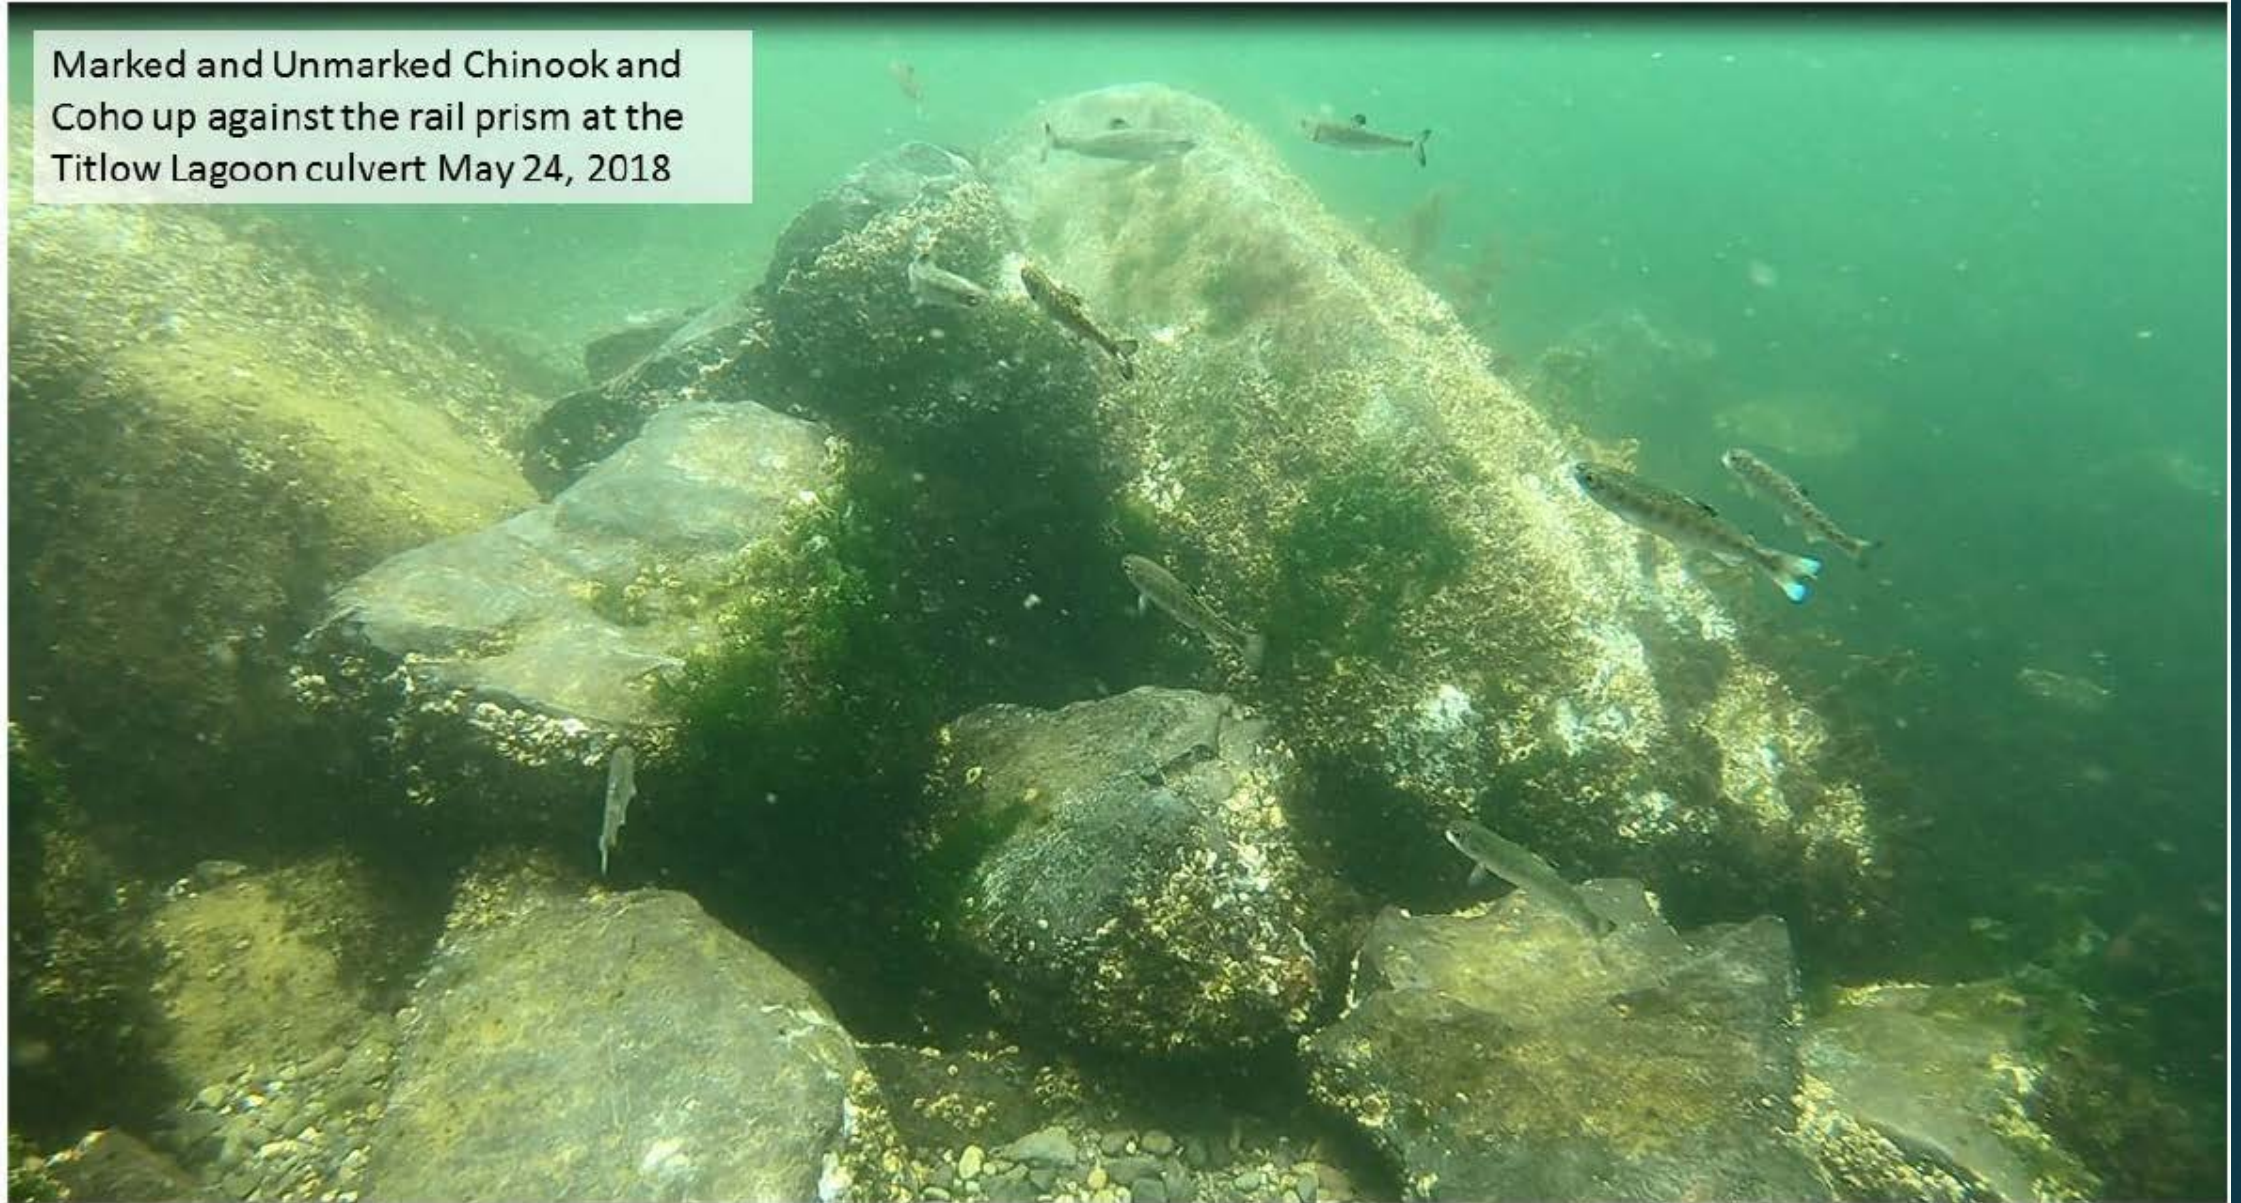
Marked and Unmarked Chinook and  
Coho up against the rail prism at the  
Titlow Lagoon culvert May 24, 2018

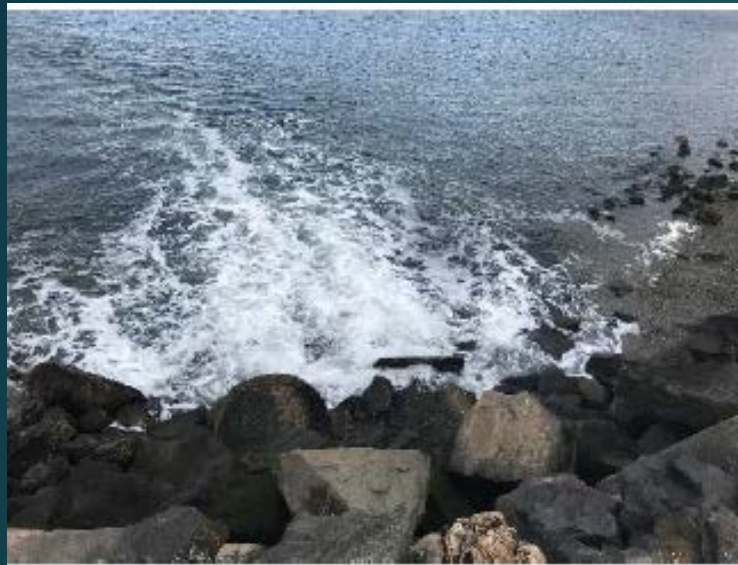
*High velocity water through the culvert limits fish passage at high tide*

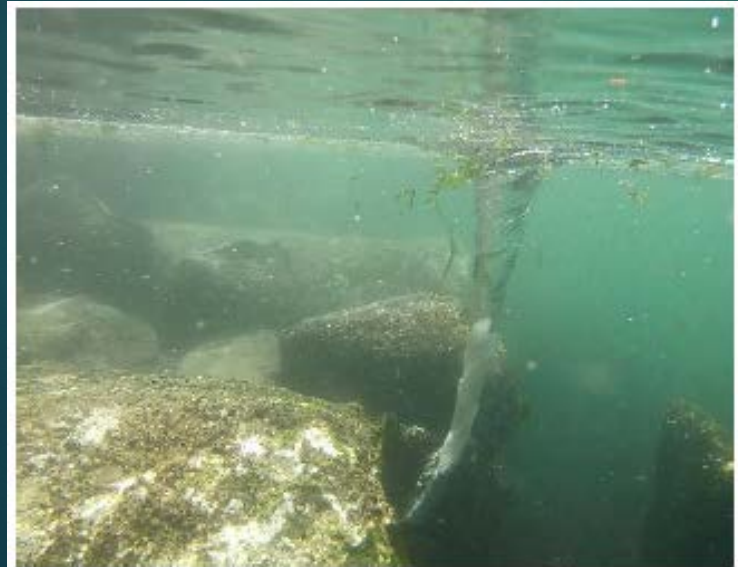
*A hydraulic head (whirlpool effect) limits fish passage at high tides*

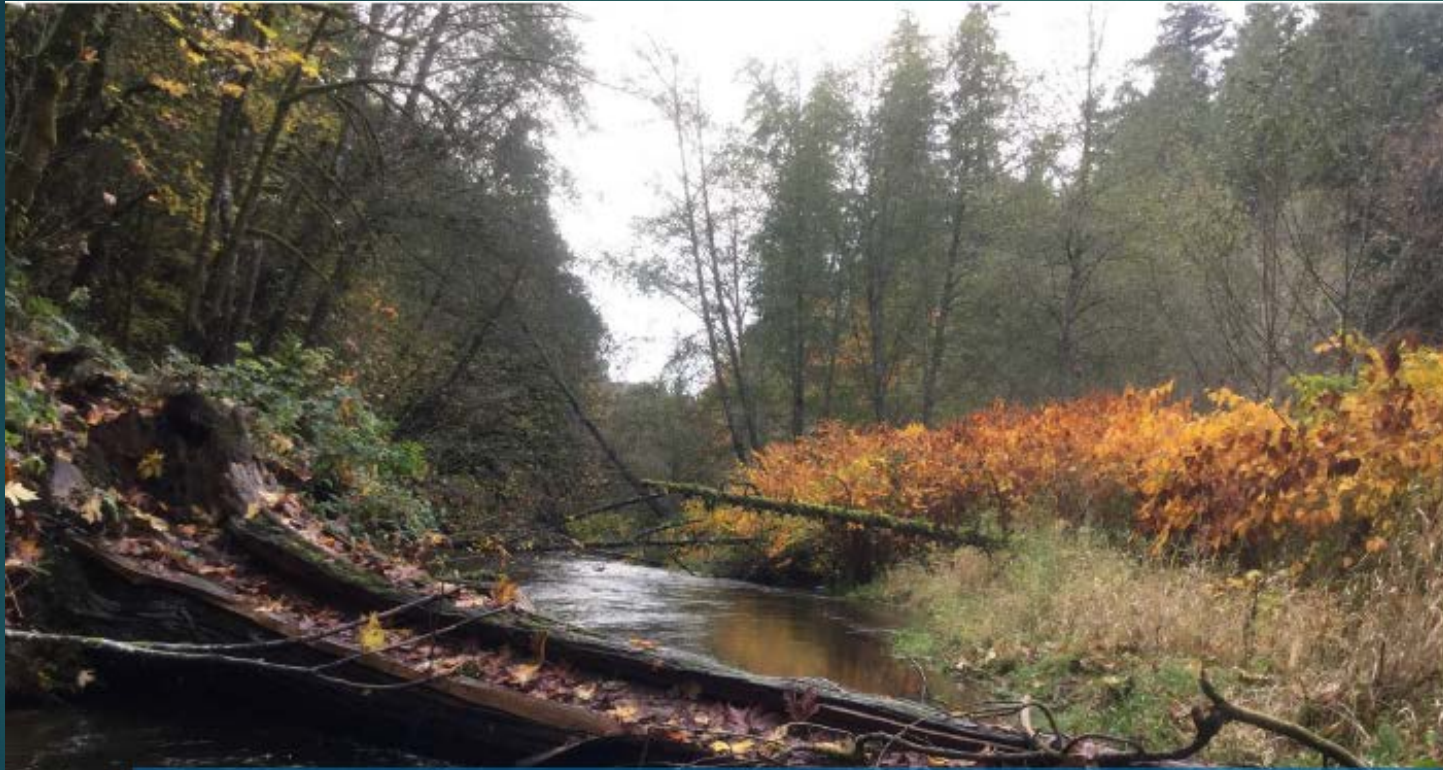
An evaluation of physical habitat within Chambers Creek to identify potential habitat deficiencies and guide restoration recommendations.

A combination of field surveys and remote sensing data (LiDAR) were used to evaluate habitat conditions.

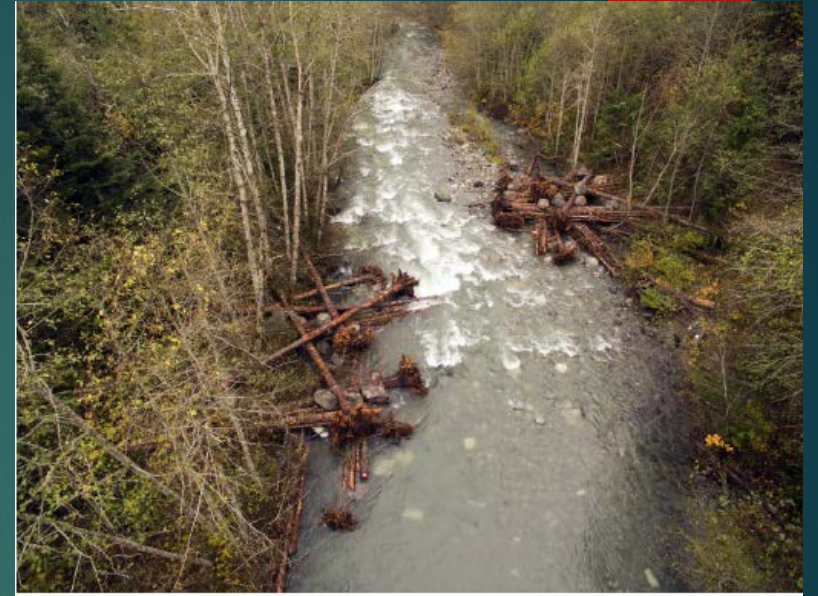
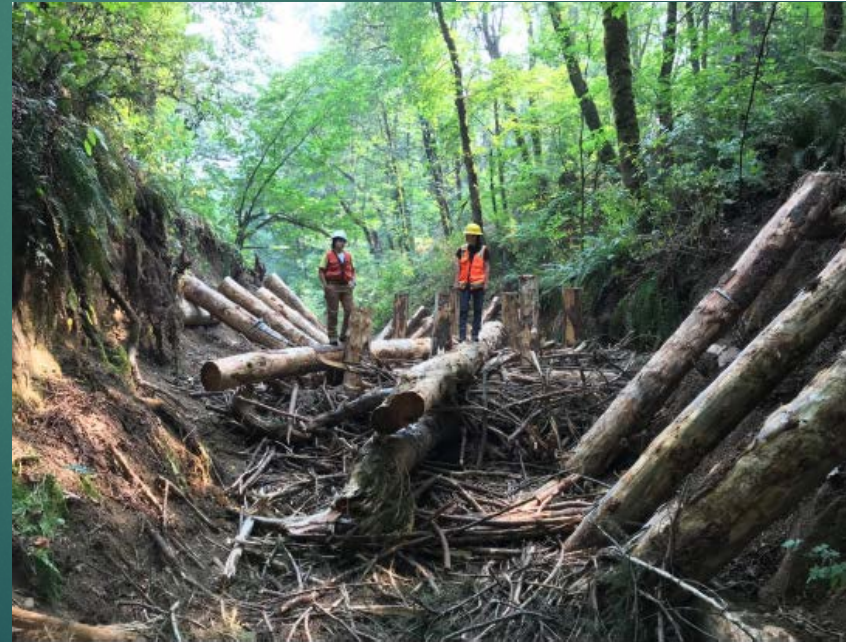
Helicopter ELJs

Ravine treatment in Peach Creek to stabilize stream banks and bed to retain sediment

Ex. Clarks Creek ravine treatment

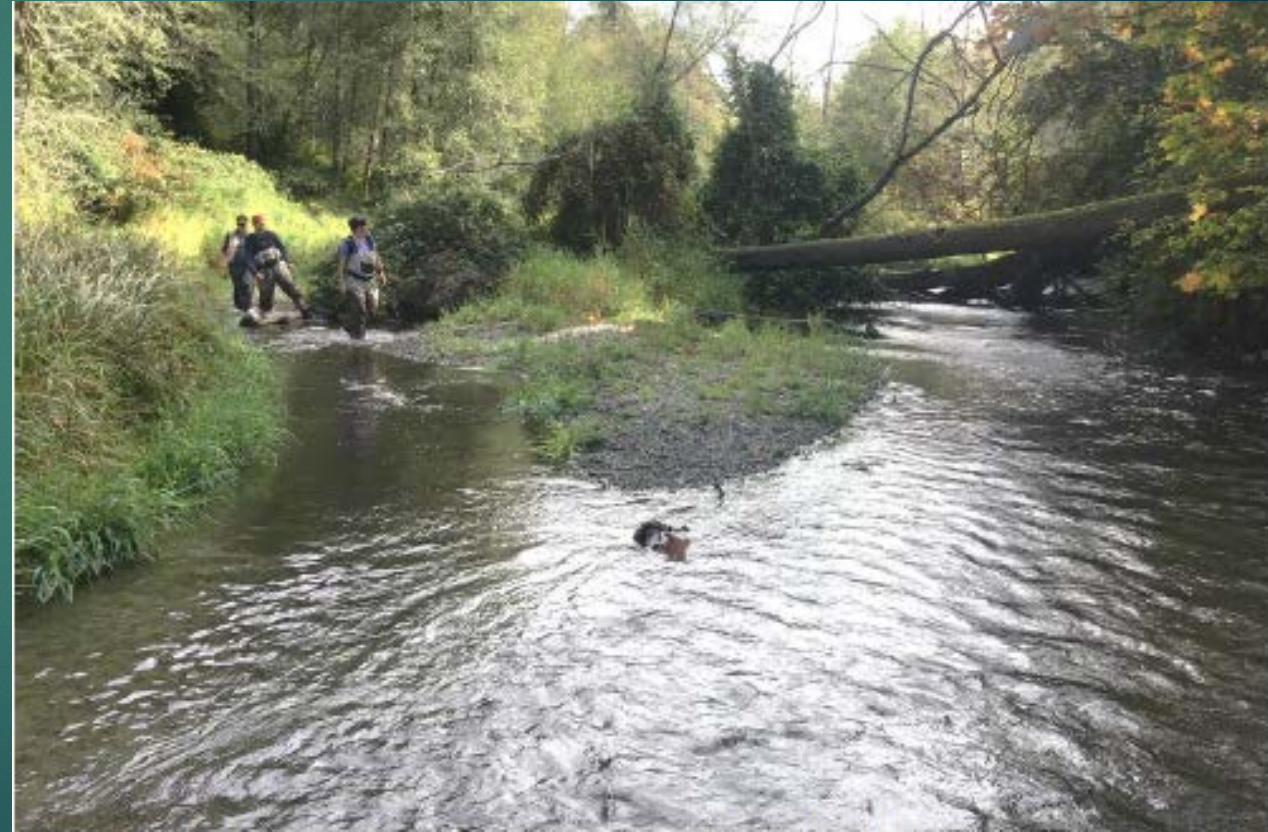
Figure 12 Field photo of Chambers Creek geomorphic reach 3, looking upstream (10/2018).

- ▶ Reaches 1 and 2- **RCG impairs riparian functions**- including shading, LWD recruitment and inputs of organic matter
- ▶ Reaches 3-6 -trees are present along the stream throughout almost the entirety of the reaches, but **invasive species threaten the long term health and degrade the overall riparian vegetation condition**. Invasive species are present at considerable levels in every reach, to the extent that invasive species were found at every riparian sampling plot except one during study.
