**Geotechnical Analysis and
Levee Certification Report
Revised**

North Shore Levee West Segment
Hoquiam, Washington

File No. 23944-001-00

March 17, 2020

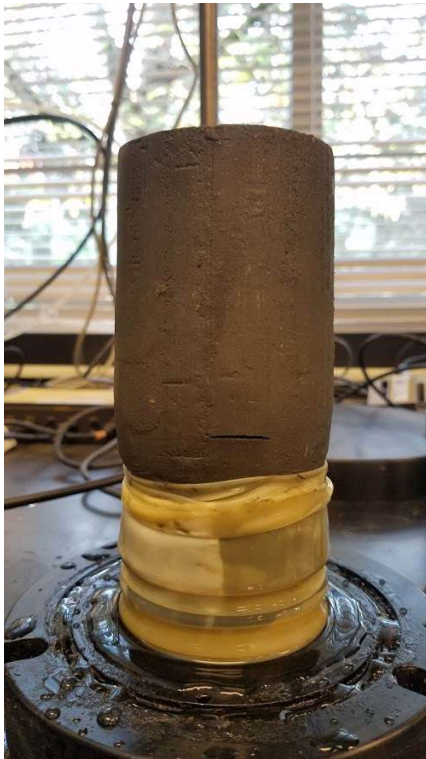
Figure A-19

SPECIMEN AT FAILURE

DESCRIPTION Silt with sand and o.m. (ML)

AXIAL STRAIN AT FAILURE: 13.6

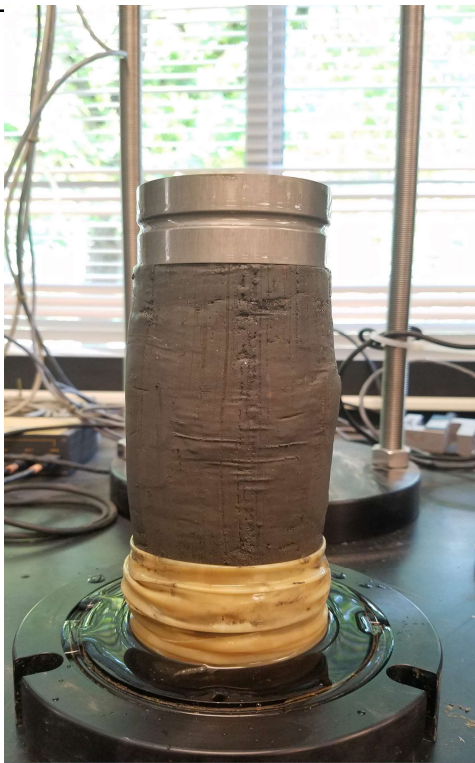
FIGURE A-20

SPECIMEN AT FAILURE

DESCRIPTION Elastic silt with occasional sand and o.m. (MH)

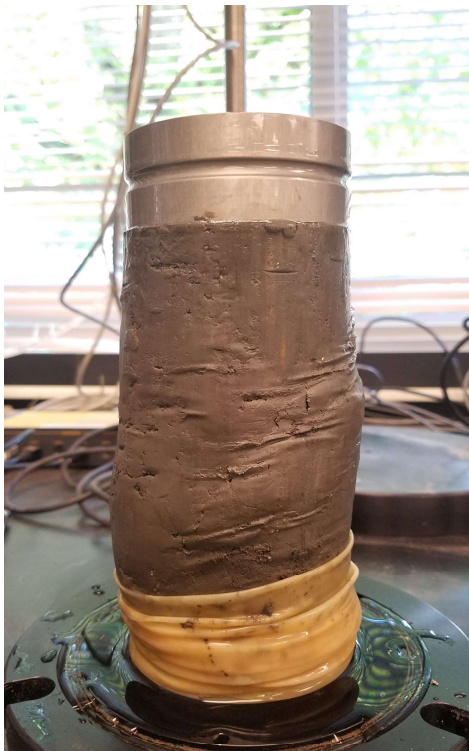
FIGURE A-21

SPECIMEN AT FAILURE

DESCRIPTION Silt with occasional o.m. (ML)

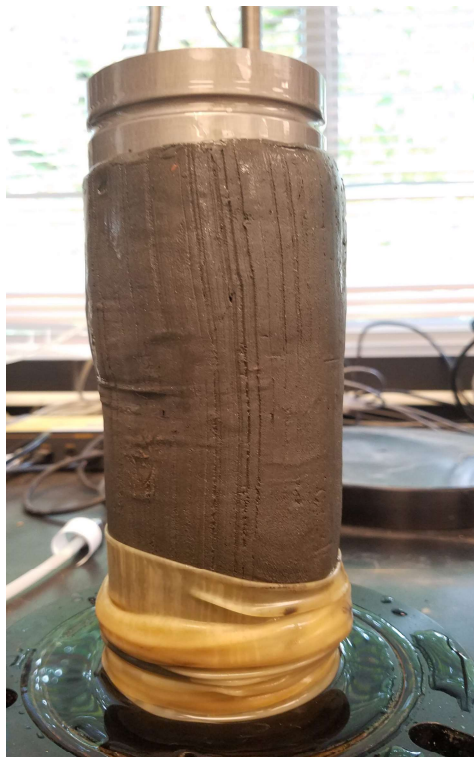
FIGURE A-22

SPECIMEN AT FAILURE

DESCRIPTION Elastic silt with occasional o.m. (MH)

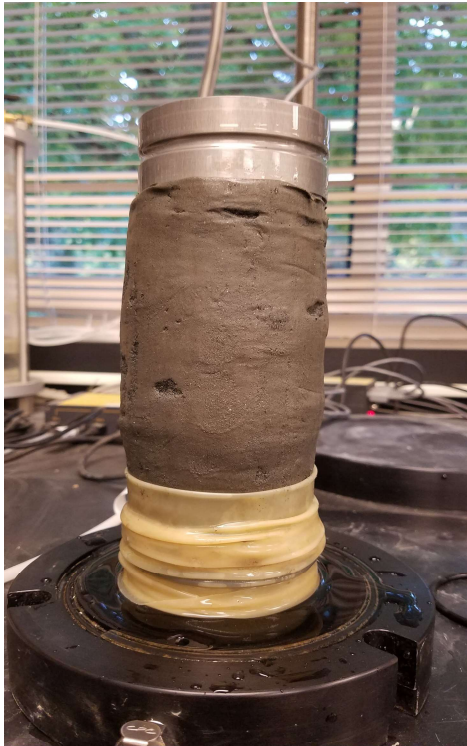
FIGURE A-23

SPECIMEN AT FAILURE

DESCRIPTION Silt with sand lense (ML)

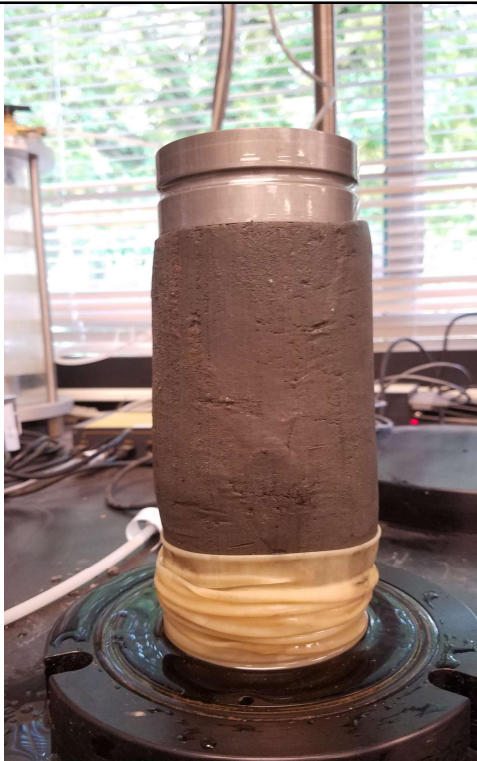
FIGURE A-24

SPECIMEN AT FAILURE

DESCRIPTION Sandy silt (ML)

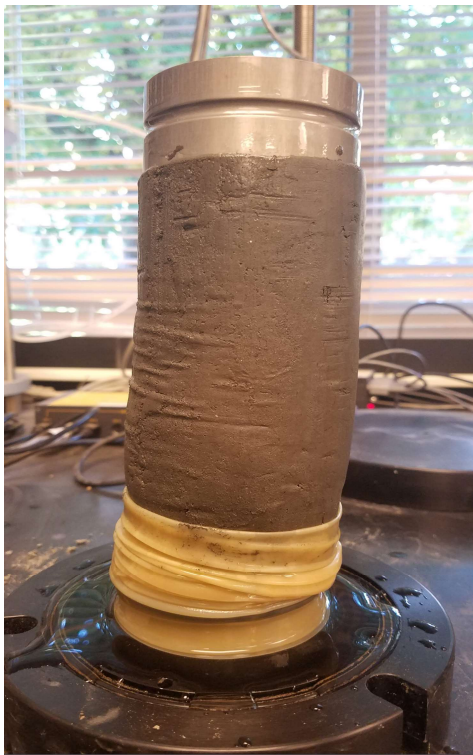
FIGURE A-25

SPECIMEN AT FAILURE

DESCRIPTION Elastic silt with sand and o.m. (MH)

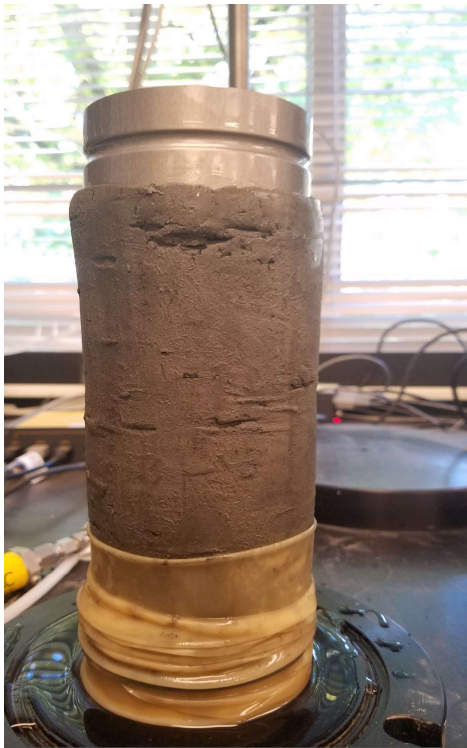
INITIAL	HEIGHT (in): 6.00	
	DIAMETER (in): 2.82	
	HEIGHT/DIAMETER: 2.1	
	WATER CONTENT: 59	
	WET DENSITY (pcf): 106.9	
	DRY DENSITY (pcf): 67.1	
VOID RATIO: 1.5		
BORING ID : GEI-3		SAMPLE NO: 6
DEPTH/ELEV(ft) : 30		DATE: 10/29/19
TECH: SAS		CHECKED: SAS
REMARKS:Gs assumed 2.7; $\gamma_{water} = 62.4$ pcf		
CELL PRESSURE: 20.8psi		
ASTM D-2850

SPECIMEN AT FAILURE

DESCRIPTION Elastic silt with sand and occasional o.m. (MH)

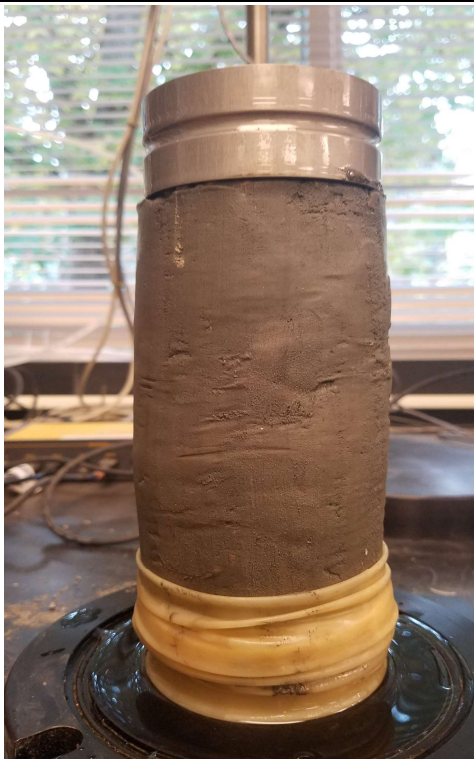
FIGURE A-29

SPECIMEN AT FAILURE

DESCRIPTION Sandy elastic silt with o.m. (MH)

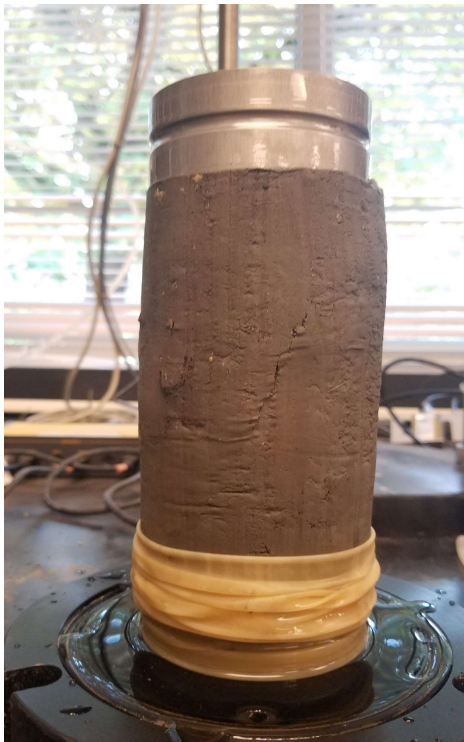
FIGURE A-31

SPECIMEN AT FAILURE

DESCRIPTION Elastic silt with occasional sand and o.m. (MH)
