Geotechnical Investigation Access Clearing

CRITICAL AREAS STUDY AND MITIGATION PLAN

Gateway Pacific Terminal

Project No. 0-915-15338 C

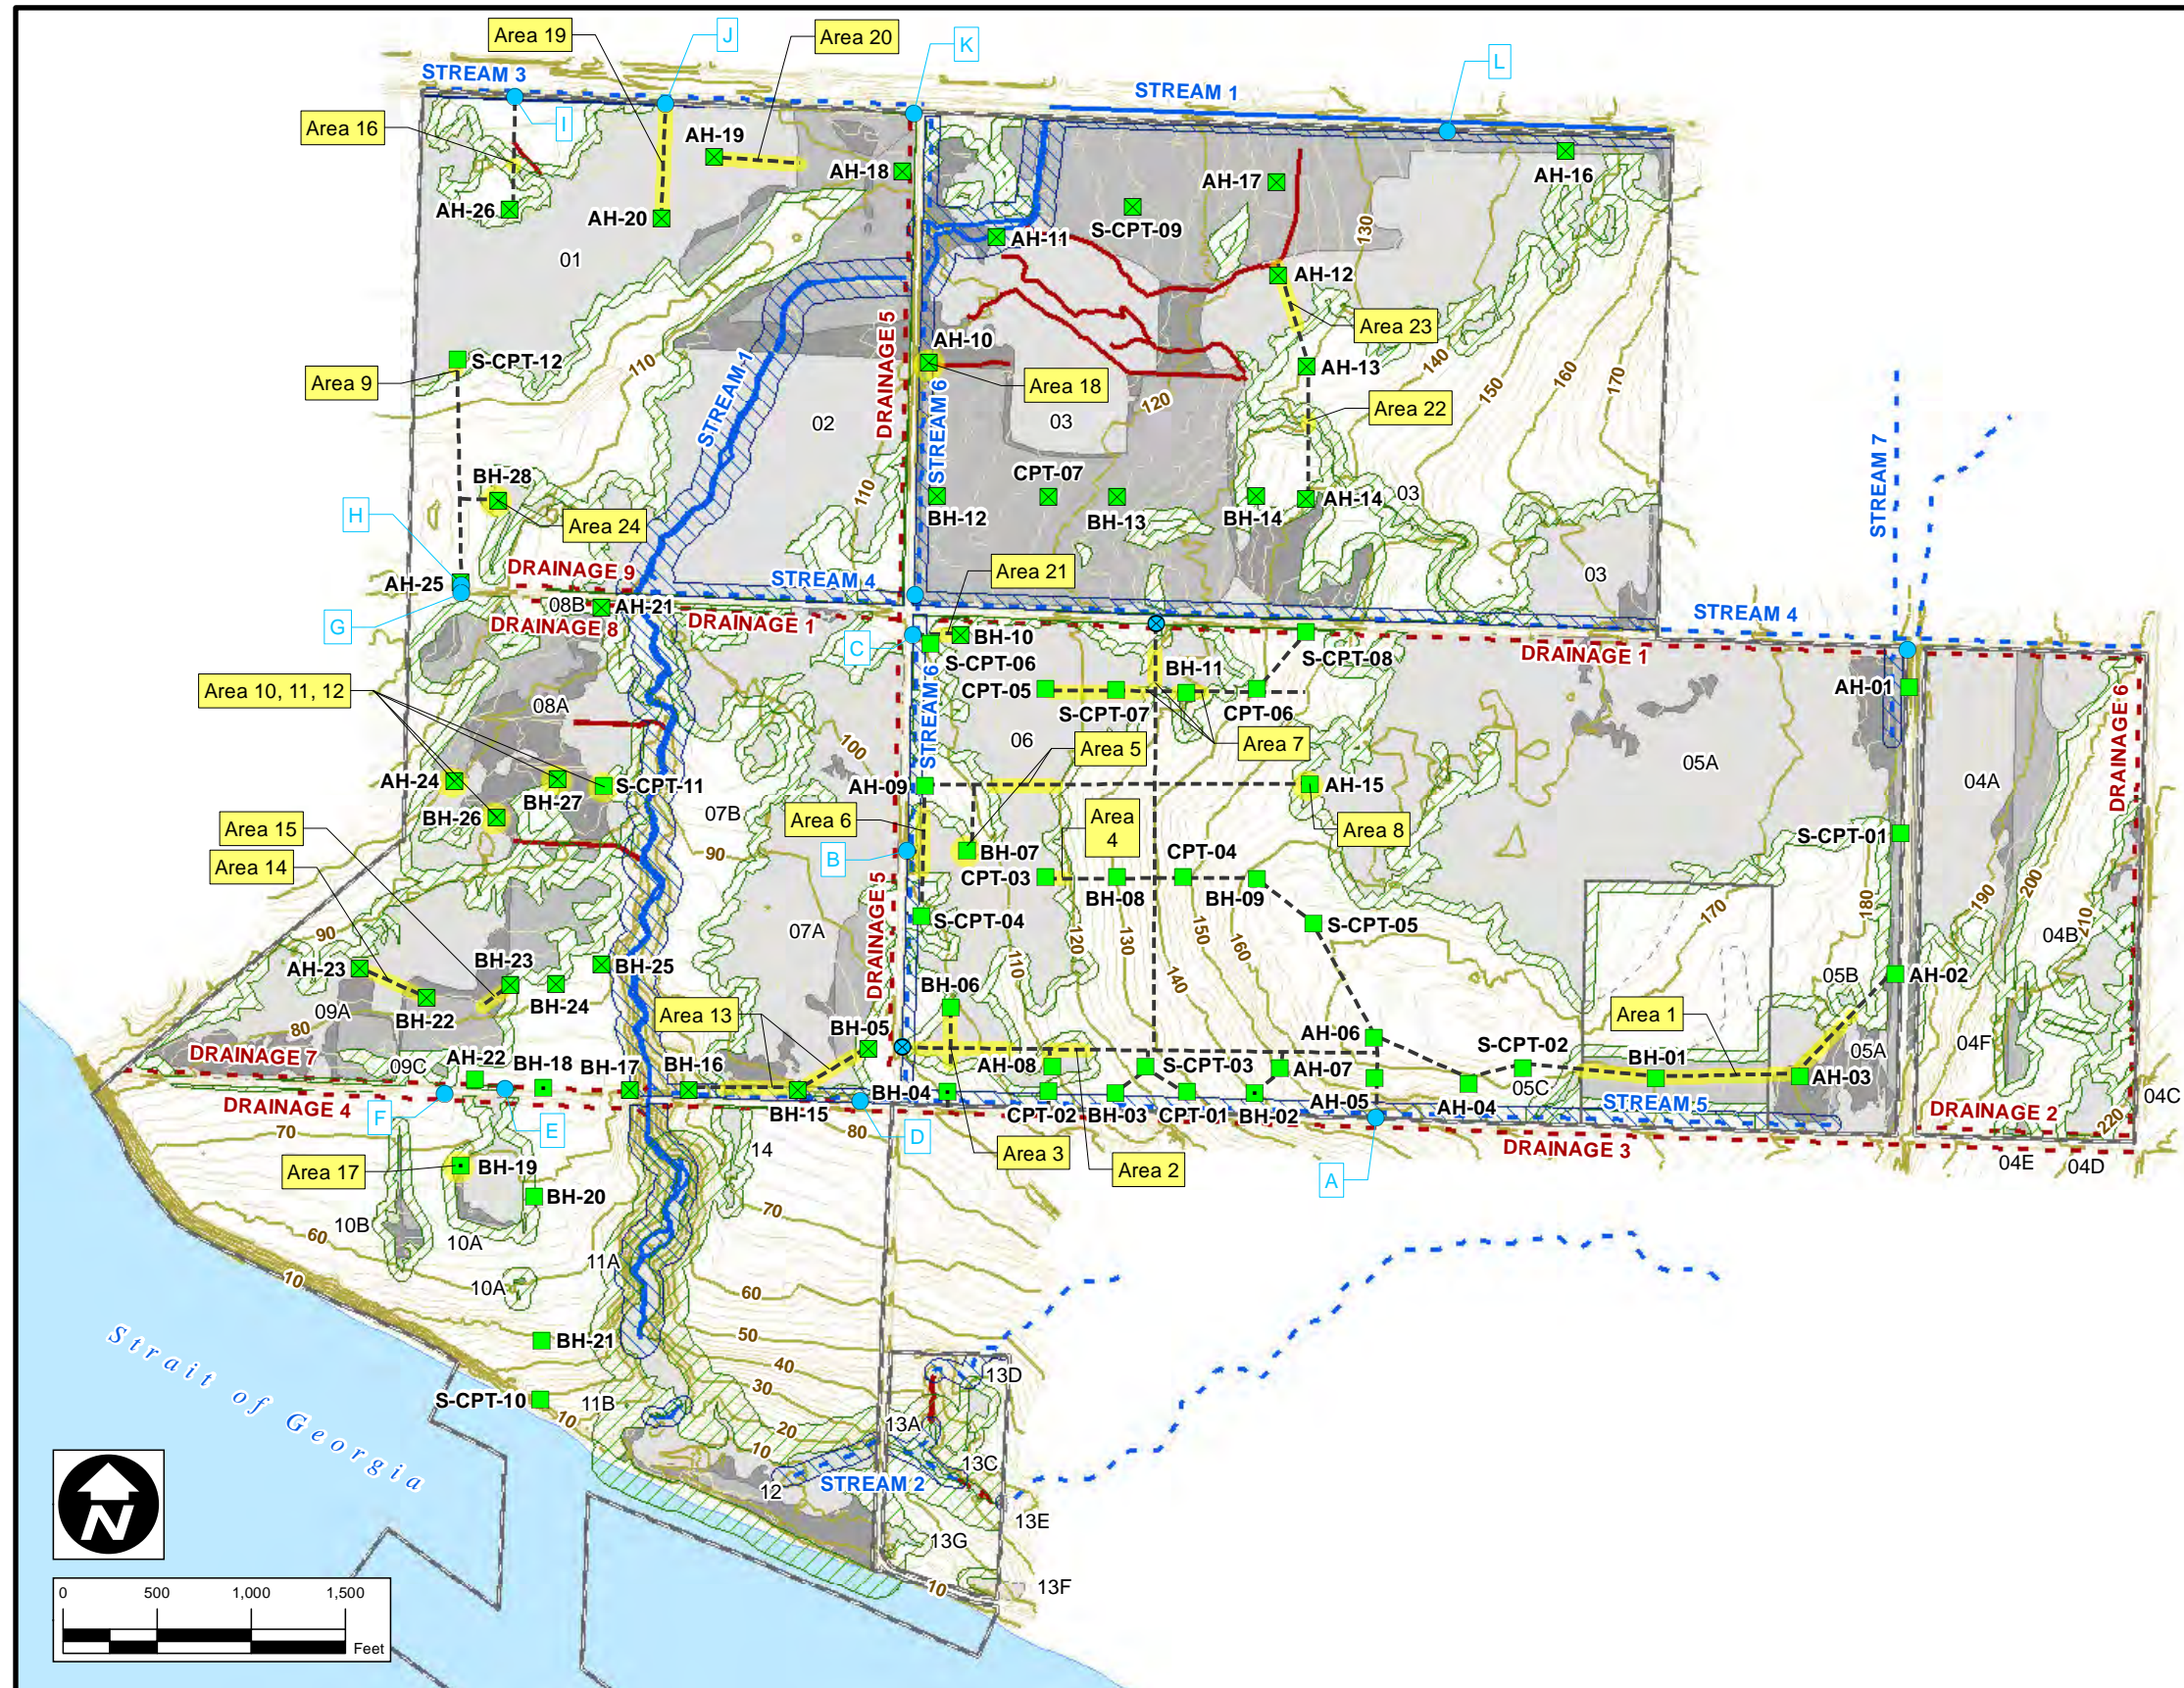
- BOREHOLE COMPLETED (37)
- BOREHOLE NOT COMPLETED (32)
- BOREHOLE IN PROGRESS (4)
- VEHICLE ACCESS POINT
- NO VEHICLE ACCESS
- AS-BUILT BOREHOLE ACCESS*
- APPROXIMATE DRAINAGE
- SURVEYED DRAINAGE
- APPROXIMATE STREAM COURSE
- SURVEYED STREAM COURSE
- STREAM BUFFER
- CURRENT ELEVATION CONTOUR (10 ft. interval, NAVD88 datum)
- CURRENT ELEVATION CONTOUR (2 ft. interval, NAVD88 datum)
- APPROXIMATE WETLAND BOUNDARY
- FRESHWATER EMERGENT WETLAND (PEM)
- FRESHWATER FORESTED WETLAND (PFO)
- FRESHWATER SHRUB WETLAND (PSS)
- WETLAND IMPACT AREA (see text)
- WETLAND BUFFER **
- PROPERTY BOUNDARY
- PROJECT AREA BOUNDARY
