Satsop River Topography

Topographic (LiDAR) Data for the lower Satsop River floodplain. Note the prominent alluvial fan (red color midway between SR 12 and the Chehalis River), the WDFW pits and spoils piles (white and red colors between Satsop and Keyes Road) and the many remnant channels of the Satsop and Chehalis Rivers.

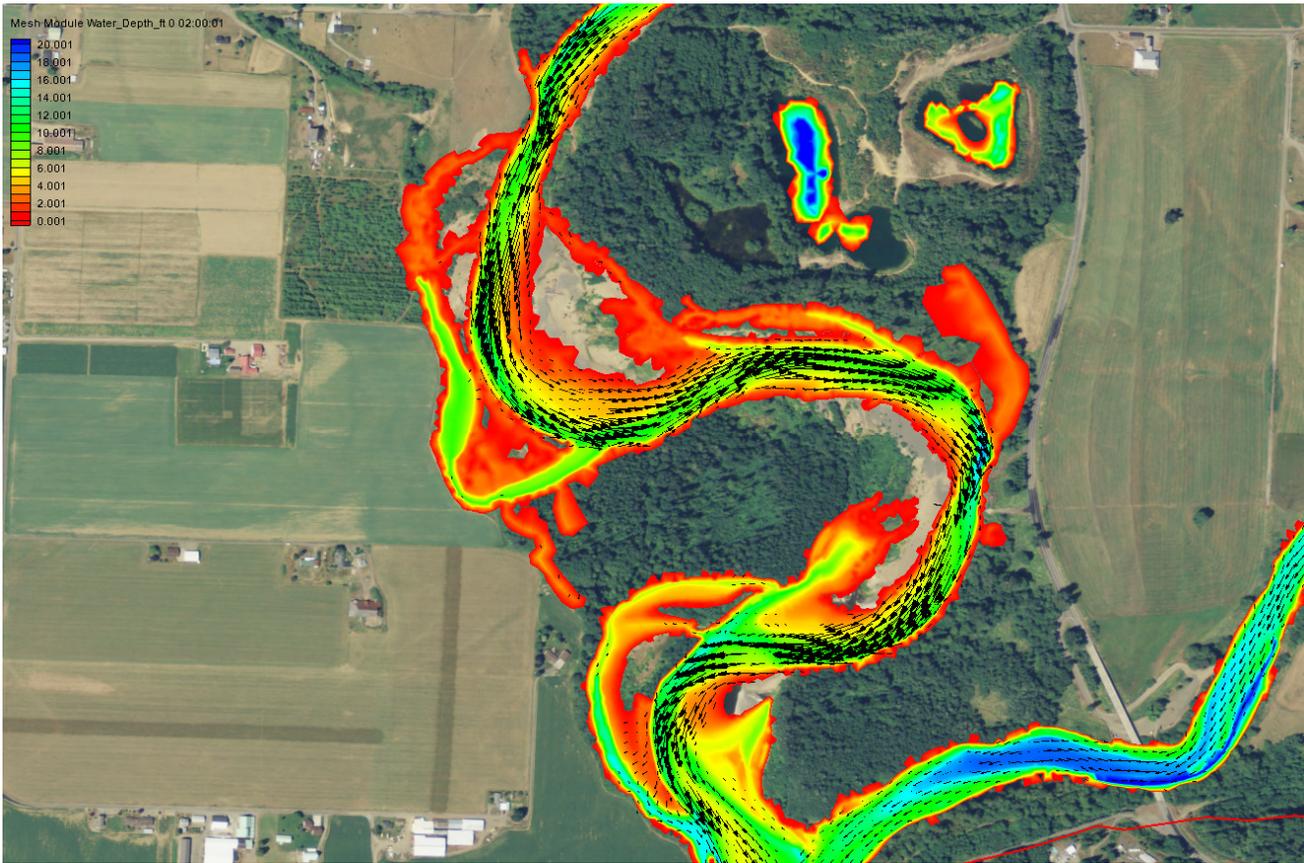
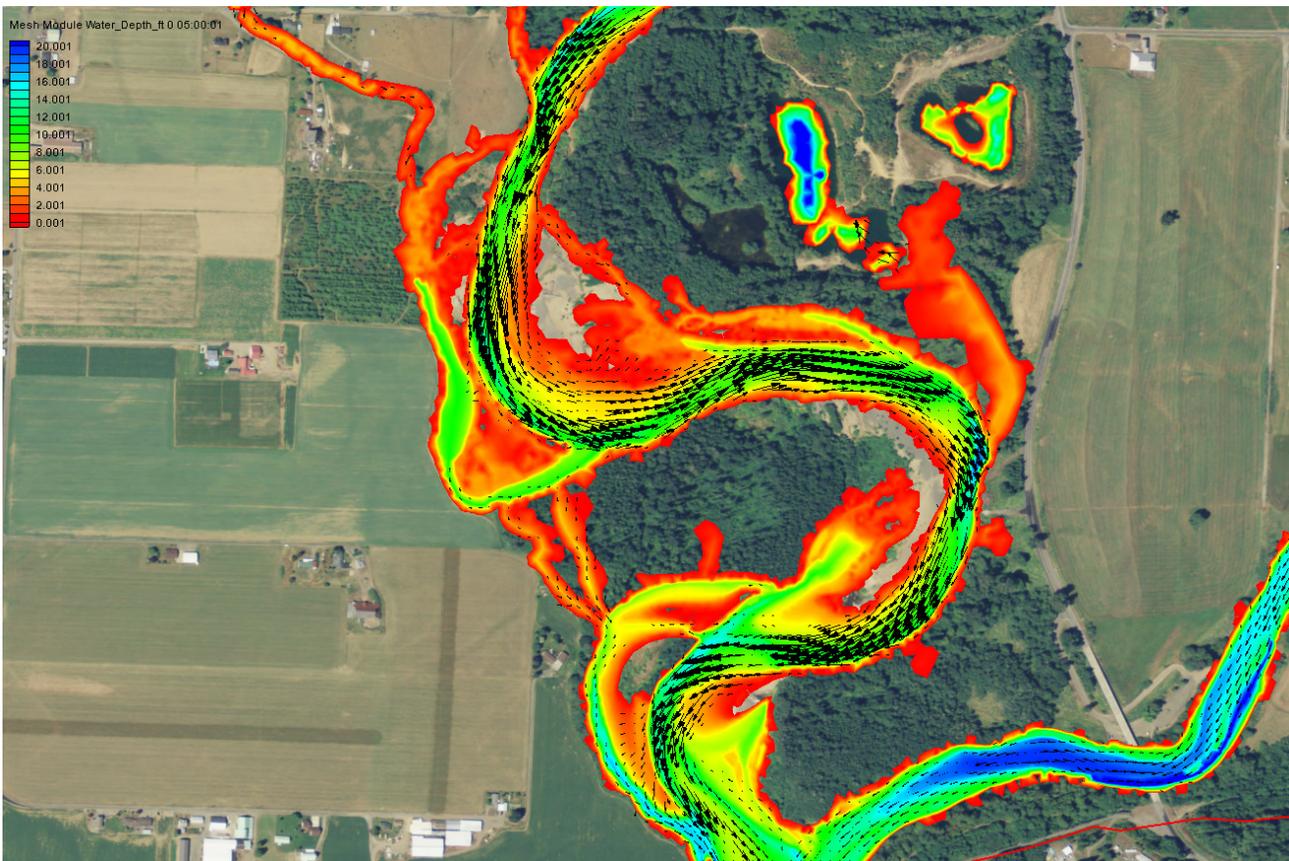
Nov. 2012 Flood: Water depth and velocity vectors at hour 2 (10,800 cfs)

Nov. 2012 Flood: Water depth and velocity vectors at hour 5 (13,200 cfs)

Figures showing the flow patterns near the start of the event. Note that the Fish and Wildlife ponds actually receive river flow initially from the south, from the Satsop River near the PDA wellhead site.

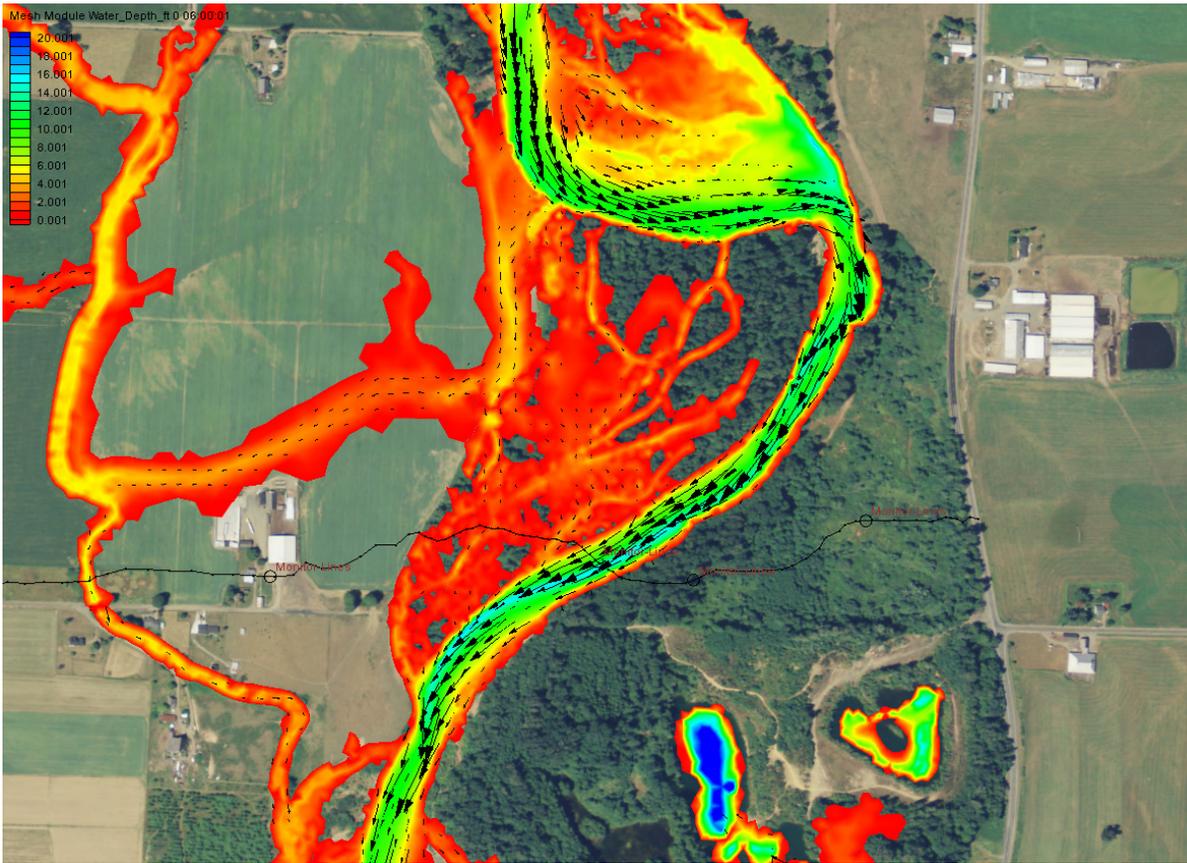
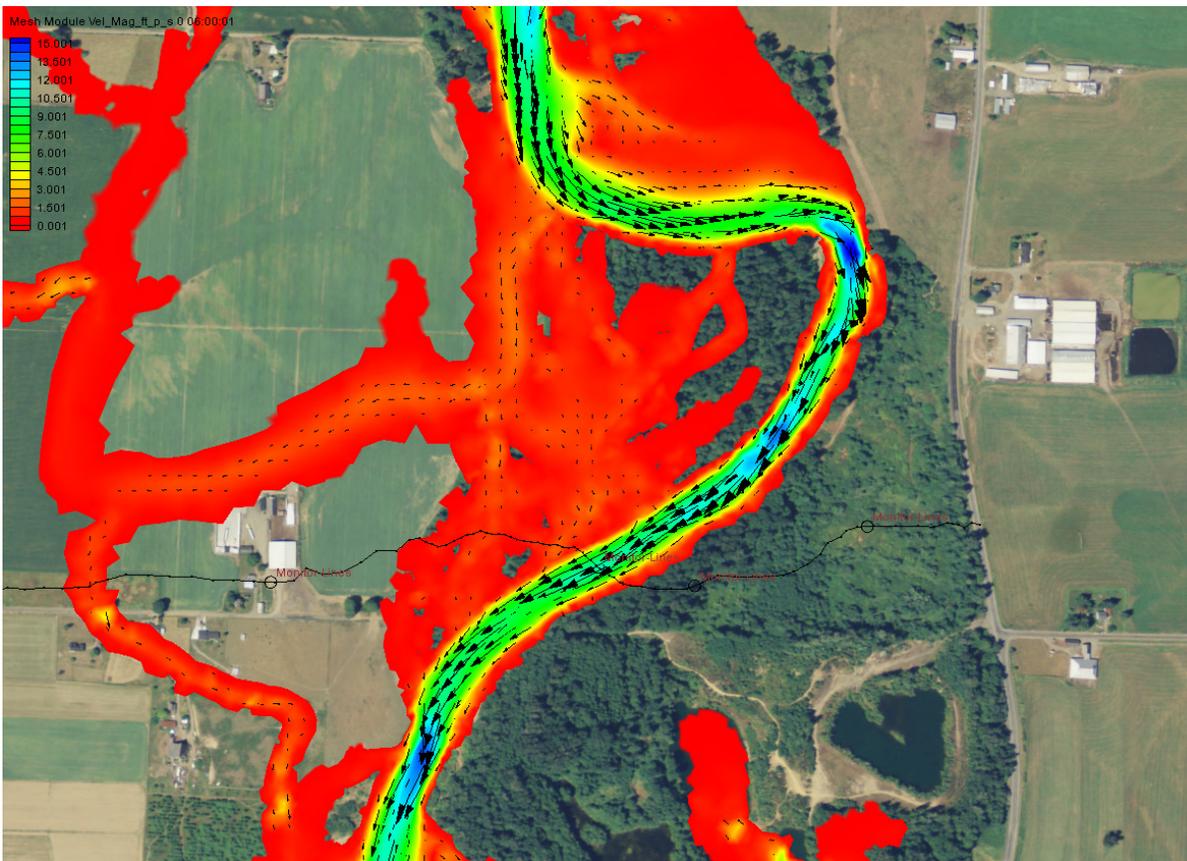
Nov 2012 Flood: Water depth and velocity vectors at hour 6 (14,200 cfs)

Nov 2012 Flood: Flow velocity magnitude and velocity vectors at hour 6 (14,200 cfs)

Figures showing the flow patterns in study reach early in the flood event. Water breaks out of the Satsop River channel upstream of SR12 at a flow of about 14,000 cfs. Overbank flow through the right bank floodplain and side channels is evident in these figures.

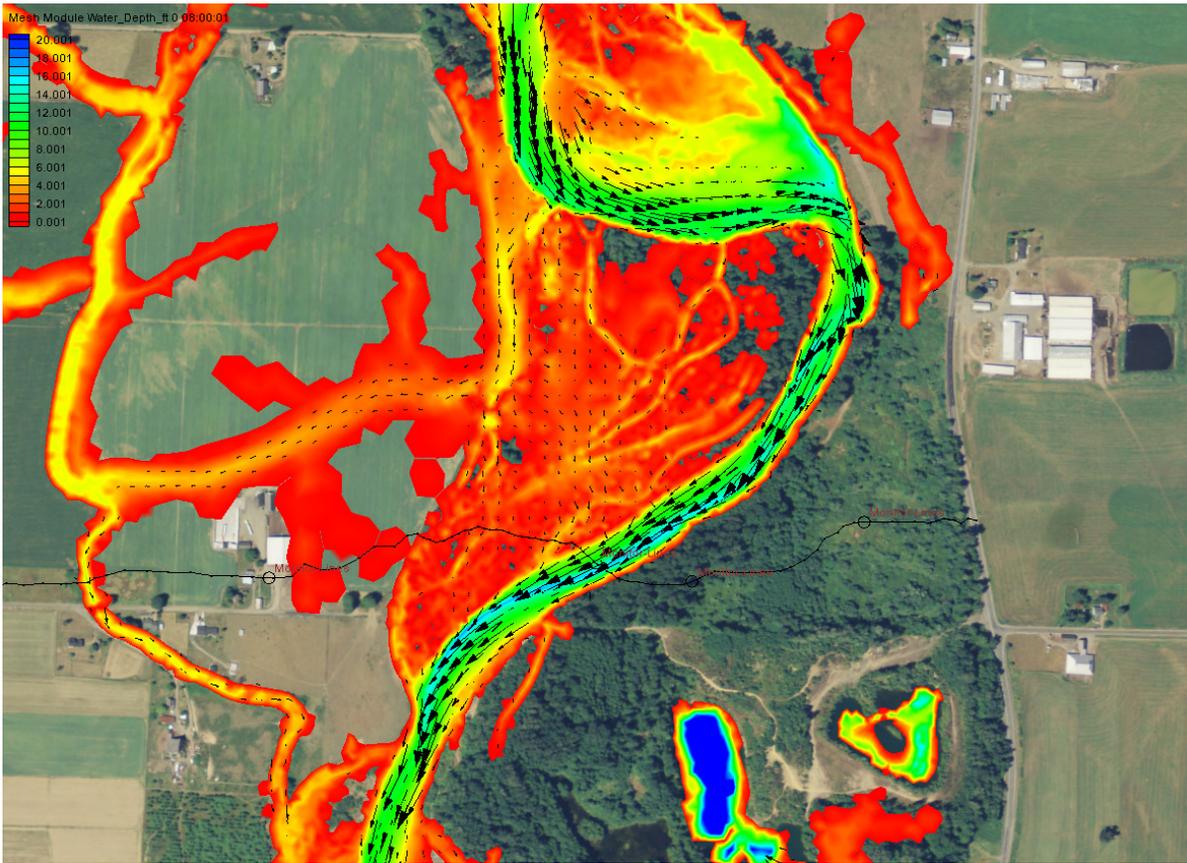
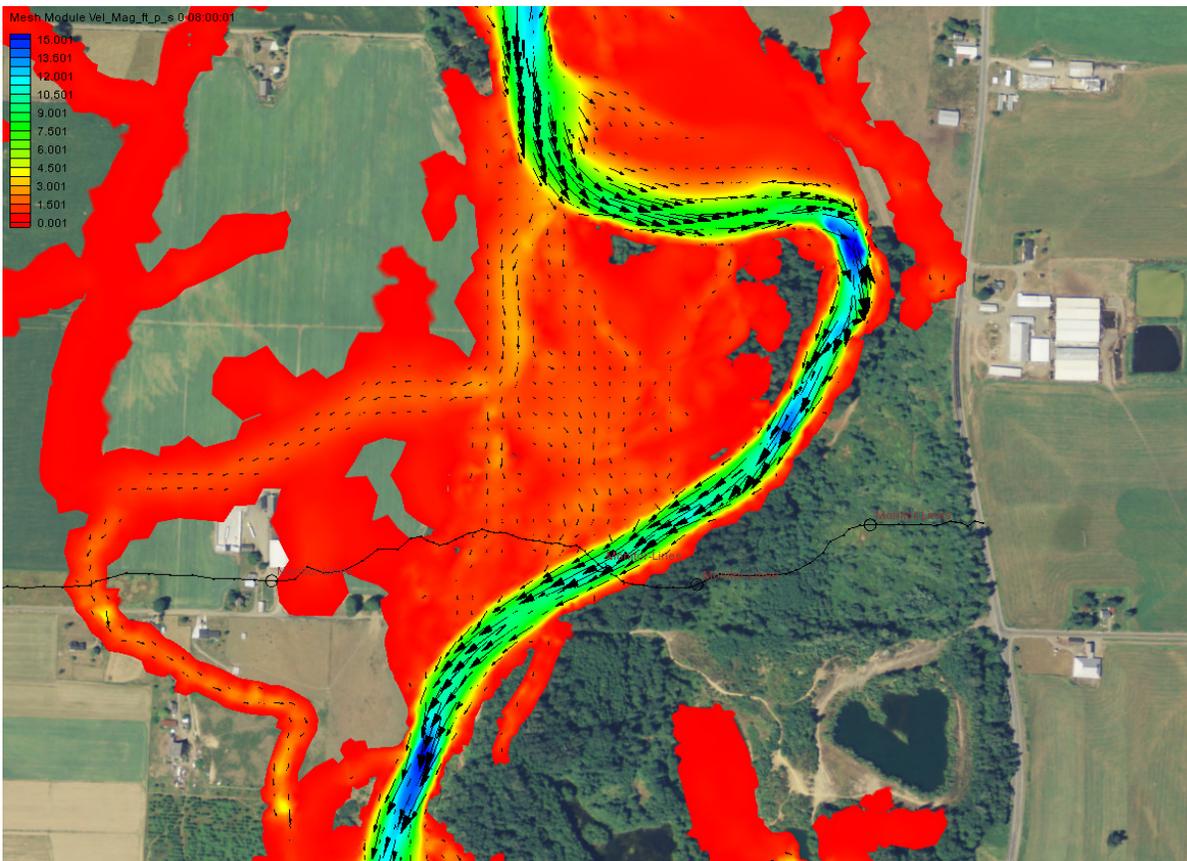
Nov 2012 Flood: Water depth and velocity vectors at hour 8 (16,800 cfs)

Nov 2012 Flood: Flow velocity magnitude and velocity vectors at hour 8 (16,800 cfs)

Figures showing the flow patterns between SR 12 and the rip rap revetment early in the flood event. Water first breaks out of the Satsop River channel upstream of 55 Keyes Road at a river flow of about 16,800 cfs.

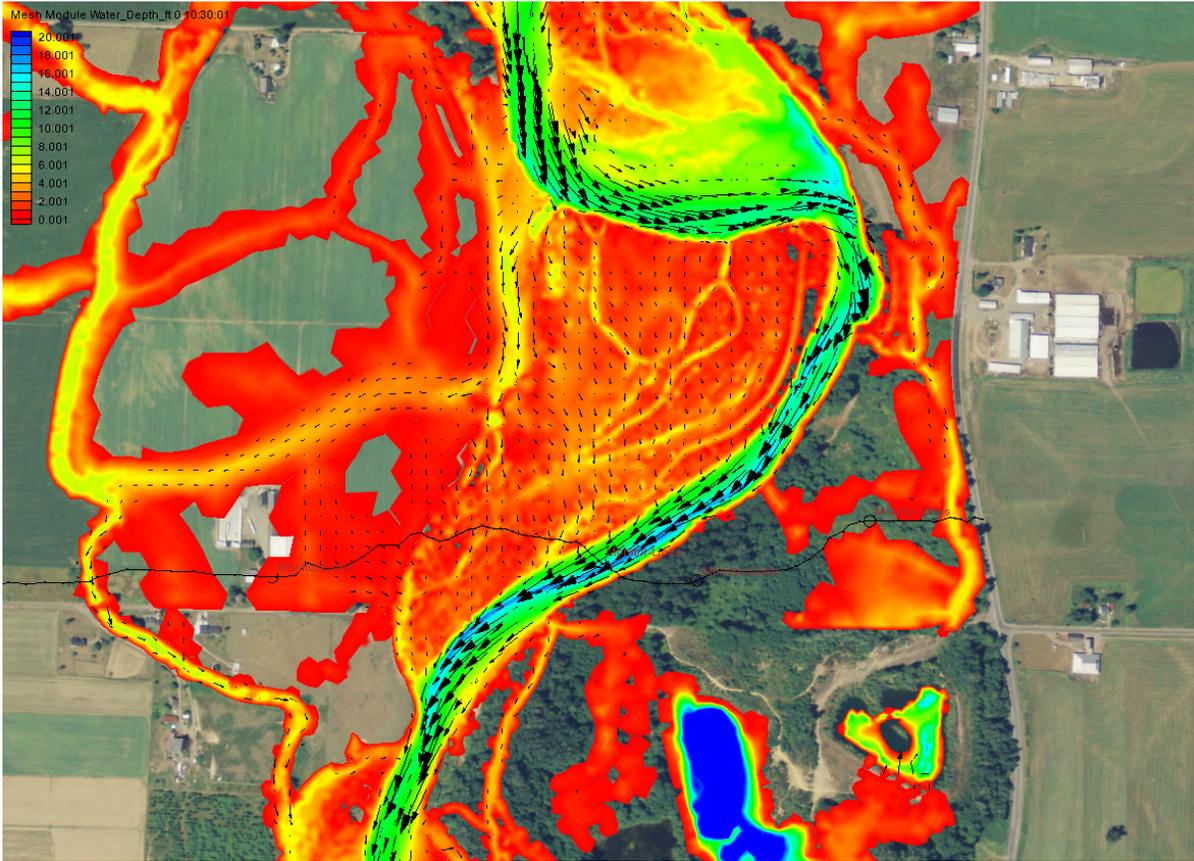
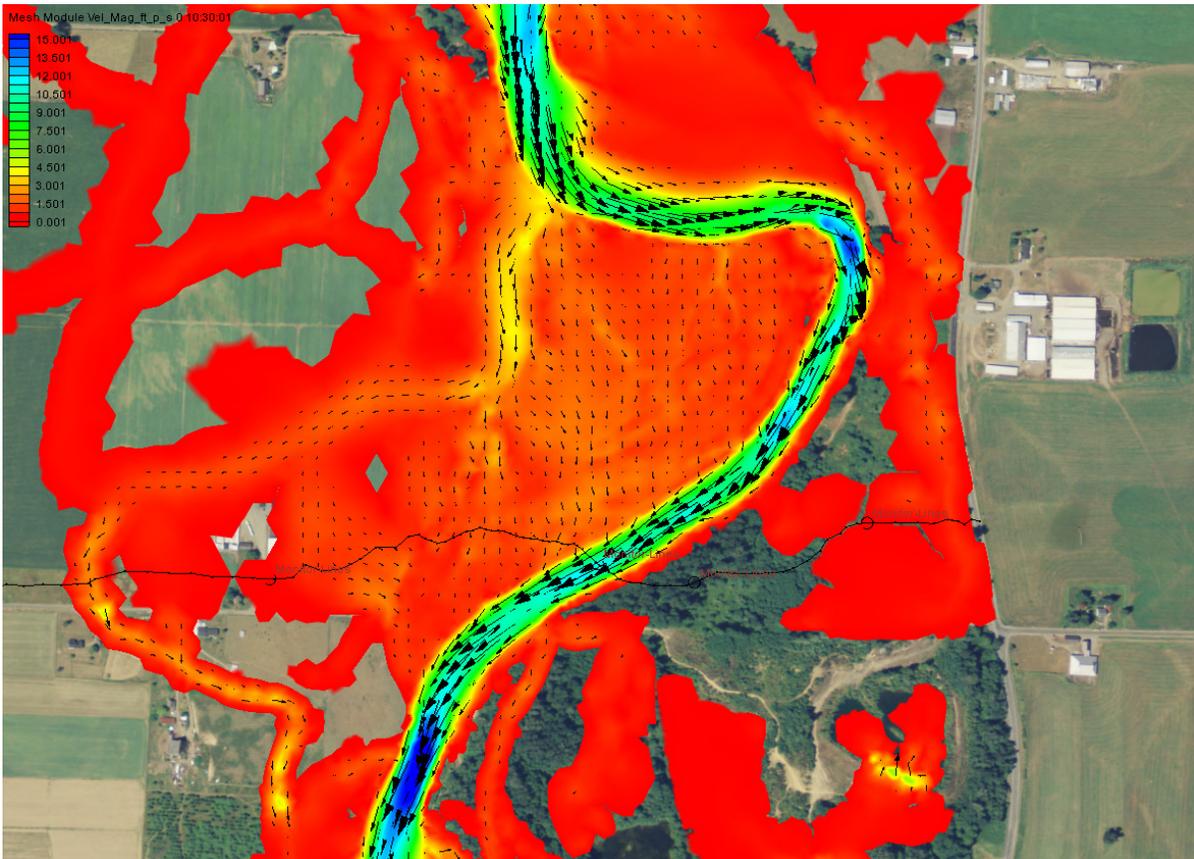
Nov 2012 Flood: Water depth and velocity vectors at hour 10.5 (20,600 cfs)

Nov 2012 Flood: Flow velocity magnitude and velocity vectors at hour 10.5 (20,600 cfs)

When Satsop River flow reaches about 20,000 cfs there is significant flow in the swale near Keyes Road and which reaches the dike along the north side of the WDFW pits and is directed back towards the west, towards the Satsop River. The WDFW ponds are still only receiving water from the south at this point in the flood event.
