# **Reach Assessment for the SR 107 Chehalis River Bridge at Montesano**

**Work Order XL-2008**

**Robert W. Schanz, PE, LHG  
Jim Park, Hydrologist  
WSDOT Environmental Services  
Watershed Management Program**

**July 2005**

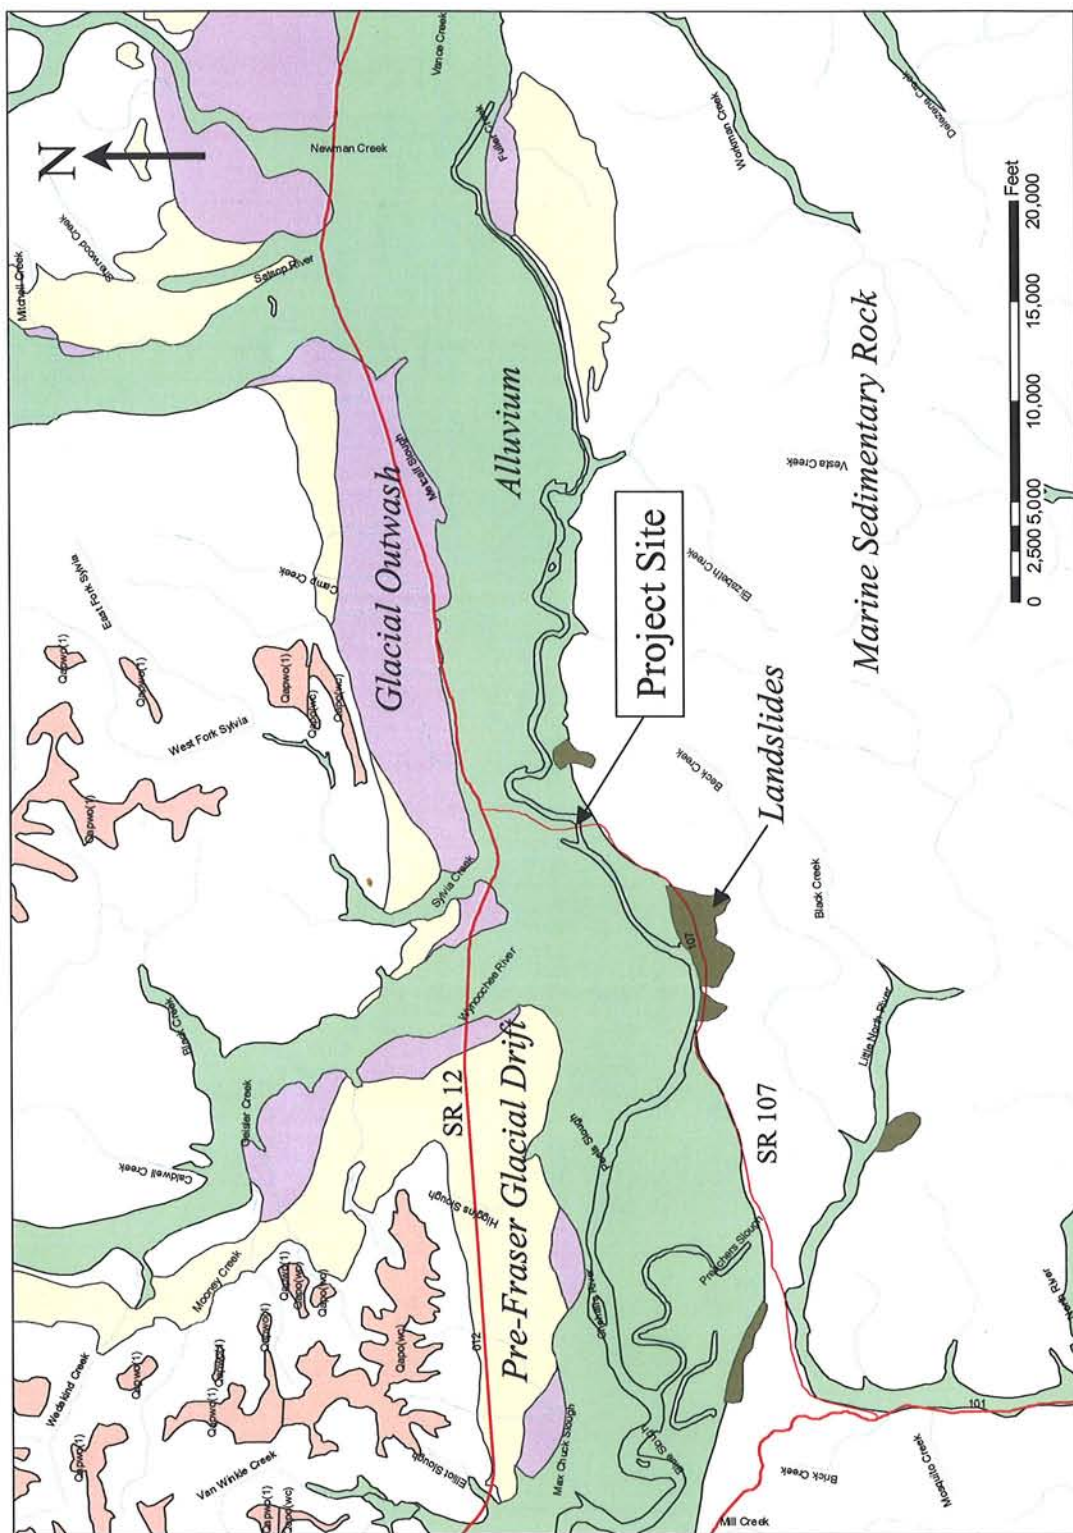
**Figure 5. Regional Geology**

The Chehalis River flows through a broad alluvial valley bounded to the south by steep slopes of marine sedimentary rock and to the north by terraces of glacial outwash (Figure 5). The alluvial valley floor is generally 8500 to 9500 feet wide, but narrows down to about 6000 feet wide at the SR 107 bridge. At the project site the river has meandered to within 600 feet of the southern edge of the alluvial valley. The deep alluvial deposits contain an unconfined aquifer with a high level of connectivity to the Chehalis River (Envirovision, 2000).

Historic survey maps from the 1860's show that the river once occupied the relic channel that enters the river just upstream of the SR 107 bridge erosion scallops. A landslide shown on DNR geology maps (Figure 5) may have closed off this channel at the upstream end and forced the river into the tight meander bend that it now follows upstream of SR 107. The relic channel is now a tidal marsh, and has generally remained stable throughout the historic photo record. In the current river alignment there does not appear to be much risk of avulsion or chute cutoff into the relic channel. However, a chute cutoff opposite the mill would tend to increase erosion within the 90-degree bend upstream of the bridge, which in turn could increase the risk of a future avulsion into the relic channel/tidal marsh. This would straighten out the river's approach to the
