# ***CONDITION REPORT***

## ***Dillenbaugh Creek Culvert Assessment***

***January 2017***

**City of Chehalis**

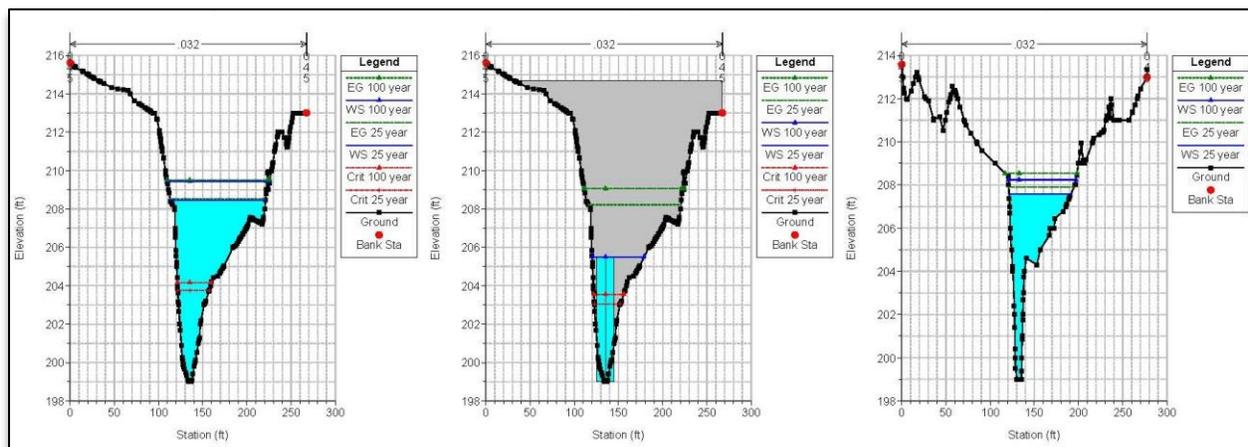
**Figure 3: HEC-RAS Upstream, Bridge, and Downstream Cross Sections**

The bottomless, double box culvert of DB15 is hydraulically undersized for the 25 and 100-year storm events according to both the Manning’s equation calculations and the HEC-RAS hydraulic model. The flow depth for both evaluated rain events is greater than the height of the culvert which restricts debris passage and can cause damage to the culvert and road embankment. The flow velocity for both evaluated rain events is within the allowable values and site conditions do not indicate an issue with culvert undermining or erosion downstream. There is minor river rock build up at the entrance of the north barrel but an increase in design velocity is not recommended. The culvert is currently undersized to provide adequate fish passage. Should future development be considered, the culvert span should be sized at a minimum of 25.04 feet.

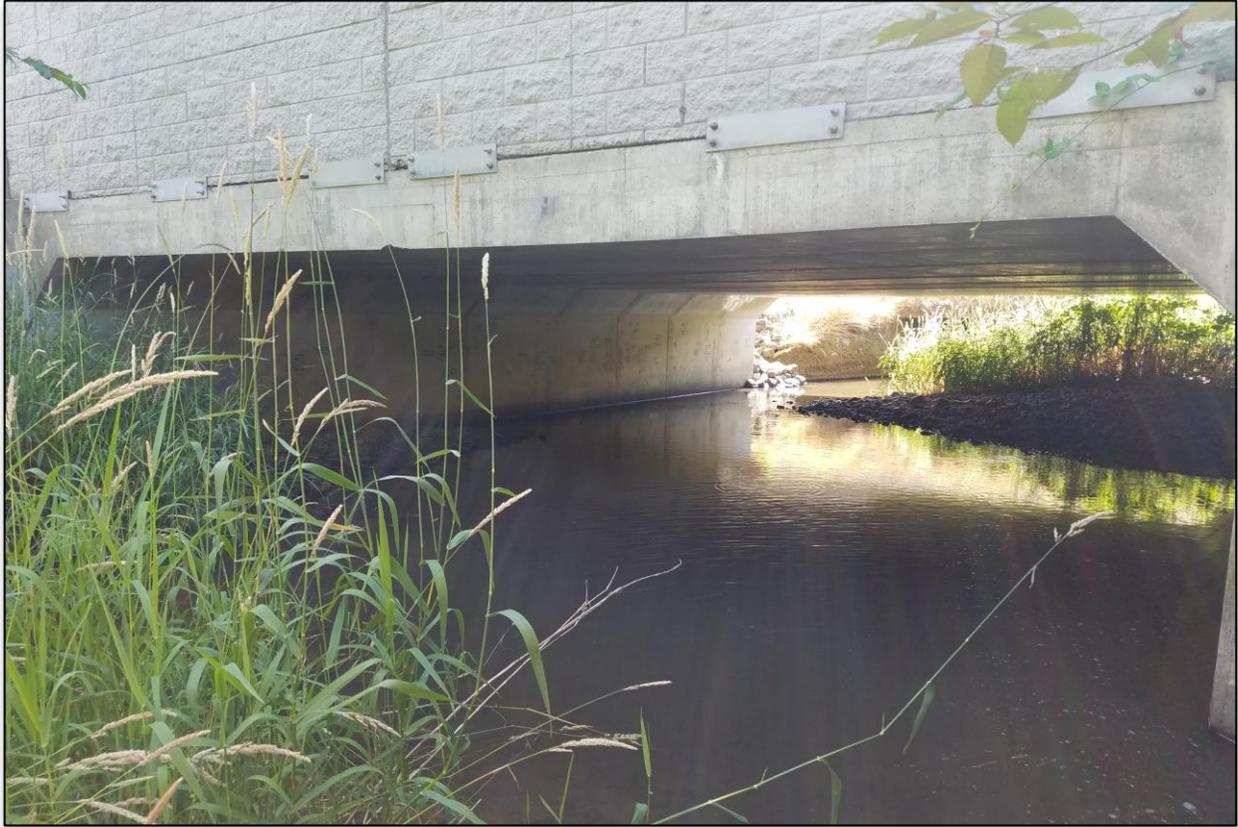
Image 7: DB14: Box Culvert under I-5 On-Ramp @ Exit 74

The bottomless, box culvert of DB14 is hydraulically sized for the 25 and 100-year storm events according to both the preliminary FEMA flood maps and Manning's equation calculations. The HEC-RAS hydraulic model shows the 25 year storm at slightly higher than the allowable value but this is not a concern as the other two methods share similar allowable values. The flow velocity for both evaluated rain events is within the allowable values and site conditions do not indicate an issue with culvert undermining or erosion downstream. There is minor river rock build up at the exit of the culvert but an increase in design velocity is not recommended. The culvert is currently undersized to provide adequate fish passage. Should future development be considered, the culvert span should be sized at a minimum of 27.20 feet.

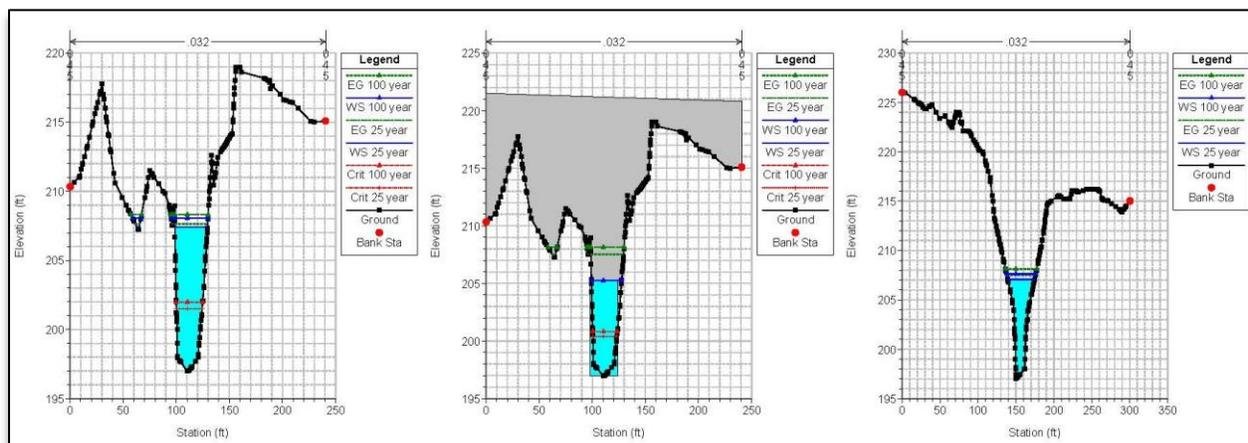
**Figure 4: HEC-RAS Upstream, Bridge, and Downstream Cross Sections**

These calculations were based using the outlet control box culvert method. Based on the calculated values, the 25-year rain event has a flow depth 0.94 ft less than the allowable value and the 100-year rain event has a flow depth 1.48 ft less than the allowable value. The velocities calculated by this method are within the allowable range and are not a cause for concern. Based on Manning's calculations this culvert is hydraulically sized.

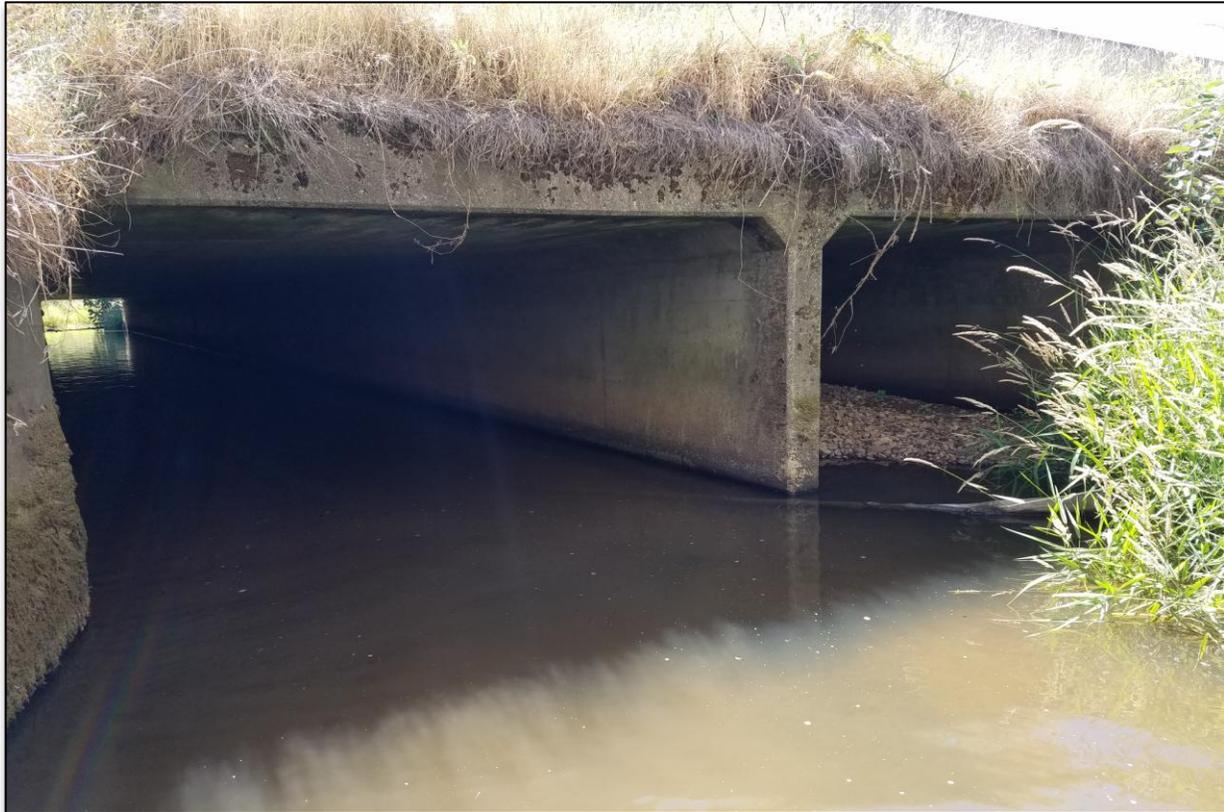
Image 9: DB13: Double Box Culvert under I-5

The bottomless, double box culvert of DB13 is hydraulically undersized for the 25 and 100-year storm events according to both the Manning's equation calculations and the HEC-RAS hydraulic model. The flow depth for both evaluated rain events is greater than the height of the culvert and the road which restricts debris passage, can cause damage to the culvert and road embankment, and restrict emergency access on I-5. The flow velocity for both evaluated rain events is within the allowable values and site conditions do not indicate an issue with culvert undermining or erosion downstream. There is minor river rock build up at the entrance of the north barrel but an increase in design velocity is not recommended. The culvert is currently sized to provide adequate fish passage.

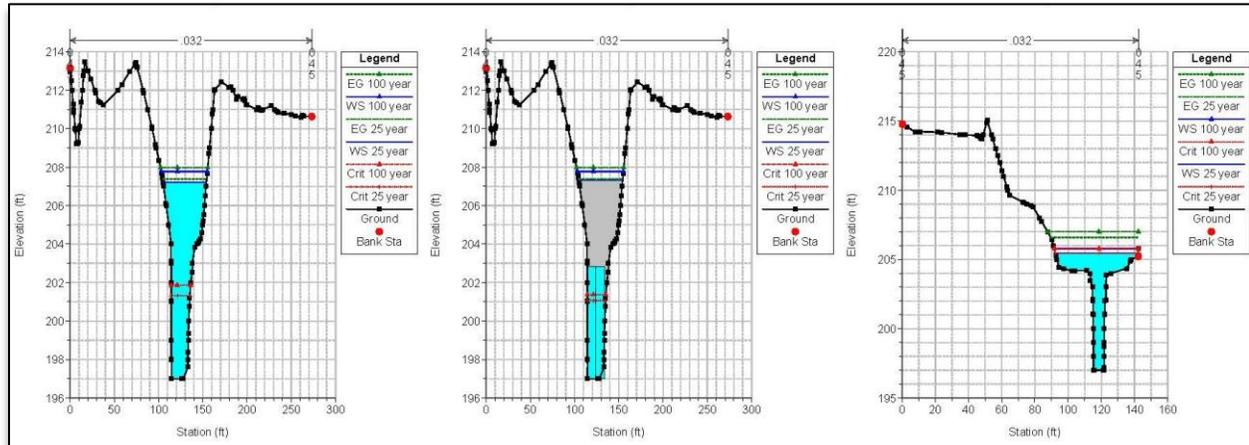
**Figure 5: HEC-RAS Upstream, Bridge, and Downstream Cross Sections**

These calculations were based using the outlet control box culvert method. Based on the calculated values, the 25-year rain event has a flow depth 1.92 ft greater than the allowable value and the 100-year rain event has a flow depth 1.86 ft greater than the allowable value. These values are very close to the observed values of the 2007 flood. It should be noted that this culvert directly follows the box culvert of Site 3 and this

calculation does not take this condition into account. The velocities calculated by this method are within the allowable range and are not a cause for concern.

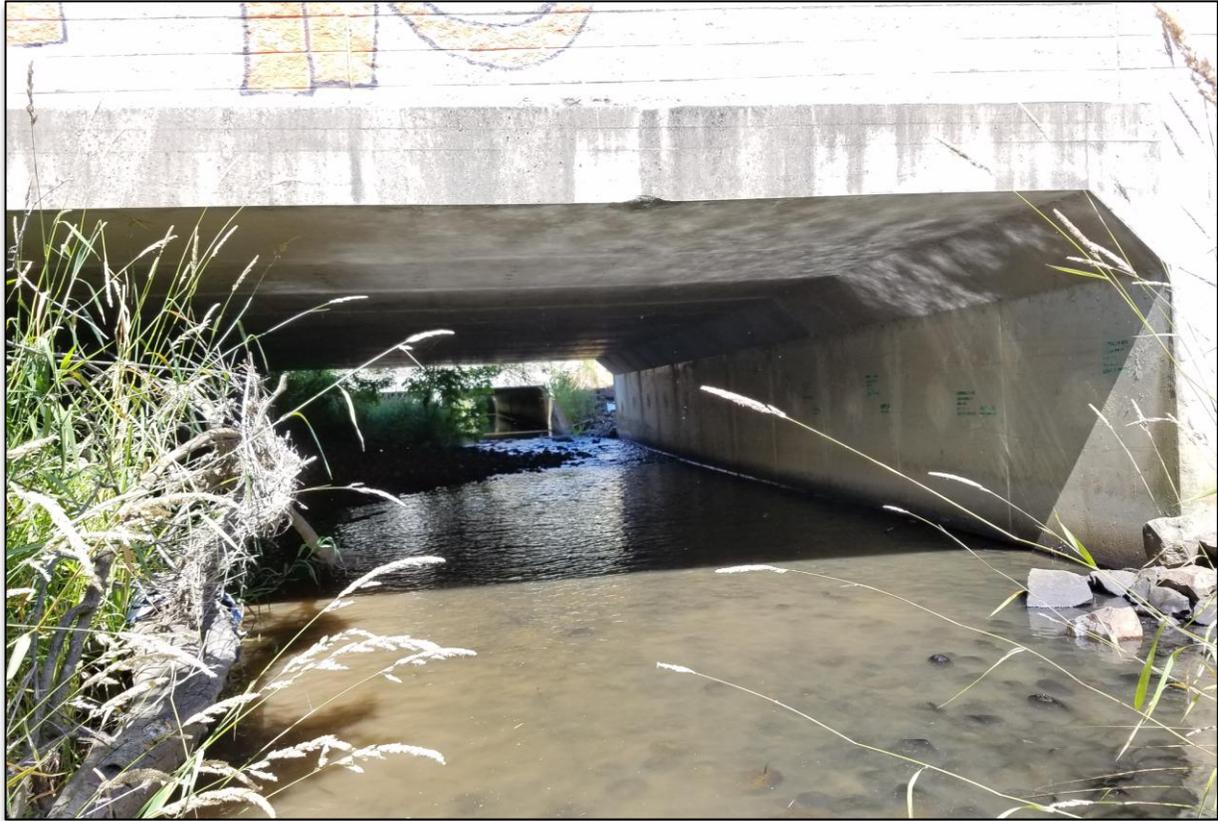
Image 11: DB12: Box Culvert under I-5 Off-Ramp @ Exit 7

The bottomless, box culvert of DB12 is hydraulically sized for the 25 and 100-year storm events according to all three methods of analysis. The HEC-RAS hydraulic model shows both the 25 and 100-year storm events at significantly lower values due to the restricted flow of DB13. The flow velocity for both evaluated rain events is within the allowable values for the Manning's equation values and outside of the allowable values for the HEC-RAS model. Given the lack of erosion of the site and the allowable depth values for all three methods, the flow velocity is not a concern. The culvert is currently sized to provide adequate fish passage.

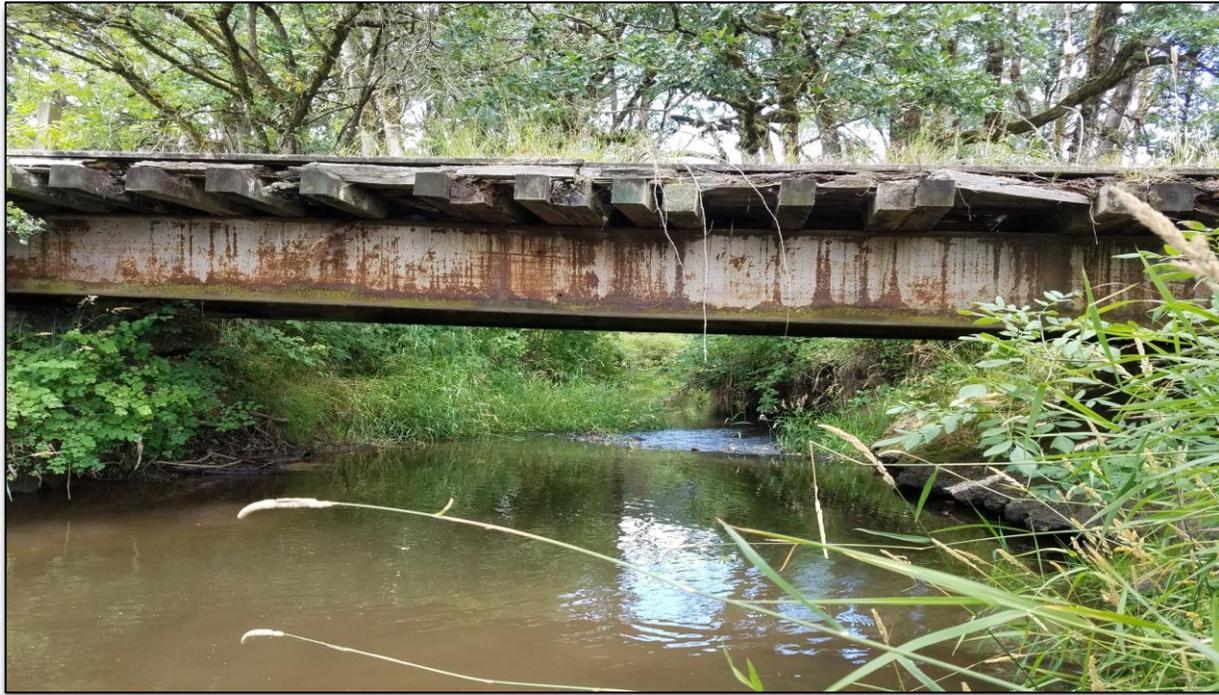
Image 13: DB11: Abandoned Farmhouse Access Road

The concrete and timber bridge of Site 5.5 is in poor condition and not suitable for vehicular use. The bridge is located in a flat area prone to flooding and the deck is set at the elevation of the surrounding ground. During significant rain events, the area surrounding and including the bridge will be underwater. If the bridge is to be repaired and recommissioned it would do little good to raise or widen the bridge, but rather it must be structurally designed to withstand the flooding characteristic to its location. It is more significant to note that the change in flow depth from upstream to downstream shows the bridge does have an effect on flow. Additionally, the flood map generated by the HEC-RAS model show an increase in flood zone width at this point. One could conclude that the bridge is an obstruction to high water flows and flooding in the immediate area could be decreased by removal of the bridge. The bridge is currently sized to provide adequate fish passage.

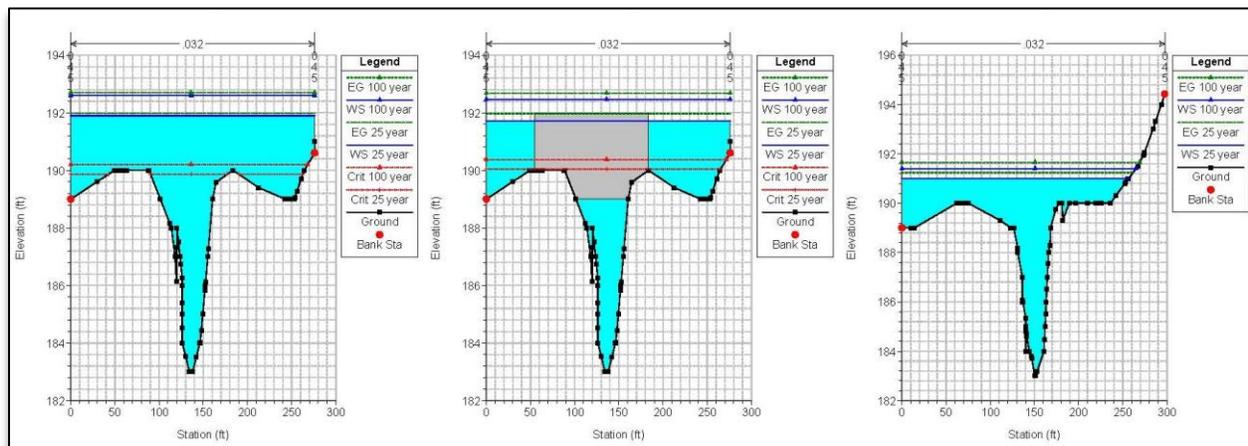
**Figure 7: HEC-RAS Upstream, Bridge, and Downstream Cross Sections**

These calculations were done using the rectangular open channel flow method. Based on the calculated values, the 25-year rain event has a flow depth 15.63 ft greater than the allowable value and the 100-year rain event has a flow depth 18.56 ft greater than the allowable value. The Manning’s trapezoidal open channel flow equation does not take into account the top of the

embankment and assumes an infinite possible depth. The channel has a depth of 9 feet with a very flat surrounding area so any calculated depth above 9 feet has spilled over into the surrounding farm fields. Here the creek has overtopped the bridge deck and flooded the surrounding area. It may not be accurate to say the bridge is undersized, but rather it must be structurally designed to withstand the flooding characteristic to its location. The velocity is within the allowable range and is not a cause for concern.

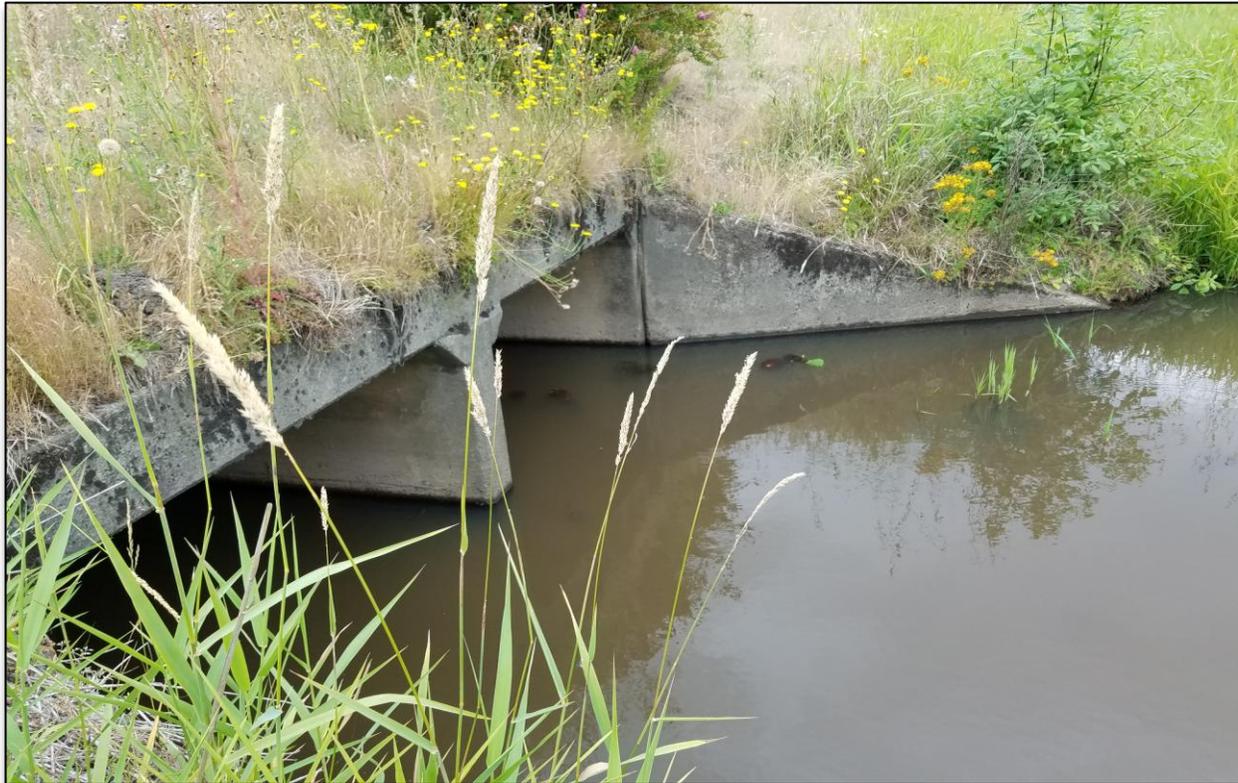
Image 15: DT1: 1 Double Box Culvert under I-5 @ Exit 7

The bottomless double box culvert of Site DT01 is hydraulically undersized for the 25 and 100-year storm events according to both the FEMA FIRMs and Manning’s equation calculations. According to the observed flows of 2007, the flow overtopped the roadway which can cause damage to the culvert and road embankment and restricts emergency access on I-5. By Manning’s equation calculations, which does not account for backwater flooding from the Dillenbaugh or Chehalis River, this culvert is barely undersized for both the 25 and 100-year rain events which restricts debris passage and can cause damage to the culvert and road embankment. The flow velocity for both evaluated rain events is within the allowable values and site conditions do not indicate an issue with culvert undermining or erosion downstream. This site was not evaluated for fish passage capacity.

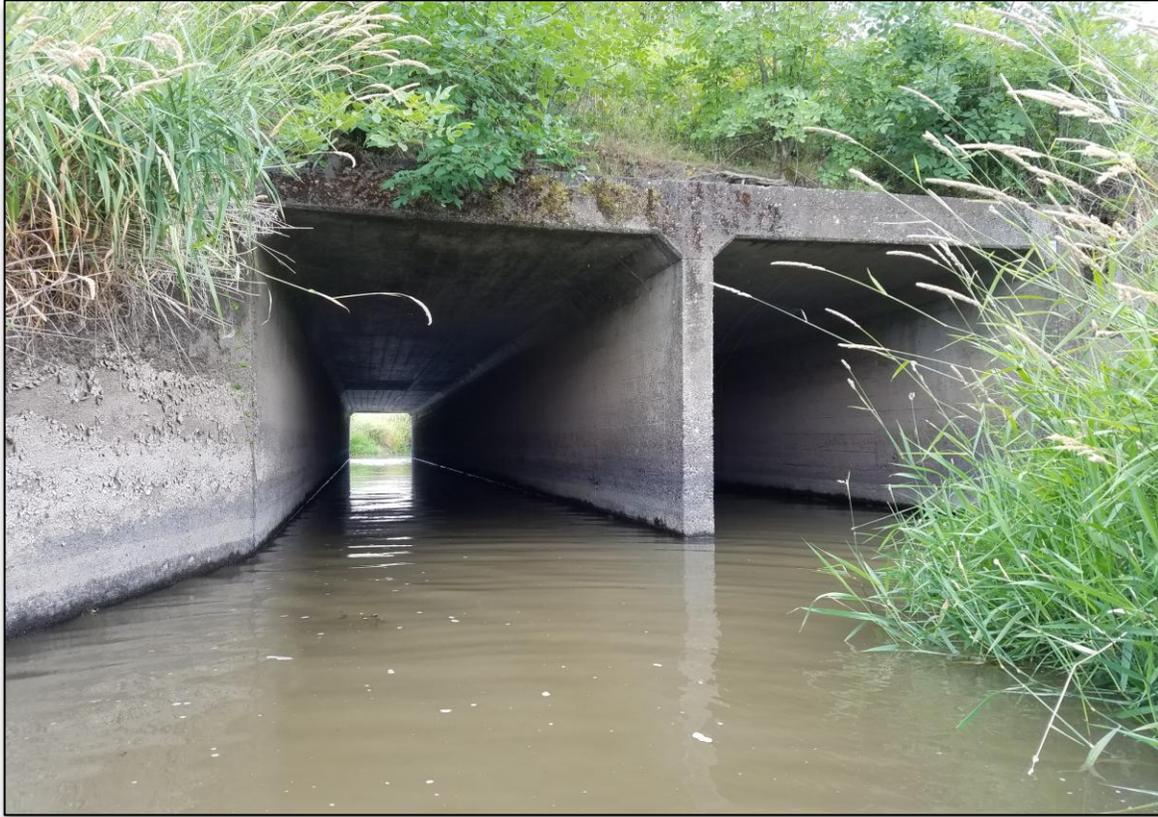
Image 16: DB10: Double Box Culvert under Rice Road

The double box culvert of DB10 is hydraulically undersized for the 25 and 100-year storm events according to both the Manning’s equation calculations and the HEC-RAS hydraulic model. The upstream flow depth for both evaluated rain events is greater than the height of Rice Road directly to the south west of the site. The flow velocities in the culvert for both the 25 and 100-year storm events exceed the allowable 10 ft/s. If the culvert size was increased in both height and width, the headwater depth would decrease and the culvert velocity would most closely match the natural channel velocity of approximately 3 ft/s found up and downstream of the site. However, the tailwater elevations of 181.65

and 182.21 for the 25 year and 100-year rain events indicate a natural channel elevation that would still overtop the 181 ft elevation of Rice Road. In order to bring the creek crossing into compliance, the culvert would need to be increased in size and portions of Rice Road would need to be raised. The culvert is currently undersized to provide adequate fish passage. Should future development be considered, the culvert span should be sized at a minimum of 25.60 feet.

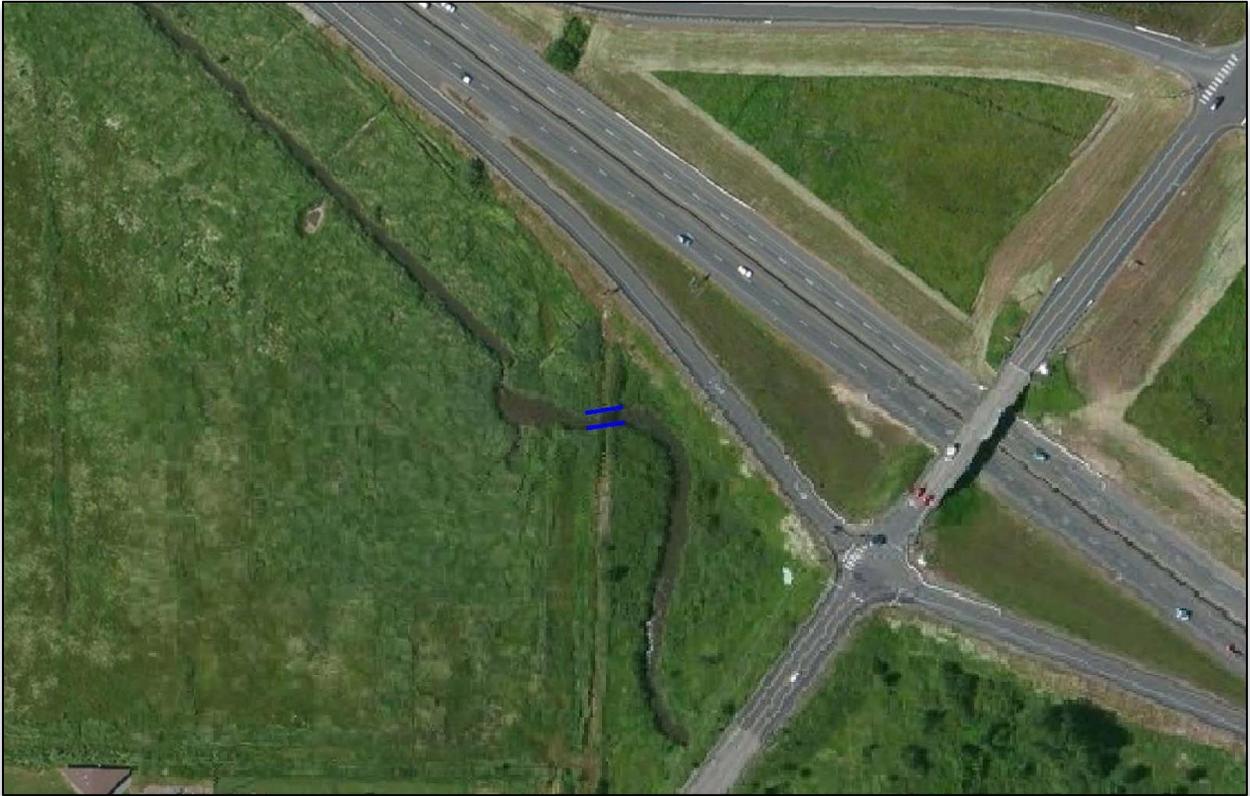
**Image 20: DB09 Aerial Image**

The steel railroad bridge over Dillenbaugh Creek near Rice Road is an abandoned, single track structure. A visual inspection of the bridge was completed through field documented photographs and video. The entirety of the top decking is missing. The steel I-beams have a significant amount of rust and corrosion on some of its members. Due to the high water level, the condition of the concrete footings is unclear. Further investigation would need to be completed to understand the condition of the footings that support the I beams.

Based on the base flood elevation values observed in 2007, the depth of flow is 18.81 ft with an allowable depth of 8.67 ft. For this method of analysis, the bridge is undersized and completely submerged.

The I beam bridge of DB09 is missing the bridge decking and is not currently suitable for use. The bridge is located in a flat area prone to flooding and the deck is set at the elevation of the surrounding ground. During significant rain events, the area surrounding and including the bridge will be underwater. If the bridge is to be repaired and recommissioned it would do little good to raise or widen the bridge, but rather it must be structurally designed to withstand the flooding characteristic to its location. It is more significant to note that the minor change in flow depth from upstream to downstream shows the bridge does have an effect on flow. While this effect would be negligible during 25 and 100-year storm events, one could conclude that the bridge is an obstruction to high water flows and flooding in the immediate area could be decreased by removal of the bridge. The abandoned bridge is currently undersized to

provide adequate fish passage. Should future development be considered, the bridge span should be sized at a minimum of 33.80 feet.

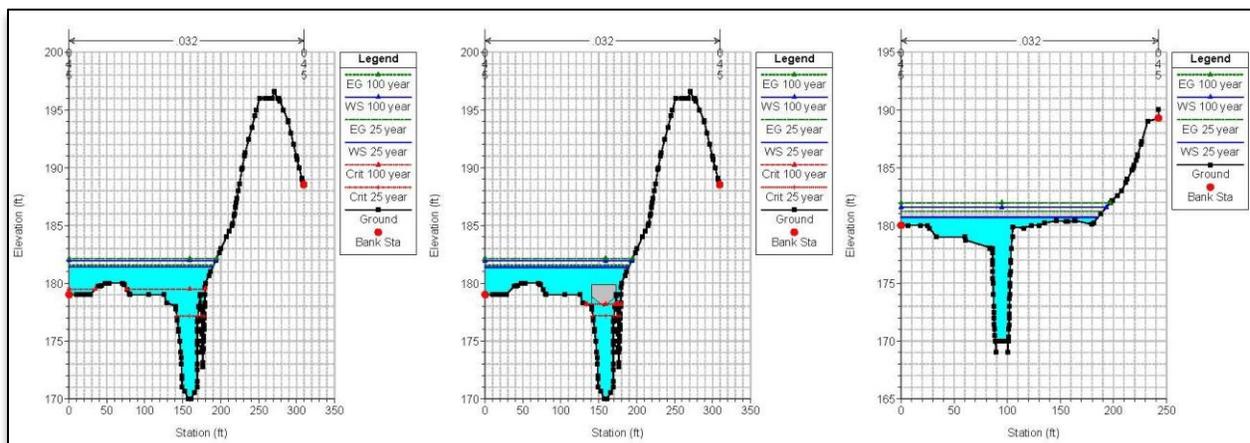
**Figure 9: HEC-RAS Upstream, Bridge, and Downstream Cross Sections**

Based on the modeled values, the 25-year rain event has a flow depth 3.69 ft greater than the allowable value and the 100-year rain event has a flow depth 3.26 ft greater than the allowable value. These values are lower than the observed flows of 2007 as this model only considers the input of the Dillenbaugh Creek flows and the resulting floodwater elevations. At this location during a 25 or 100 year

storm event, the Chehalis River has overtopped its banks and floods the surrounding area, to include this bridge location. The observed values as documented by the Preliminary FIRMs reflect floodwater elevations influence by both the Chehalis River and Dillenbaugh Creek. The downstream cross sections of this model show tailwater depths of 11.03 ft and 11.68 ft for the 25 and 100-year event respectively. The velocity values for the 100-year event are within the allowable range and are not a cause for concern.

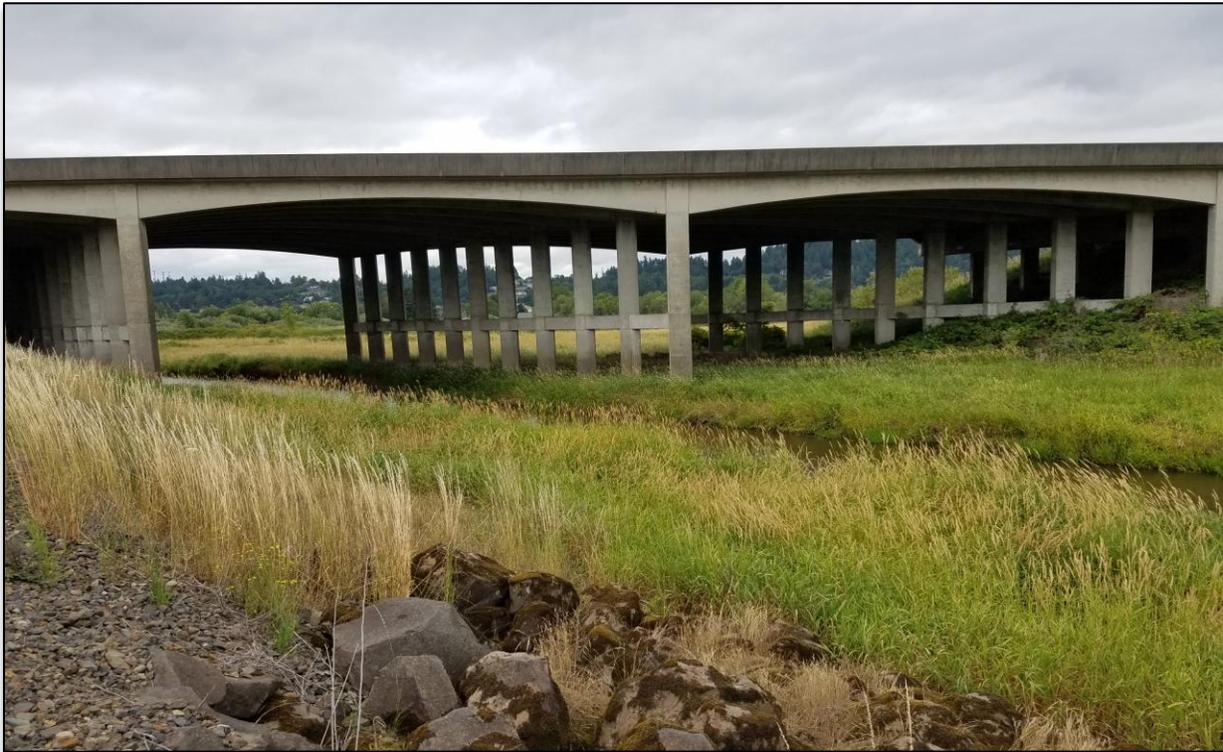
Image 21: DB08: Bridge for I-5

The reinforced concrete bridge of I-5 between exit 76 and exit 77 is a passageway for two railroad tracks and Dillenbaugh Creek. The scale of the bridge was prohibitive to inspection for the sake of this report. Visual inspection at the site visit on July 7<sup>th</sup> revealed no conspicuous damages from floodwater.

Based on the base flood elevation values observed in 2007, the depth of flow is 17 ft and did not overtop the roadway. For this method of analysis, the bridge is adequately sized.

The bridge of I-5 is hydraulically sized for both the 25 and 100 year storm events. Further analysis using survey and modeling was considered unnecessary due to the oversized character of the bridge. The concrete bridge is adequately sized to provide fish passage.

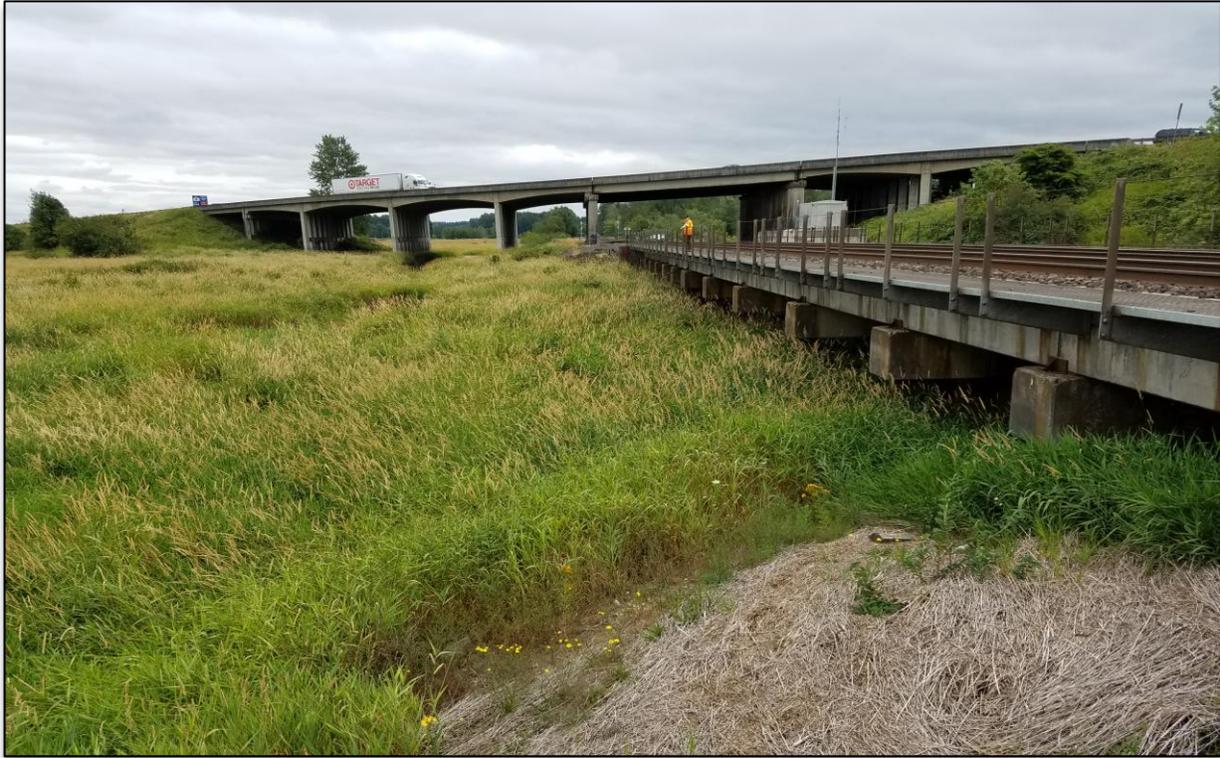
Image 23: DB07: Railroad Bridge

The concrete and steel railroad bridge over Dillenbaugh Creek between exit 76 and exit 77 is a double-track structure of frequent use. The bridge is utilized and maintained by BNSF Railway and Union Pacific so the structural condition is outside of the scope of this report. Visual inspection at the site visit on July 7<sup>th</sup> revealed no conspicuous damages from floodwater.

Based on the base flood elevation values observed in 2007, the depth of flow is 17 ft with an allowable depth of 12.5 ft to bridge low chord height. By this standard, the bridge is undersized. However, flood waters are permitted to overtop a roadway provided that it is not an emergency route and the structure and embankment are designed to withstand the flows. For the purposes of this report, we will assume BNSF Railway and Union Pacific designed the bridge to withstand the floodwaters of Dillenbaugh Creek.

The concrete and steel railroad bridge of DB07 is hydraulically sized for the 25 and 100-year storm events when analyzed using Manning’s equation or the HEC-RAS modeling program. The Preliminary FEMA FIRMs show 100-year flood waters overtopping the bridge but do not appear to be retained or obstructed by the structure. The flow velocity for both evaluated rain events is within the preferred values. The concrete railroad bridge is adequately sized to provide fish passage.

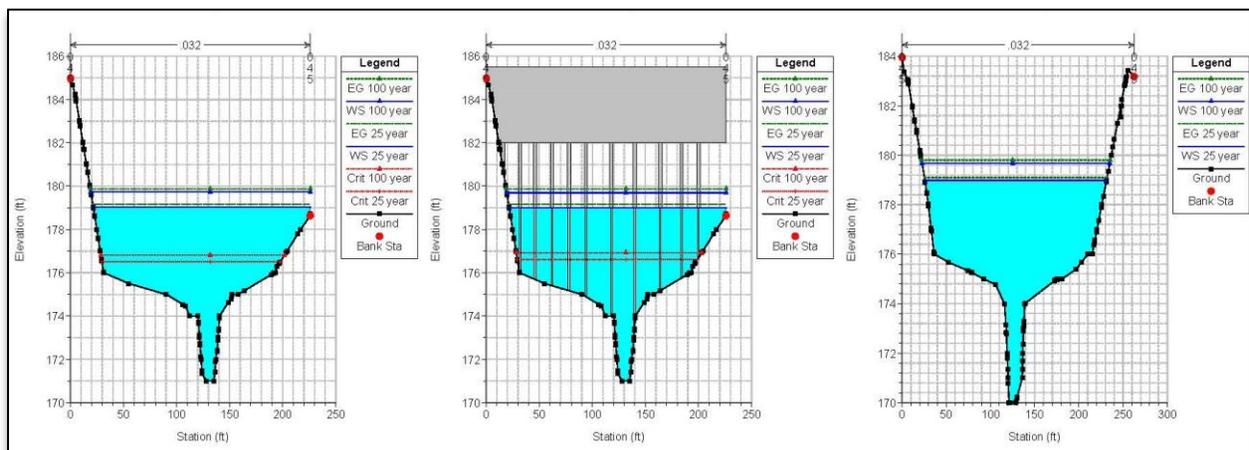
**Figure 10: HEC-RAS Upstream, Bridge, and Downstream Cross Sections**

Based on the modeled values, the 25-year rain event has a flow depth 3.49 ft less than the allowable value and the 100-year rain event has a flow depth 0.10 ft less than the allowable value. These values are lower than the observed flows of 2007 but reasonable given the model did not include the backwater effects of the Chehalis River. The downstream cross sections do not show a reduction in flow depth

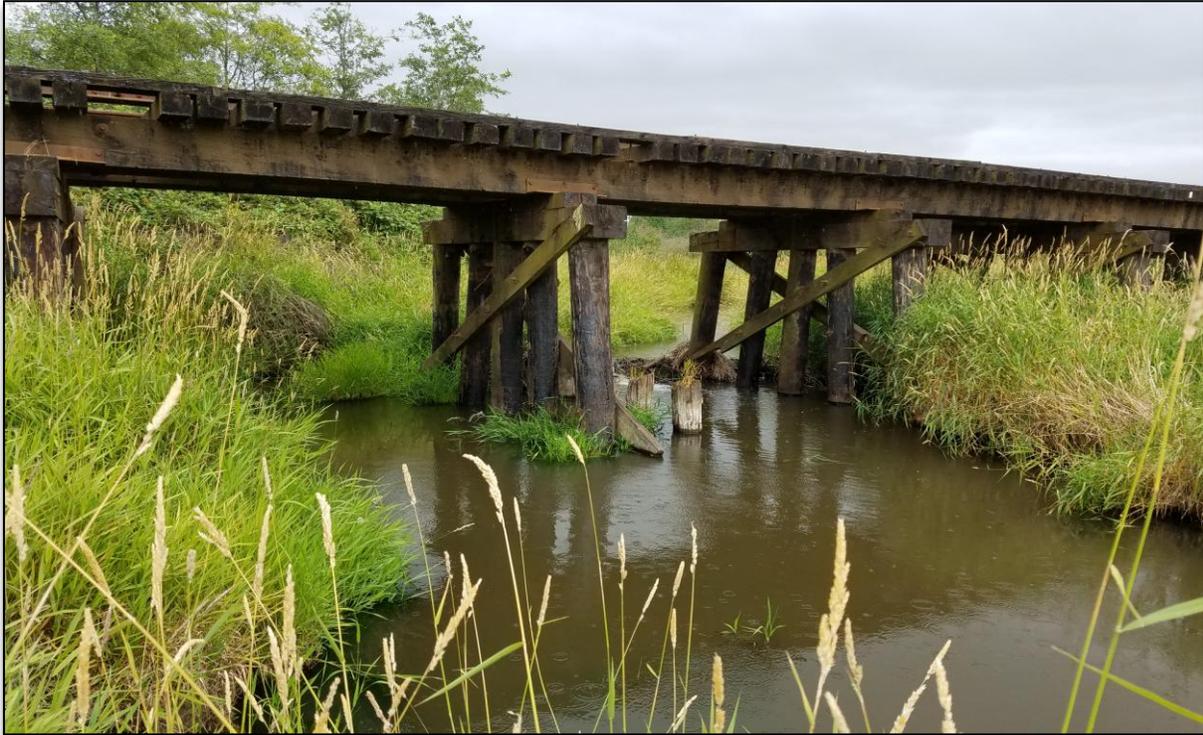
Image 25: DB06: Railroad Bridge

The timber railroad bridge over Dillenbaugh Creek near Exit 77 is a single-track structure of minor use. A visual inspection of the bridge was completed through field documented photographs and video. There are no obvious signs of serious deterioration above water for the timber truss bridge. There are typical cracks often associated with timber beams and pilings but as the timbers are creosote<sup>22</sup> treated, there is minimal impact from the freshwater creek. The metal hardware has typical signs of surface rust, but none of the bolts appear to be missing or compromised. Typical inspection for a more detailed inspection would include the following methods:

Based on the base flood elevation values observed in 2007, the depth of flow is 17.44 ft with an allowable depth of 11 ft. For this method of analysis, the bridge is undersized.

The timber railroad bridge of DB06 is hydraulically undersized for the 25 and 100-year storm events. The bridge is located in a flat area prone to flooding and the deck is set at the elevation of the surrounding ground. According to the FEMA FIRMs and the Manning's Equation calculations, the area surrounding and including the bridge will be underwater during significant rain events. It must be structurally designed to withstand the flooding characteristic to its location. By the analysis of the HEC-RAS model, the bridge is adequately sized to allow floodwaters to flow with adequate freeboard. The difference in values from the observed values to the modeled values can be attributed to the backwater flooding of the Chehalis River during the 100-year rain event. There is little change in flow depth across the bridge so one could conclude that the bridge is not an obstruction to high water flows and is not the cause of local area flooding. The conclusion of this report is that it is hydraulically undersized for the Dillenbaugh Creek flows and should be structurally reinforced to withstand the backwater flooding of the Chehalis River during the 100-year storm. The timber bridge is adequately sized to provide fish passage.

- Conduct initial visual assessment with hammer sounding.
- Obtain moisture content measurements in suspect and decay prone areas.
- Establish baseline NDE data by collecting stress wave and resistance micro-drilling data from areas of suspected sound wood
- Investigate marked areas to measure the extent of internal deterioration by utilizing stress wave timer and resistance micro-drilling tool as needed.

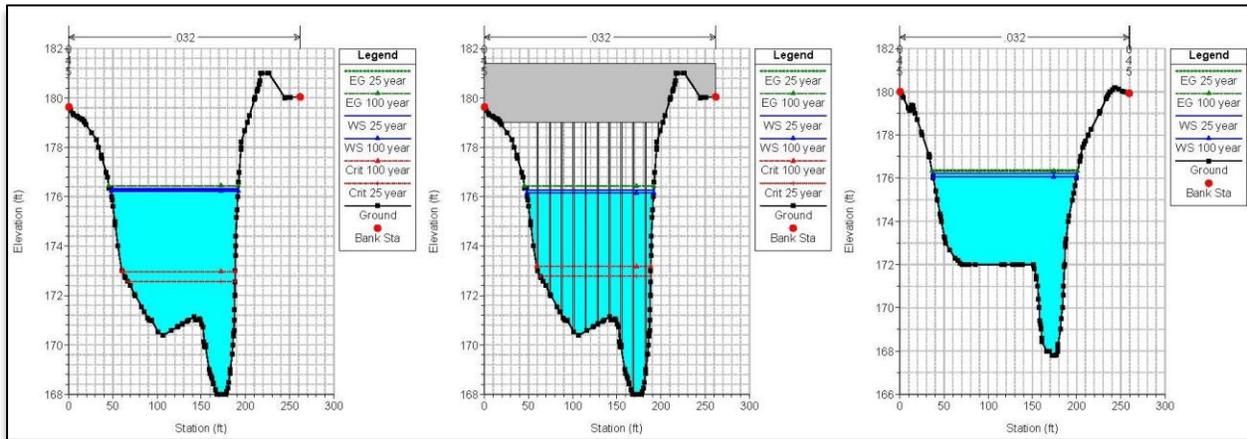
**Figure 11: HEC-RAS Upstream, Bridge, and Downstream Cross Sections**

Based on the calculated values, the 25-year rain event has a flow depth 1.23 ft greater than the allowable value and the 100-year rain event has a flow depth 1.83 ft greater than the allowable value. These values are slightly lower than the observed values of the 2007 flood as these calculations only consider the input of the Dillenbaugh Creek flows and the resulting floodwater elevations. At this

location during a 25 or 100-year storm event, the Chehalis River has overtopped its banks and flooded the surrounding area, to include this bridge location. The observed values as documented by the Preliminary FIRMs reflect floodwater elevations influence by the Chehalis River and Dillenbaugh Creek. It may not be accurate to say the bridge is undersized, but rather it must be structurally designed to withstand the flooding characteristic to its location. The velocity is within the allowable range and is not a cause for concern.

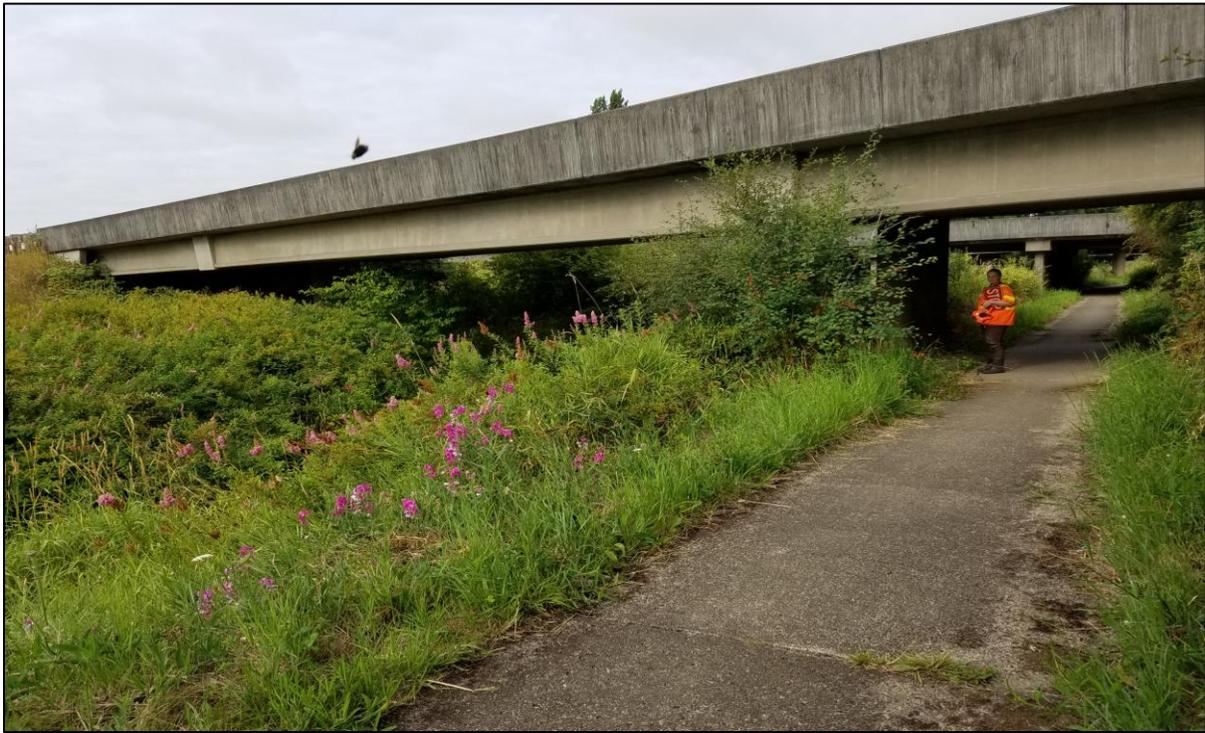
Image 27: DB05: Bridge for I-5 Off-Ramp @ Exit 7

The reinforced concrete bridge of DB05 is hydraulically undersized for the 25 and 100-year storm events as indicated by the FEMA FIRMs and the Manning’s equation analysis. The bridge is located in an area prone to flooding and it should be assumed the bridge deck will be submerged during the 25 and 100-year rain events. It must be structurally designed to withstand the flooding characteristic to its location. There is little change in flow depth across the bridge so one could conclude that the bridge is not an obstruction to high water flows and is not the cause of local area flooding. The conclusion of this report is that it is hydraulically undersized for the Dillenbaugh Creek flows and should be structurally reinforced to withstand the backwater flooding of the Chehalis River during the 100-year storm. The concrete bridge is adequately sized to provide fish passage.

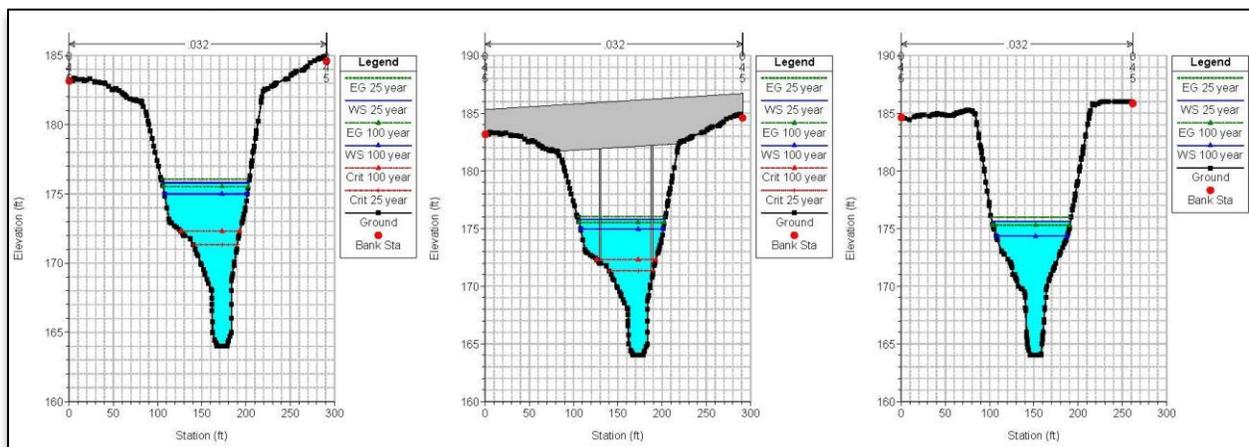
**Figure 12: HEC-RAS Upstream, Bridge, and Downstream Cross Sections**

Based on the calculated values, the 25-year rain event has a flow depth 4.07 ft greater than the allowable value and the 100-year rain event has a flow depth 4.96 ft greater than the allowable value. These values are slightly less than the observed values of the 2007 flood as these calculations only consider the input of the Dillenbaugh Creek flows and the resulting floodwater elevations. At this location during a 25 or 100-year storm event, the

Chehalis River has overtopped its banks and flooded the surrounding area, to include this bridge location. The observed values as documented by the Preliminary FIRMs reflect floodwater elevations influence by the Chehalis River and Dillenbaugh Creek. It may not be accurate to say the bridge is undersized, but rather it must be structurally designed to withstand the flooding characteristic to its location. The velocity is within the allowable range and is not a cause for concern.

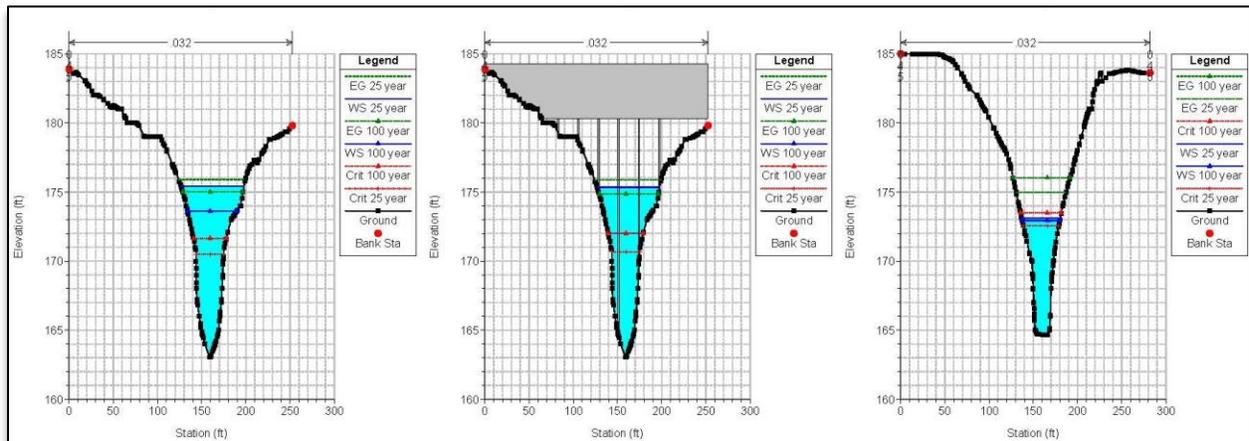
**Figure 13: HEC-RAS Upstream, Bridge, and Downstream Cross Sections**

Based on the calculated values, the 25-year rain event has a flow depth 1.56 ft less than the allowable value and the 100-year rain event has a flow depth 0.71 ft less than the allowable value. These values are less than the observed values of the 2007 flood as these calculations only consider the input of the Dillenbaugh Creek flows and the resulting floodwater elevations. At this location during a 25 or

100-year storm event, the Chehalis River has overtopped its banks and flooded the surrounding area, to include this bridge location. The observed values as documented by the Preliminary FIRMs reflect floodwater elevations influence by the Chehalis River and Dillenbaugh Creek. It may not be accurate to say the bridge is undersized, but rather it must be structurally designed to withstand the flooding characteristic to its location. The calculated velocity is lower than the allowable range, but site visits showed no sign of sedimentation.

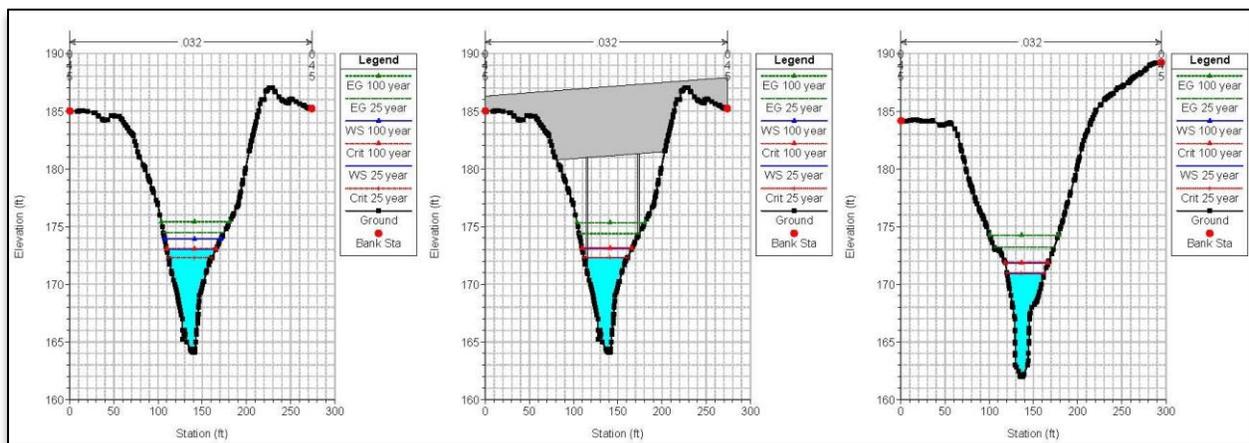
**Figure 14: HEC-RAS Upstream, Bridge, and Downstream Cross Sections**

Based on the calculated values, the 25-year rain event has a flow depth 1.93 ft less than the allowable value and the 100-year rain event has a flow depth 1.04 ft less than the allowable value. These values are slightly less than the observed values of the 2007 flood as these calculations only consider the input of the Dillenbaugh Creek flows and the resulting floodwater elevations. At this location during a 25 or

100-year storm event, the Chehalis River has overtopped its banks and flooded the surrounding area, to include this bridge location. The observed values as documented by the Preliminary FIRMs reflect floodwater elevations influence by the Chehalis River and Dillenbaugh Creek. It may not be accurate to say the bridge is undersized, but rather it must be structurally designed to withstand the flooding characteristic to its location. The velocity is within the allowable range and is not a cause for concern.
