# ***CONDITION REPORT***

## ***Dillenbaugh Creek Culvert Assessment***

***January 2017***

**City of Chehalis**

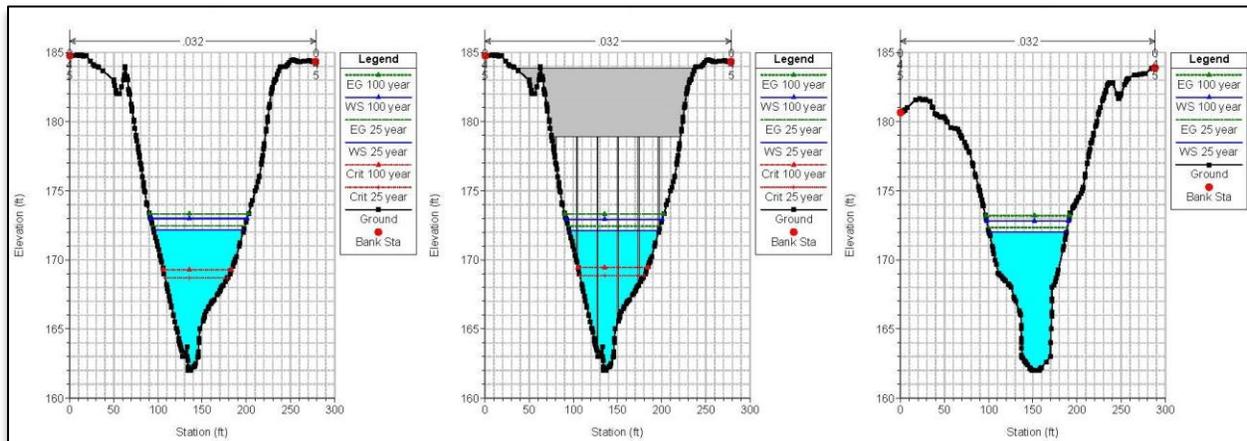
**Figure 15: HEC-RAS Upstream, Bridge, and Downstream Cross Sections**

Based on the calculated values, the 25-year rain event has a flow depth 1.50 ft less than the allowable value and the 100-year rain event has a flow depth 0.61 ft less than the allowable value. These values are less than the observed values of the 2007 flood as these calculations only consider the input of the Dillenbaugh Creek flows and the resulting floodwater elevations. At this location during a 25 or

100-year storm event, the Chehalis River has overtopped its banks and flooded the surrounding area, to include this bridge location. The observed values as documented by the Preliminary FIRMs reflect floodwater elevations influence by the Chehalis River and Dillenbaugh Creek. It may not be accurate to say the bridge is undersized, but rather it must be structurally designed to withstand the flooding characteristic to its location. The calculated velocity is lower than the allowable range, but site visits showed no sign of sedimentation.

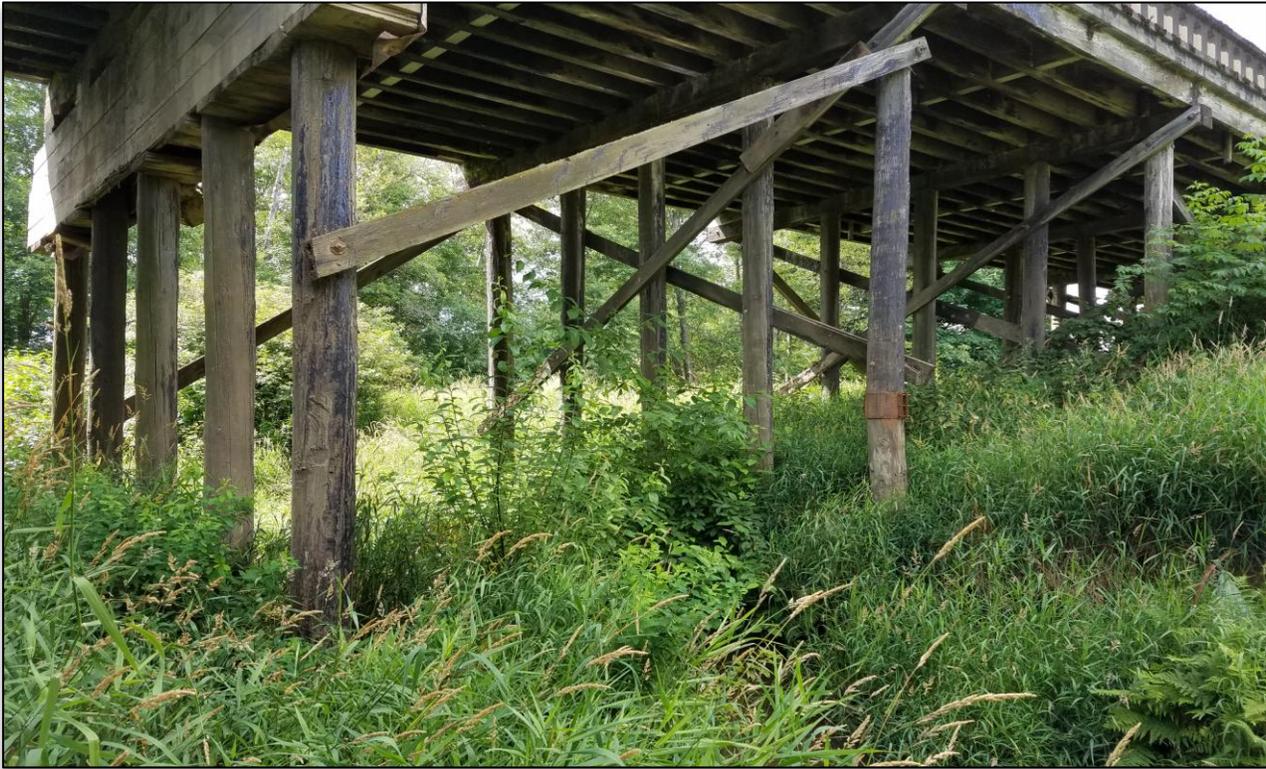
Image 35: DB01: Bridge for State Route 6

Specifications	
Type	Timber Truss Bridge
Span	1000 feet
Low Chord Height	30 feet
Length	30 feet
Bank Full Width	20.3 feet

Based on the base flood elevation values observed in 2007, the depth of flow is 22.17 ft and did not overtop the roadway. For this method of analysis, the bridge is adequately sized.
